# Special Report 81-3

March 1981

## AN INVESTIGATION OF THE SNOW ADJACENT TO DYE-2, GREENLAND

H.T. Ueda, M.A. Goff and K.G. Nielsen

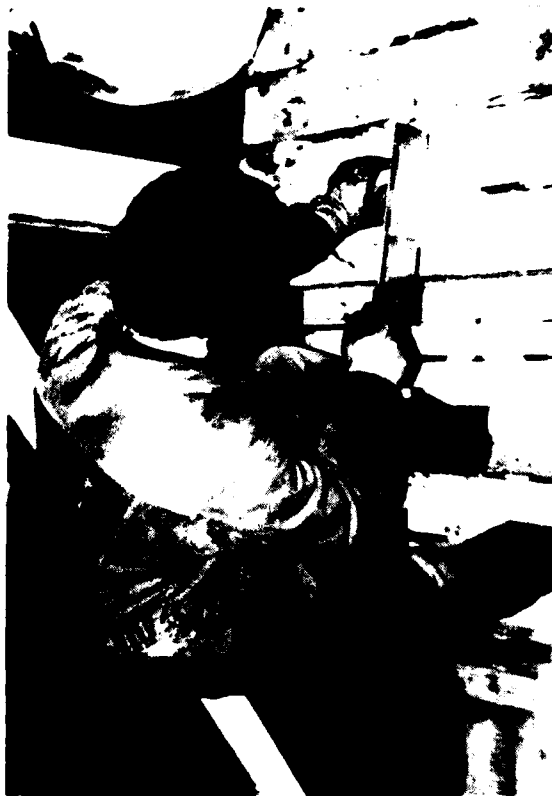
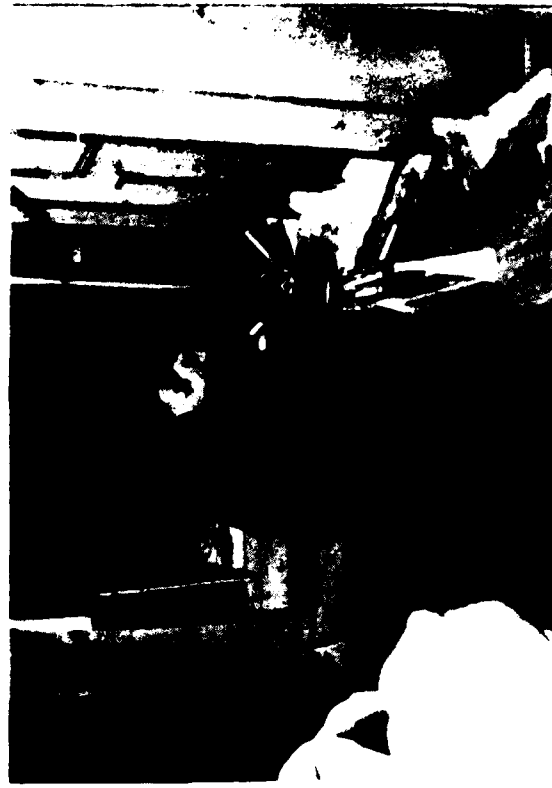
Figure 6 Sample preparation

a Rough squaring of sample ends in a wooden miter box

b Smoothing sample ends in a steel V-block

Usually one sample per drilling run was selected for testing. The ends of the sample were first rough-trimmed with a hand saw and a wooden miter box. Next, the sample was placed in a steel V-block where the ends were smoothed and squared. A circumferential measuring tape (Pi-tape)\* and a steel rule were used to measure the diameter and length, respectively (Fig. 6).

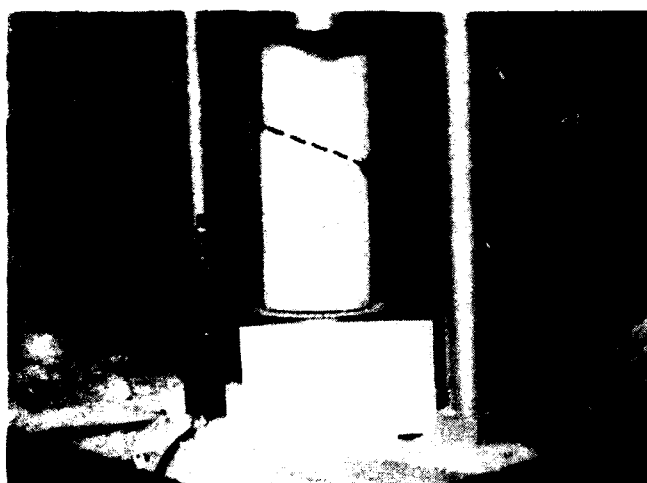
Figure B5. Sample B8, dashed line shows failure mode (time interval 1s).

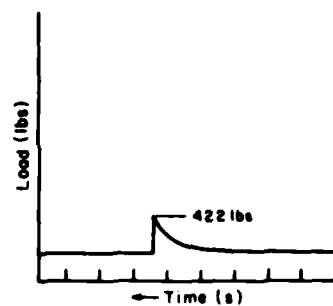
Figure B13. Sample A8, dashed line shows failure mode (time interval 1s).

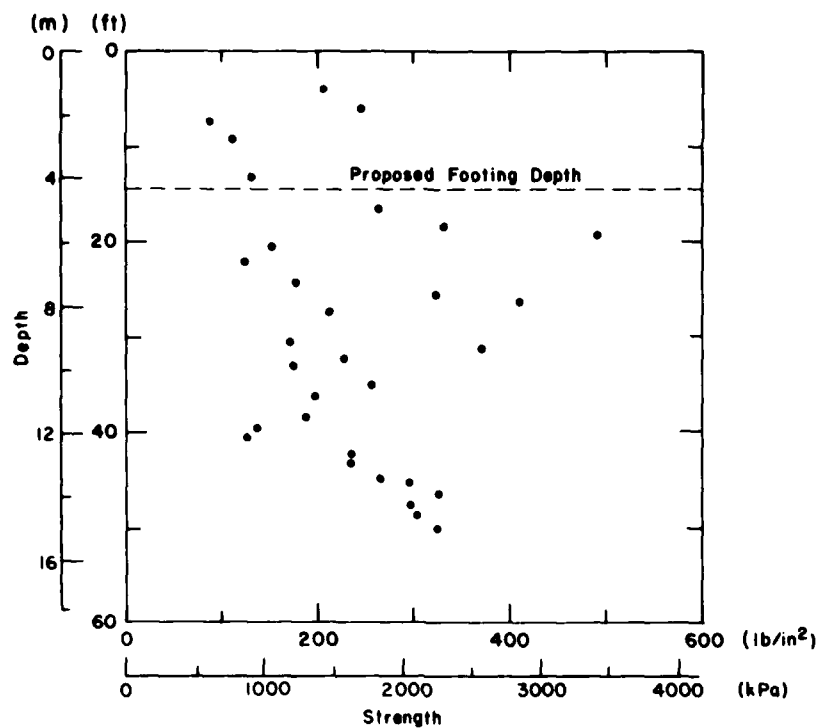
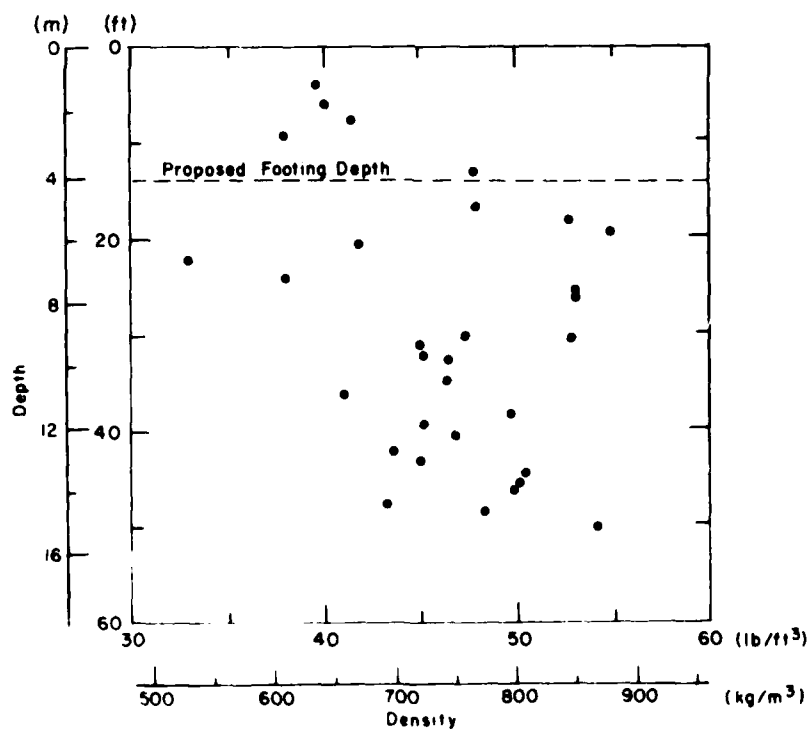
Figure C2. Borehole B, location N1 + 90, DYE-2, 1979.

a. Strength vs depth.

b. Density vs depth.

Uniaxial compressive strength and density are plotted against depth in Appendix C for the five sets of samples. The proposed depth of footings associated with a sideways move are also included. These depths are based on a design footing depth of 15 to 20 ft (4.6 to 6.1 m) below the estimated 1981 snow surface (Tobiasson and Tilton 1980).

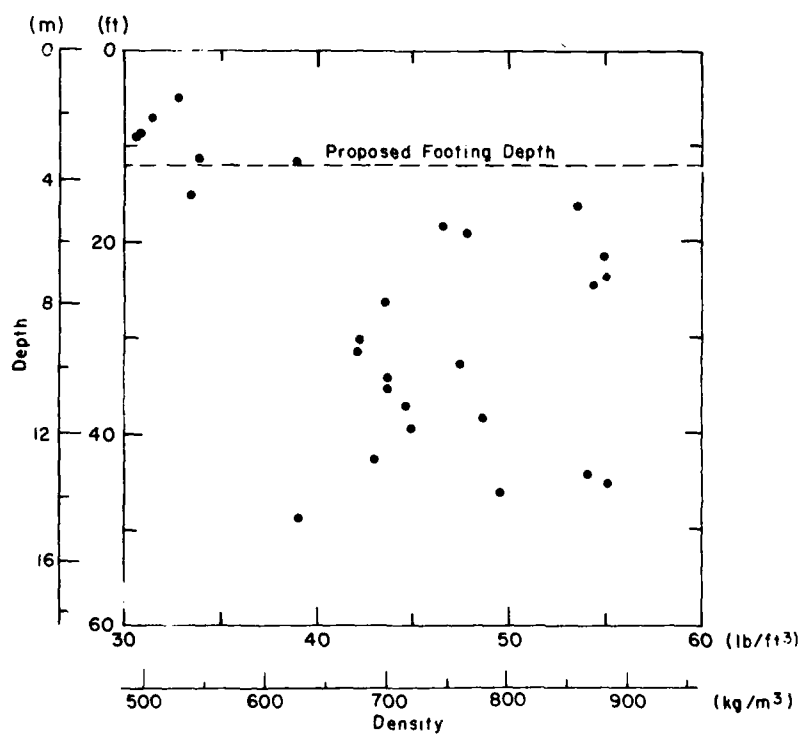
Figure C4. Borehole D, location A1 + 165, DYE-2, 1979.

a. Strength vs depth.

b. Density vs depth.

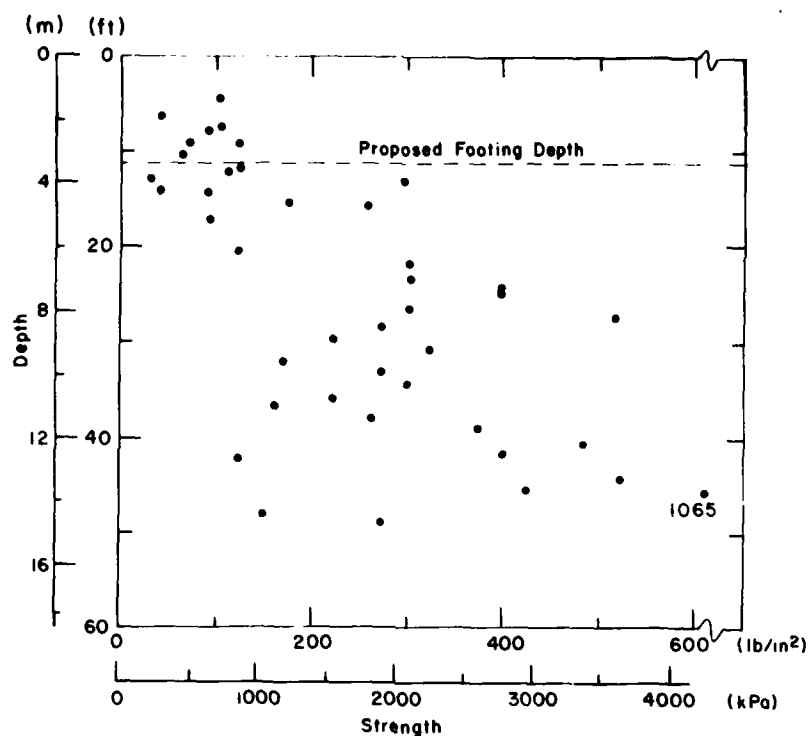
Figure C5. Borehole E, location A1 + 50, DYE-2, 1979.

a. Strength vs depth.

b. Density vs depth.

Below the design footing depths proposed for a sideways move, all samples displayed a strength exceeding 61 psi (0.42 MPa) except for two samples from borehole E. Samples E8 and E13 failed at 41 psi (0.28 MPa) and 31 psi (0.21 MPa) respectively. The value of 31 psi (0.21 MPa) is the minimum measured strength of the snow which will support the footings.
