FLOOD PLAIN INFORMATION

BUSHKILL CREEK VICINITY OF EASTON, PENNSYLVANIA

PREPARED FOR THE LEHIGH-NORTHAMPTON COUNTY JOINT PLANNING COMMISSION BY THE
DEPT. OF THE ARMY, PHILADELPHIA DISTRICT, CORPS OF ENGINEERS, PHILADELPHIA, PA.

JANUARY 1972

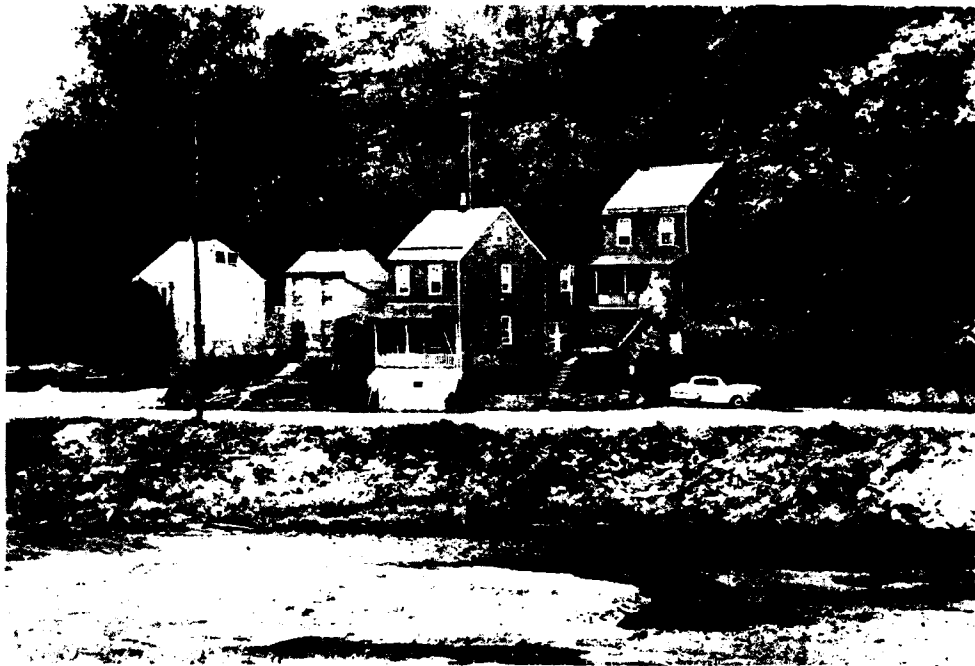
FIGURE 5 - Bushkill Drive at Easton, Pennsylvania, as it normally appeared during the summer of 1955

Figures 5 and 6 provide an unusual opportunity to compare a site before and during a flood.

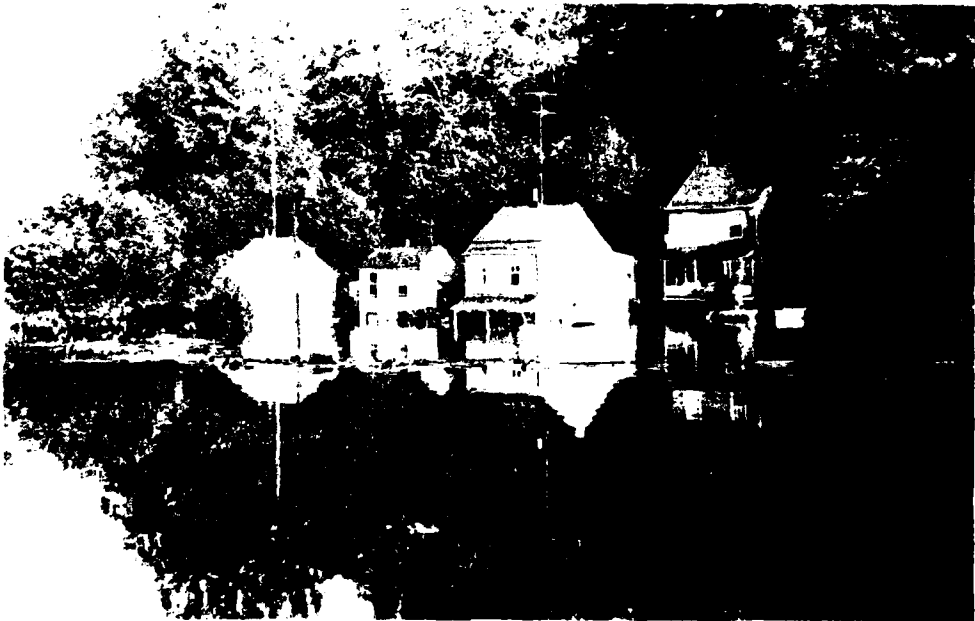
FIGURE 6 - Bushkill Drive at Easton, Pennsylvania, as it appeared during the flood of 18-19 August 1955. Note floating debris in center of photograph.

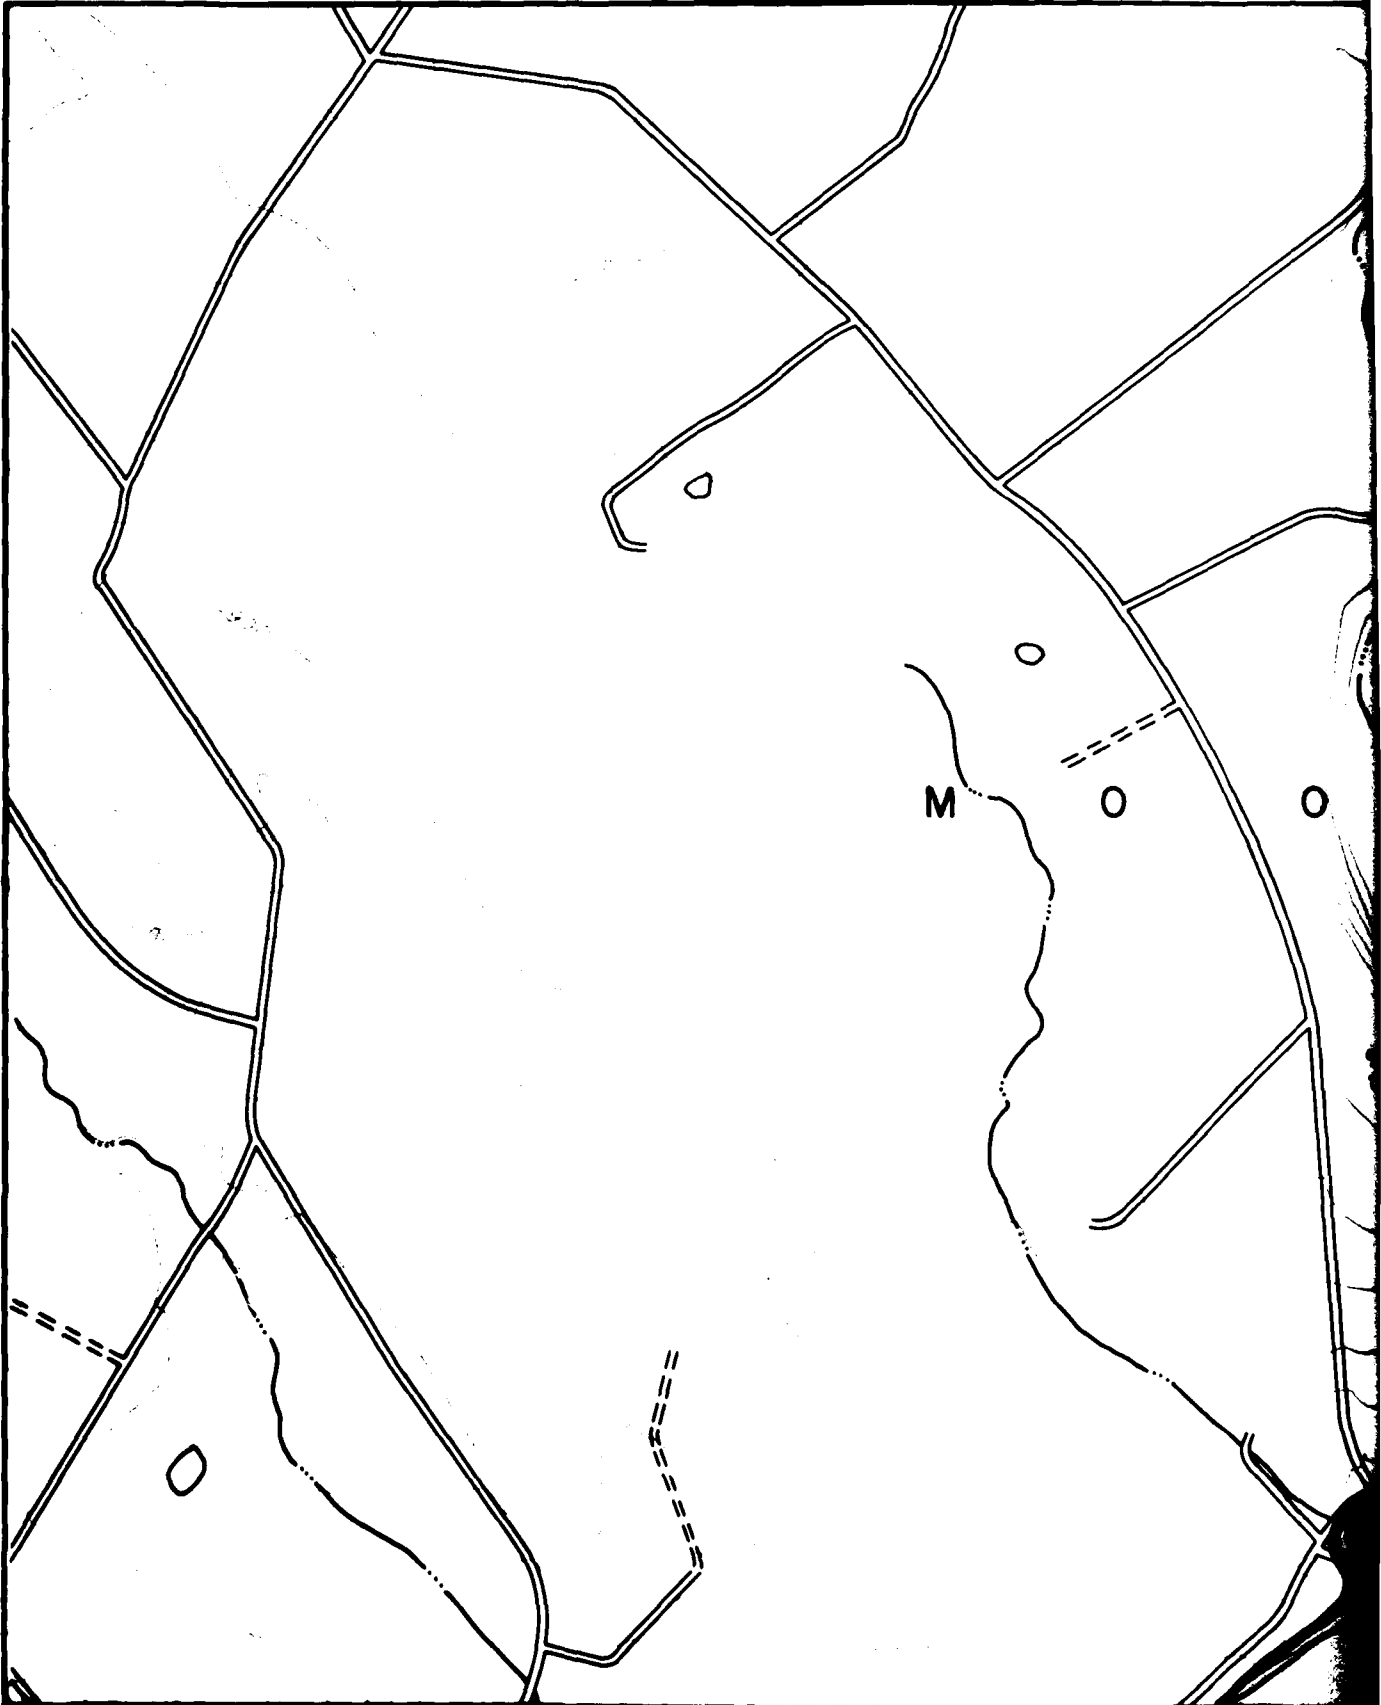
INDEX MAP - FLOODED AREAS

Flooded areas and flood damages - The areas along Bushkill Creek that would be flooded are shown on Plate 2, which is also an index map to Plates 3 through 9. Areas that would be flooded by the Intermediate Regional and Standard Project Floods are shown in detail on Plates 3 through 9. The actual limits of these overflow areas may vary somewhat from those shown on the maps because the 20-foot contour interval and scale of the maps do not permit precise plotting of the flooded area boundaries. As may be seen from these plates, floodflows from Bushkill Creek and Delaware River cover a large portion of Easton and other communities in the area. The areas that would be flooded by the Intermediate Regional and Standard Project Floods include commercial, industrial, and residential sections and the associated Streets, roads, and private and public utilities in Easton and the smaller communities of Tatamy and Stockertown. Considerable damage to these facilities would occur during an Intermediate Regional Flood. However, due to the wider extent, greater depths of flooding, higher velocity flow and longer duration of flooding during a Standard Project Flood, damage would be more severe than during an Intermediate Regional Flood. Plates 10, 11, 12, and 13 show water surface profiles of the Intermediate Regional and Standard Project Floods. Depth of flow in the channel can be estimated from these illustrations. Typical cross sections of the flood plain at selected locations together with the water surface elevation and lateral extent of the Intermediate Regional and Standard Project Floods are shown on Plate 14.
