UPGRADING OF EXISTING STRUCTURES, PHASE III, SHELTER DESIGN OPT--ETC(U)

May 1981

# Upgrading of Existing Structures Phase III Shelter Design Options

FINAL REPORT

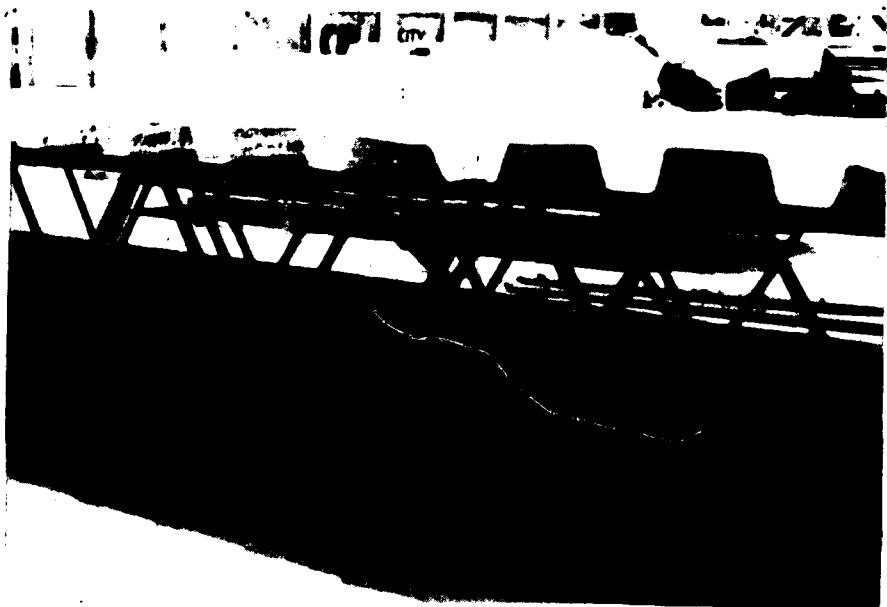
Fig. 2-2. Test Assembly Under Construction.

Photographs of the test assemblies under construction are shown in Figures 2-2 and 2-3, and details are shown in Figures 2-4 and 2-5.

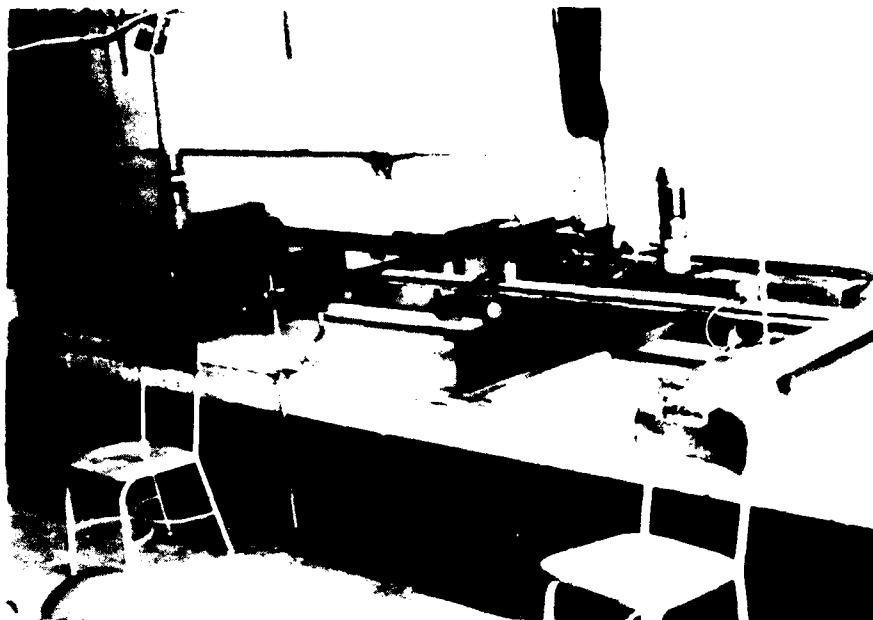
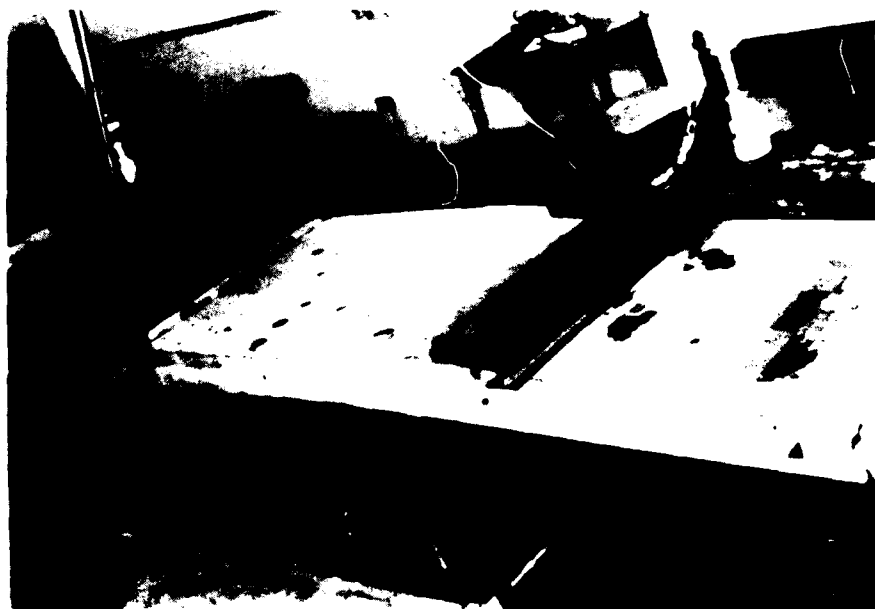
Fig. 3-30. Pre- and Posttest Photographs, Test No. 7.

Figure 3-30 shows the slab before and after test. Figure 3-31 shows the failure near the left support and the right span failure.

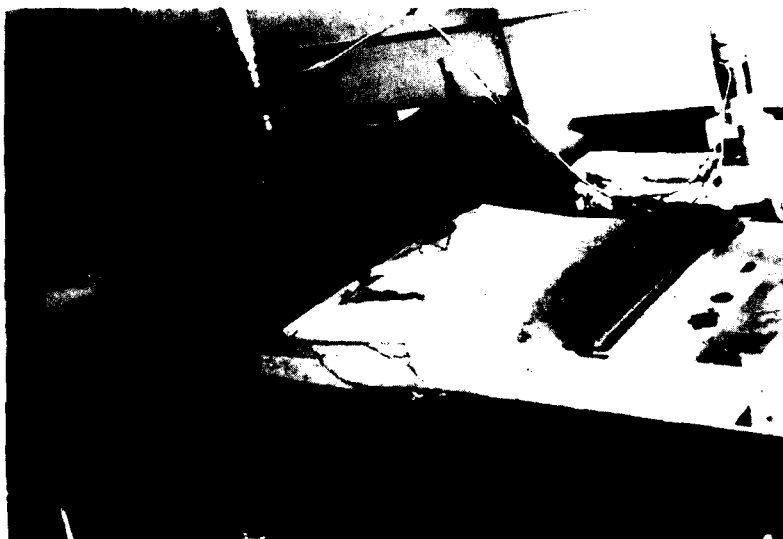
Fig. 3-34. Pre- and Posttest Photographs, Test No. 8.

Figure 3-34 shows the slab before and after test. Figure 3-35A shows the failure of the right span, and Figure 3-35B shows the failure of the center span, which occurred just left of the right shore.

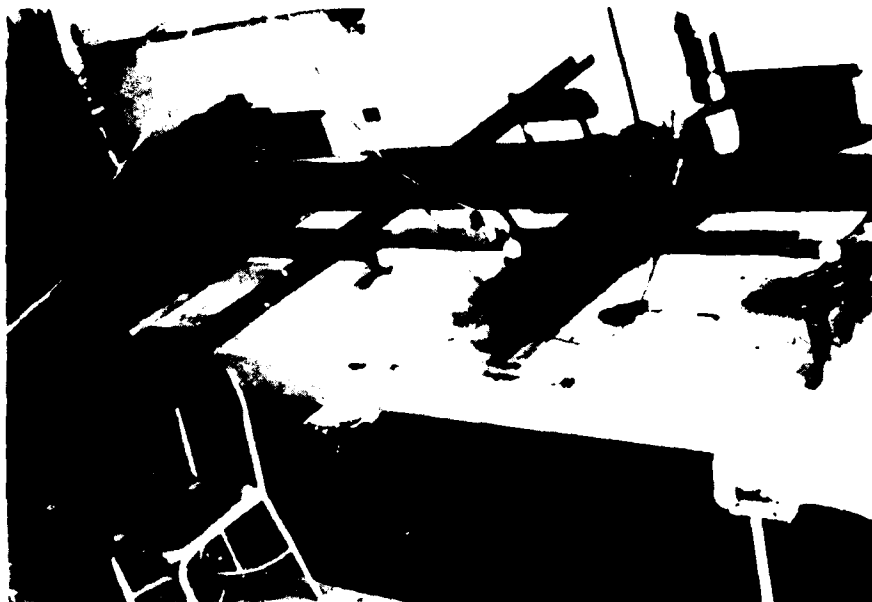
Fig. 3-48. Pre- and Posttest Photographs, Test No. 11.

Figure 3-48A shows the slab prior to test. Figure 3-48B shows the left end of the slab after test. Figure 3-49A shows a closeup of the failed portion of the slab, and Figure 3-49B, the negative moment tension crack over the shore after test.

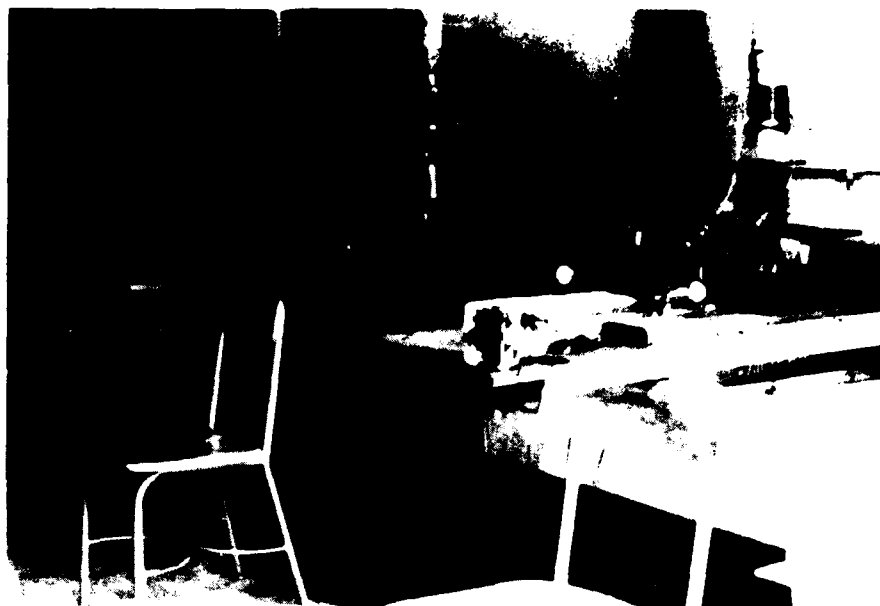
A

Fig. 3-60 Pre- and Posttest Photographs, Test No. 14.

Figure 3-60A shows the slab prior to test. Figure 3-60B shows the failed area immediately after test and before unloading. Figure 3-61A shows the slab after test and after unloading. Figure 3-61B shows a closeup of the failed section.

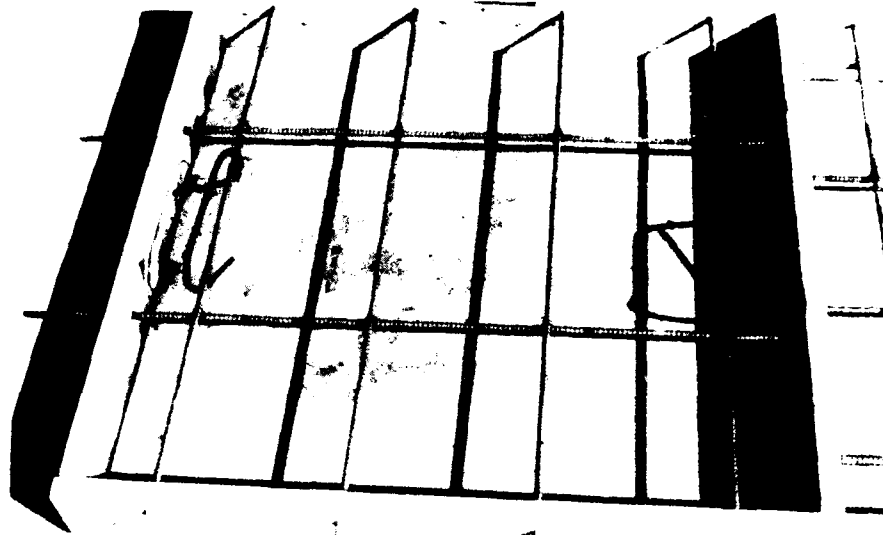
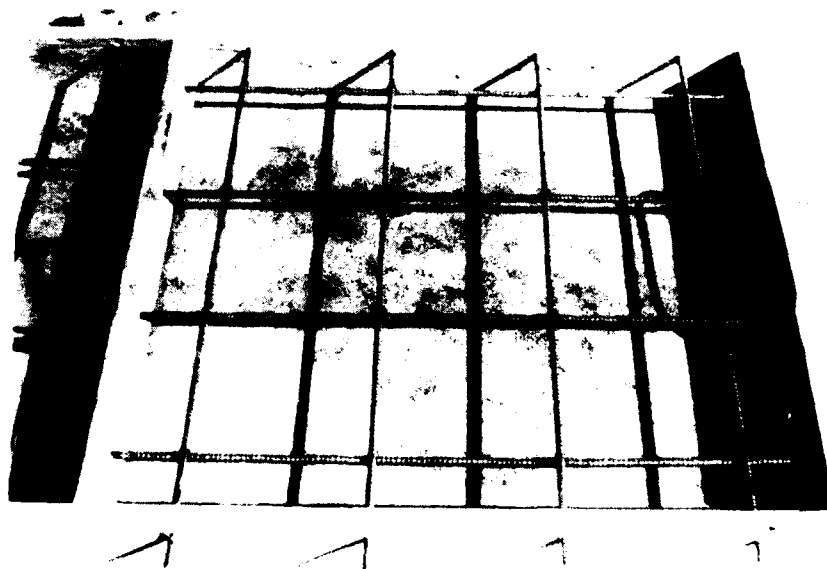
One-Way Slab

Two-Way Slab

Fig. 5-3. Forms Prior to Casting.

Figure 5-3 shows the one-way and two-way slab forms with the steel in place prior to casting.

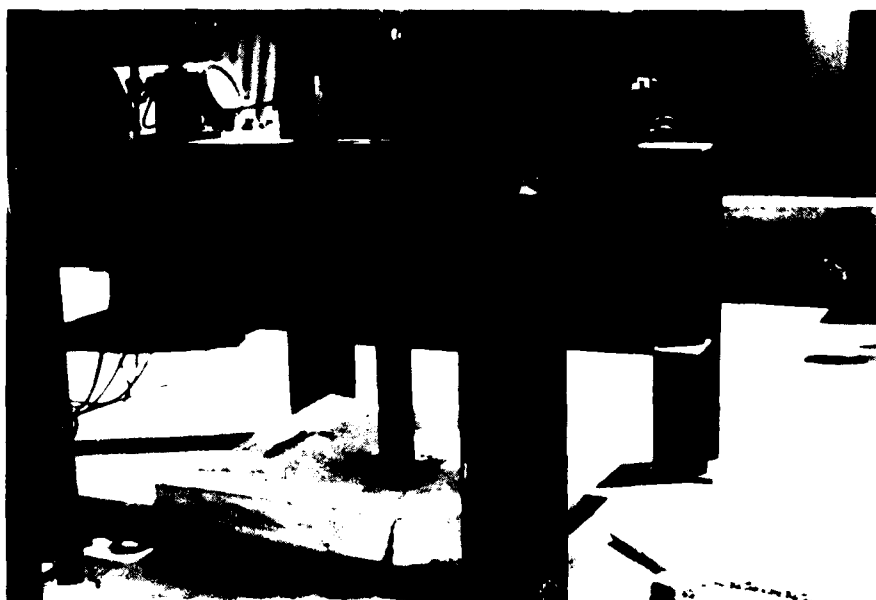
Test No. 4

Test No. 6

Fig. 5-9. Posttest Photographs, Tests Nos. 4 and 6.

A list of all the test results is presented in Table 5-1. Figures 5-7 through 5-11 show a representative sampling of the slabs after test.

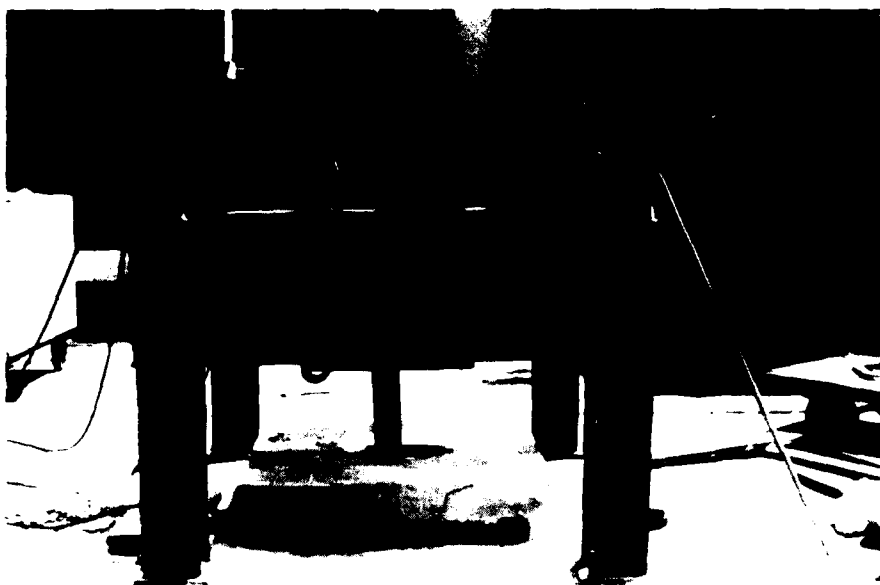
Test No. 7

Test No. 8

Fig. 5-10. Posttest Photographs, Tests Nos. 7 and 8.
