CORPS OF ENGINEERS BUFFALO N Y BUFFALO DISTRICT  
FLOOD PLAIN INFORMATION, CUYAHOGA RIVER, MANTUA AND HIRAM, PORT--ETC(U)  
APR 72

| REPORT DOCUMENTATION PAGE | | READ INSTRUCTIONS<br>BEFORE COMPLETING FORM |
|---|---|---|
| Flood Plain Information Cuyhoga River<br>Mantua and Hiram,<br>Portage County, Ohio, | | Final |
| U.S. Army Engineer Distrist, Buffalo<br>1776 Niagara Sreet<br>Buffalo, New York 14207 | | 1021 |

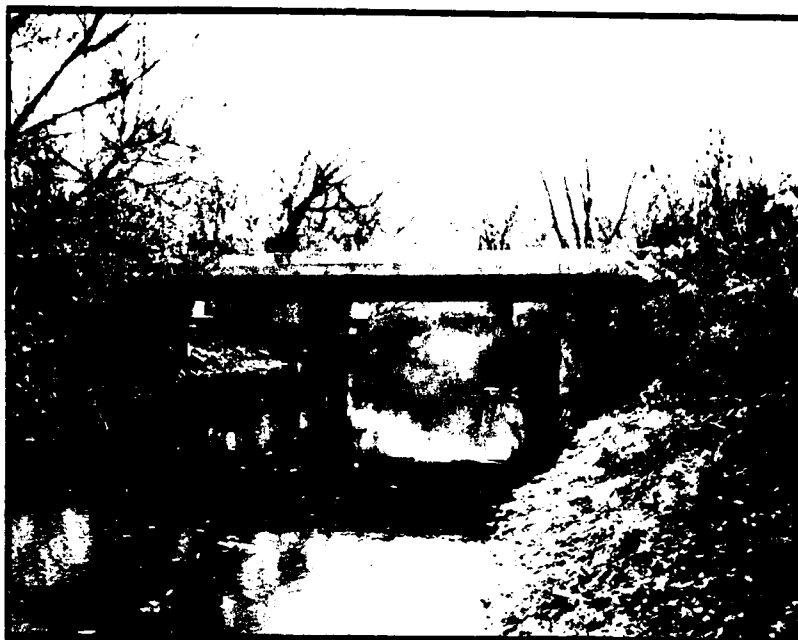
Figure 2 - Looking downstream at Gravel Road bridge,  
stream mile 69.25.

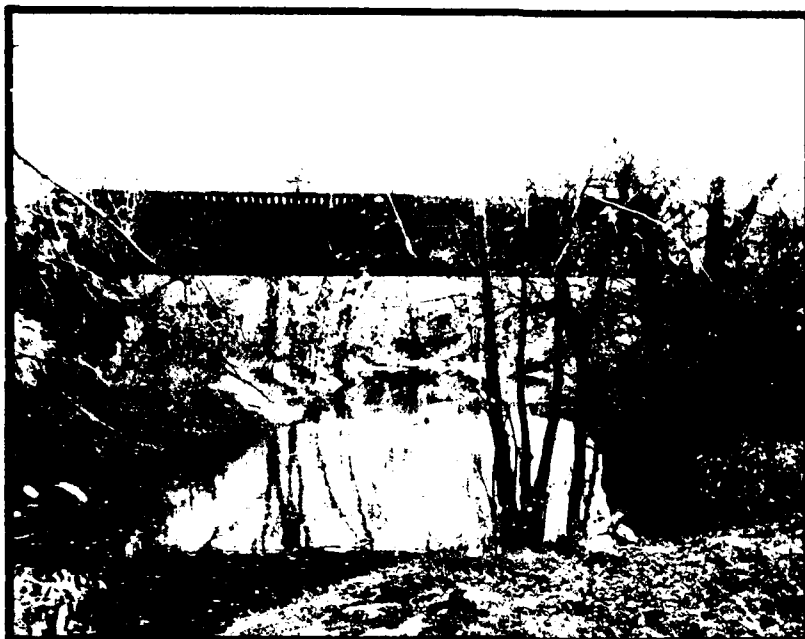
Figure 4 - Looking downstream at Erie - Lackawanna  
Railway bridge, stream mile 69.92.

Various channel conditions in the study area are shown on figures 4 through 8. Table 2 shows various drainage areas within the Cuyahoga River basin.

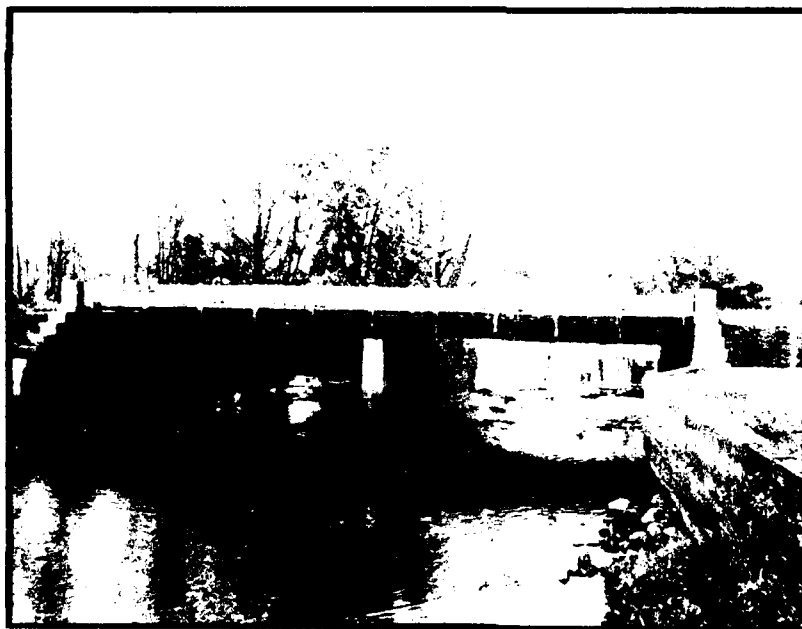
Figure 5 - Looking upstream at Mennonite Road bridge,  
stream mile 70.19.

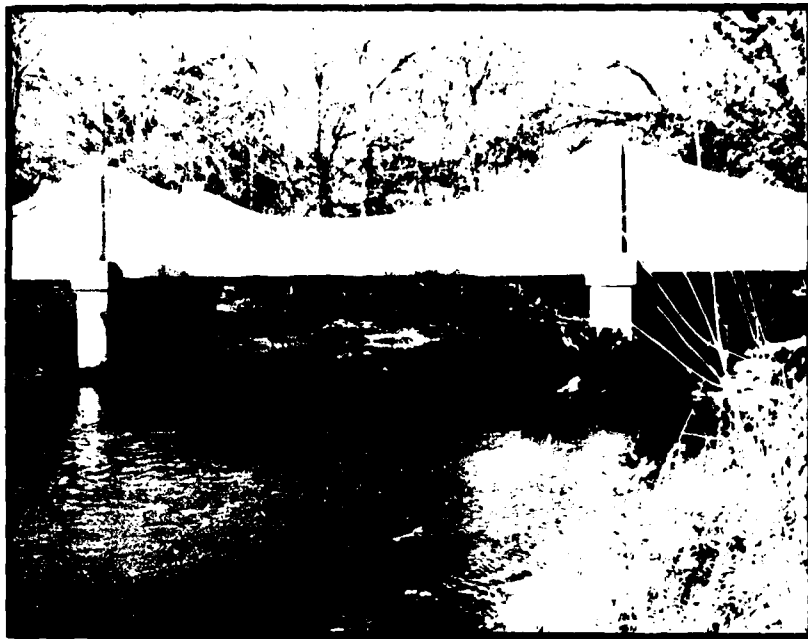
Figure 6 - Looking upstream at Pioneer Trail bridge,  
stream mile 71.71.

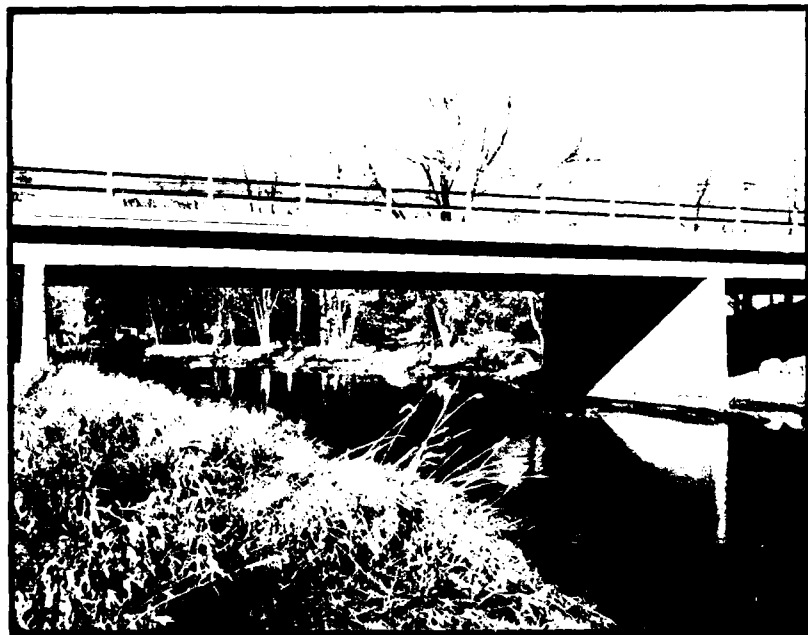
Figure 7 - Looking upstream at Ohio State Route 82  
bridge, stream mile 72.63.

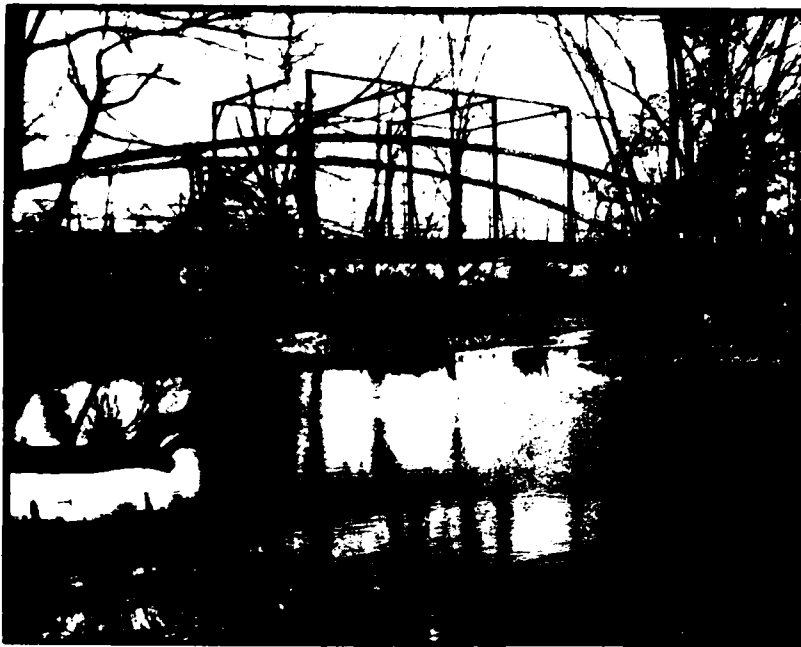
Figure 8 - Looking upstream at Allyn Road bridge,  
stream mile 75.63.

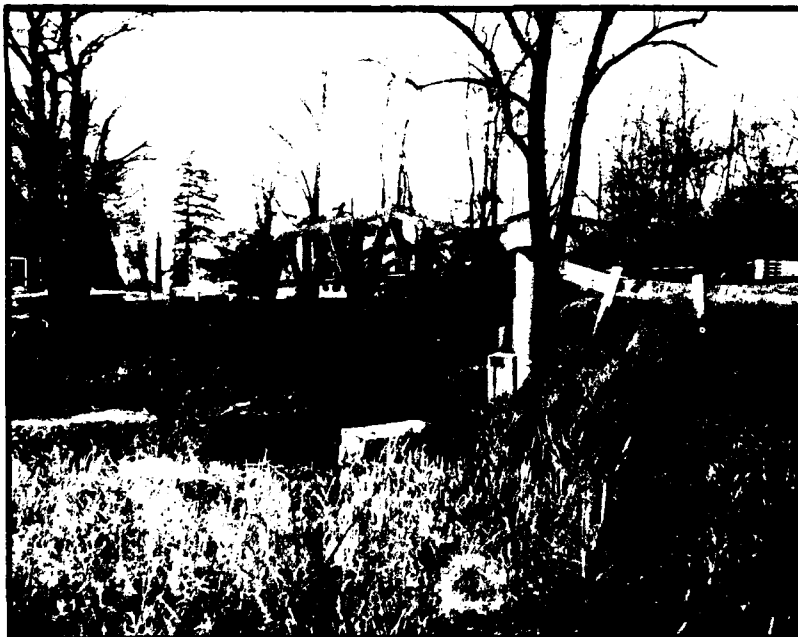
Figure 9 - Looking upstream at Winchell Road bridge,  
stream mile 75.80.

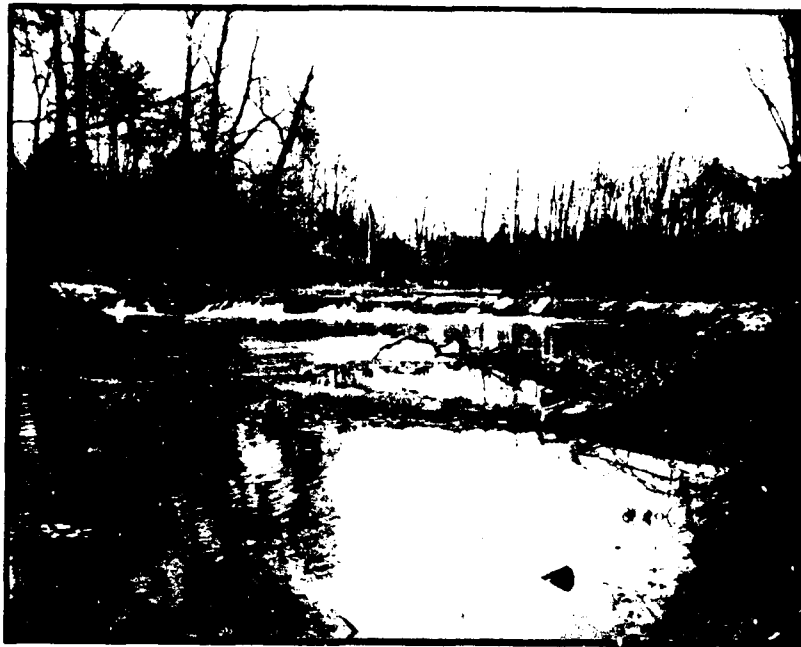
Figure 10 - Looking upstream at the dam at stream mile 74.72.

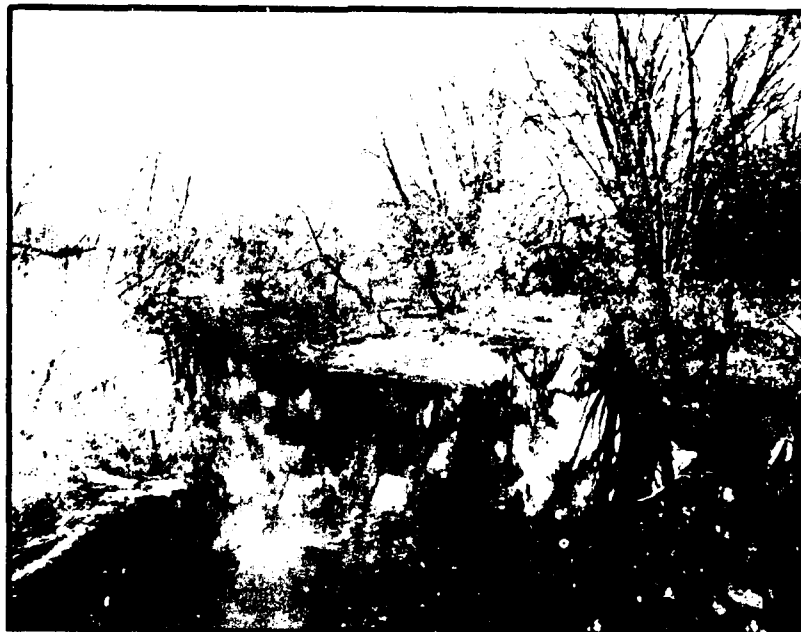
Figure 11 - Typical obstruction in the study area, stream mile 69.40.

OBSTRUCTIONS TO FLOOD FLOWS - Inadequate bridge areas, abandoned dams, encroachments, and fills are some of the obstructions to flood flows. Other serious obstructions are bends in the stream, irregularity of channel section, and heavy brush, weeds, and large trees growing on the channel banks and extending into the stream. Figures 11 and 12 show typical obstruction in the study area, which tend to reduce floodway capacity and increase river stages. Figures 13 and 14 show channel sections in the study area which are fairly free of obstructions. However, both of these photos show a heavy brush growth in the overbank areas which would tend to restrict flow during floods.

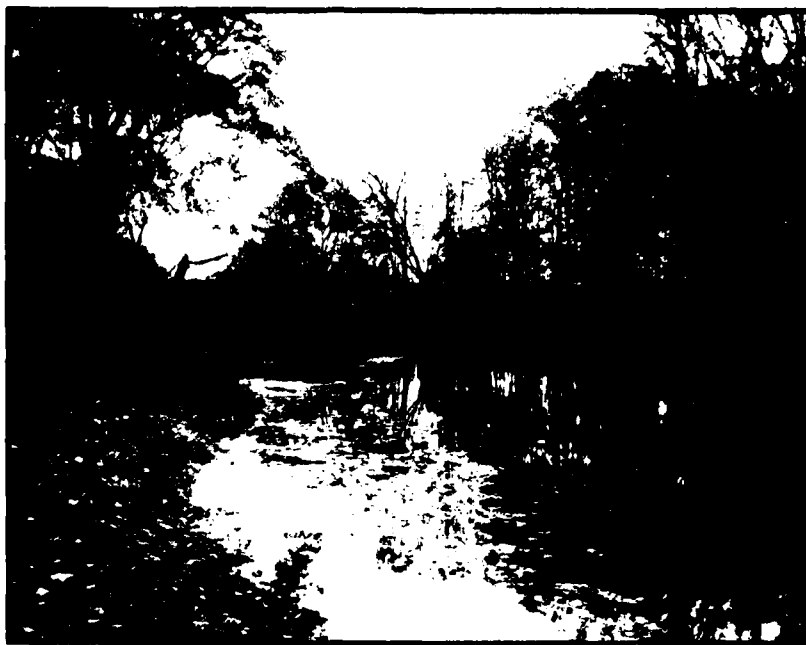
Figure 12 - Typical obstruction in the study area, stream mile 74.72.

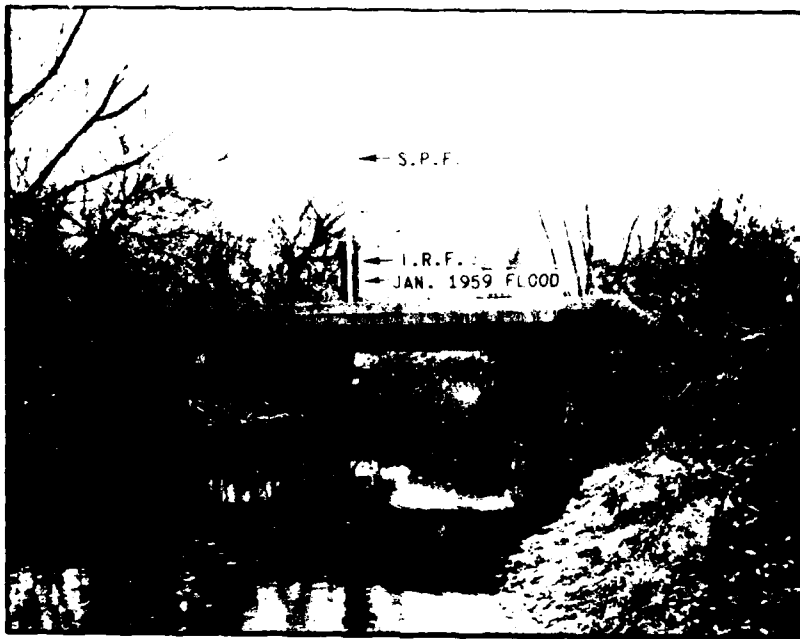
Figure 17 - Arrows indicate the heights of the Standard Project, Intermediate Regional, and January 1959 floods at the gravel road bridge, stream mile 69.25.

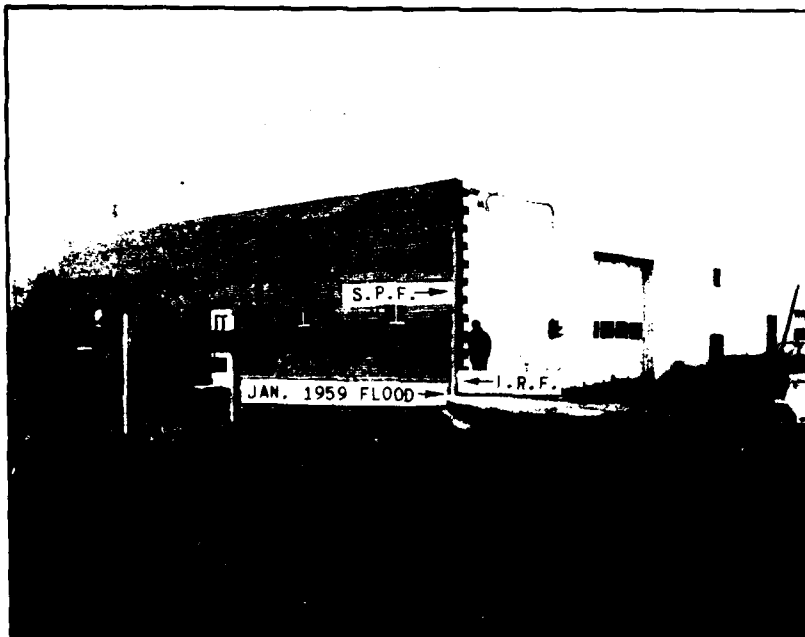
Figure 18 - Arrows indicate the heights of the Standard Project, Intermediate Regional, and January 1959 floods at Tummonds Corporation on State Route 44, stream mile 69.30

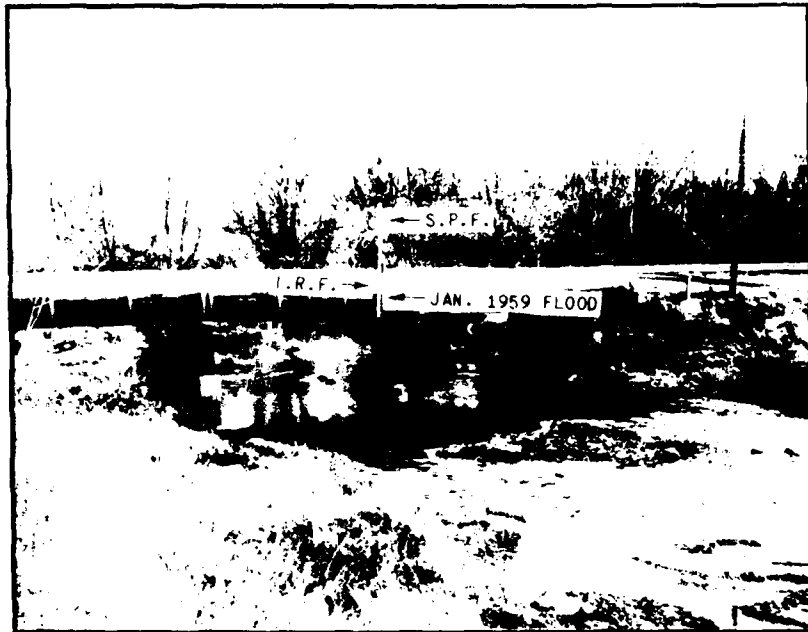
Figure 21 - Arrows indicate the heights of the Standard Project, Intermediate Regional, and January 1959 floods on the downstream side of State Route 44 bridge, stream mile 69.40.

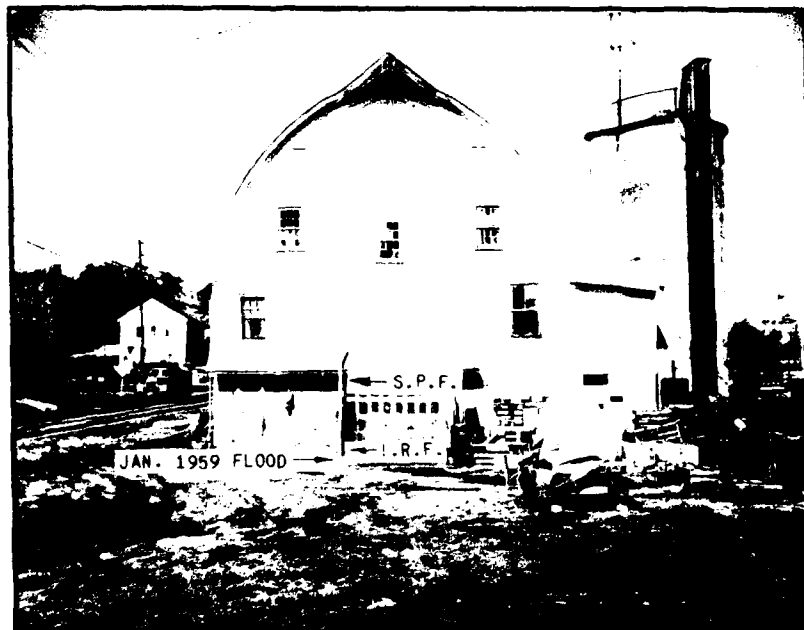
Figure 22 - Arrows indicate the heights of the Standard Project, Intermediate Regional, and January 1959 floods on the Modern Cement Company building upstream of State Route 44, stream mile 69.43.

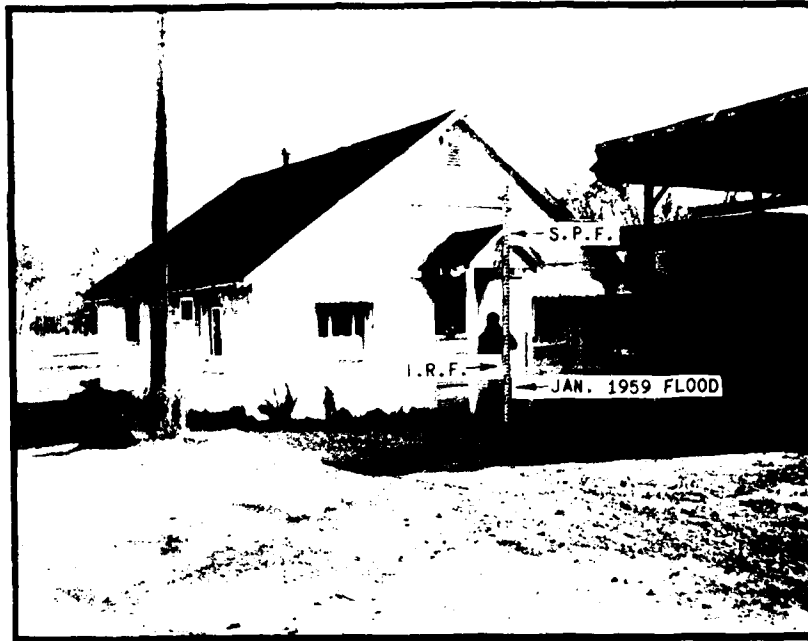
Figure 23 - Arrows indicate the heights of the Standard Project, Intermediate Regional, and January 1959 floods on the Wells Truck Lines office building, upstream of State Route 44, stream mile 69.45.

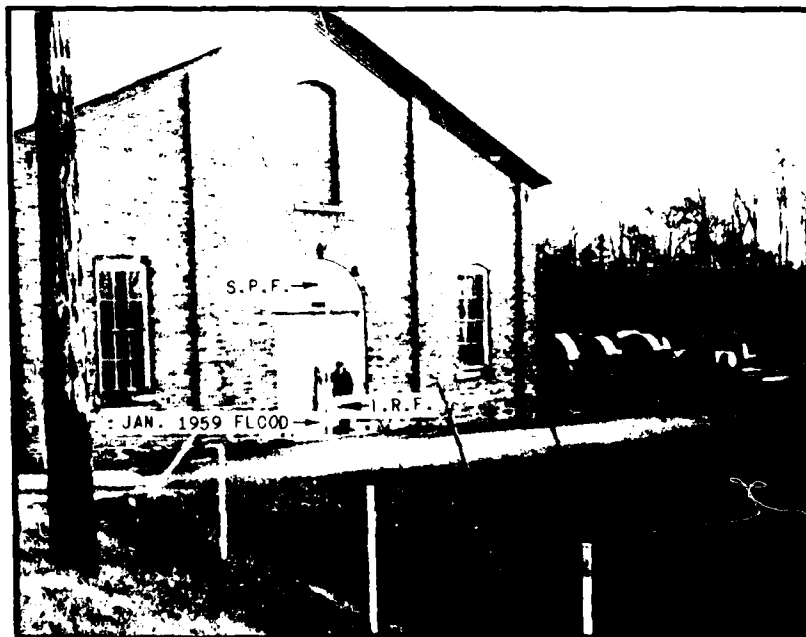
Figure 24 - Arrows indicate the heights of the Standard Project, Intermediate Regional, and January 1959 floods on a building located just downstream of Mennonite Road bridge, stream mile 70.15.

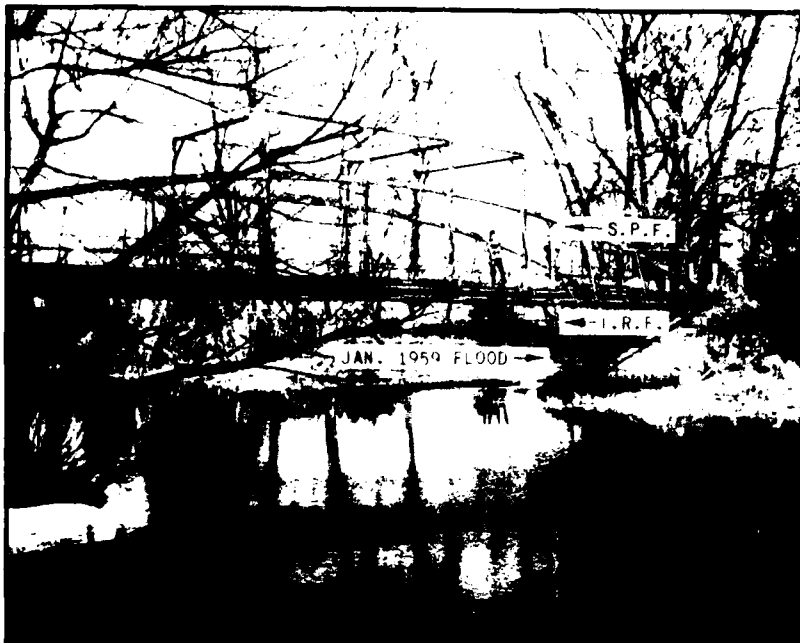
Figure 25 - Arrows indicate the heights of the Standard Project, Intermediate Regional, and January 1959 floods at Allyn Road bridge, stream mile 75.63.

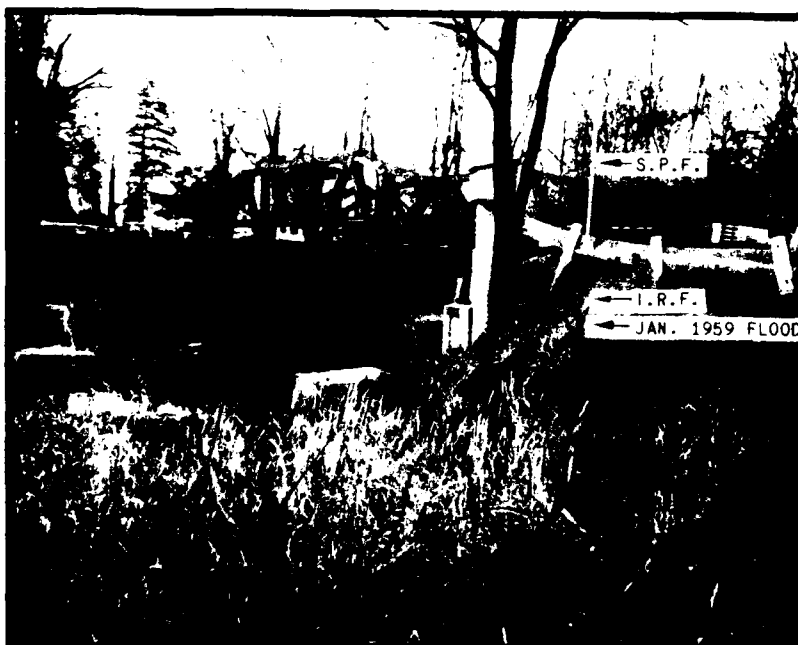
Figure 26 - Arrows indicate the heights of the Standard Project, Intermediate Regional, and January 1959 floods at Winchell Road bridge, stream mile 75.80.
