FLOOD PLAIN INFORMATION  
WEST BRANCH ROCKY RIVER **(4)**  
CUYAHOGA AND LORAIN  
COUNTIES  
OHIO  
**LEVEL**

PREPARED FOR  
OHIO DEPARTMENT OF NATURAL RESOURCES  
DIVISION OF WATER  
REGIONAL PLANNING COMMISSION, CUYAHOGA COUNTY  
LORAIN COUNTY REGIONAL PLANNING COMMISSION  
BY

CORPS OF ENGINEERS, U.S. ARMY  
BUFFALO DISTRICT  
FEBRUARY 1971

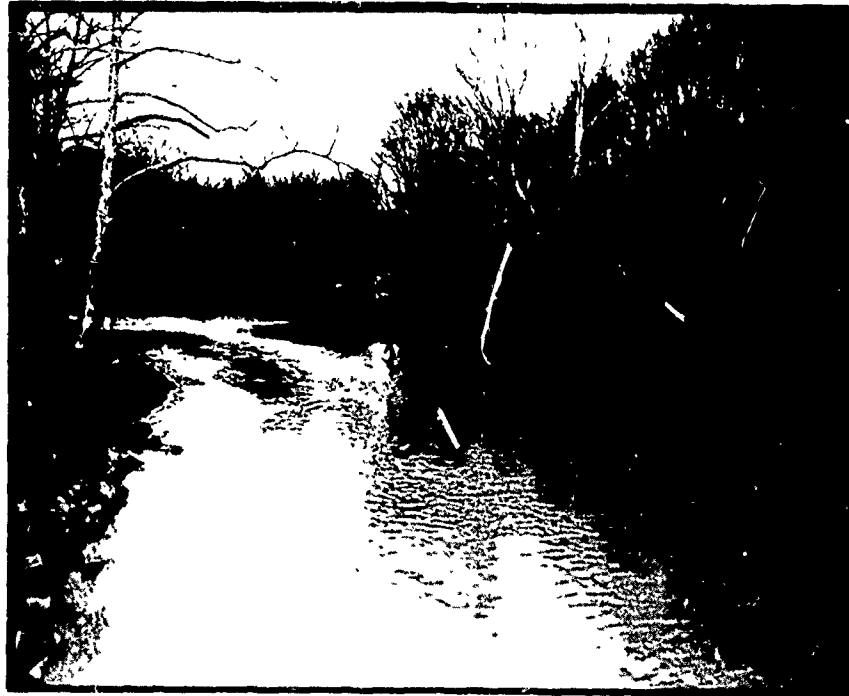
Figure 1 - Looking upstream at East Branch of Rocky River from atop Cedar Point Road bridge, North Olmsted, Ohio.

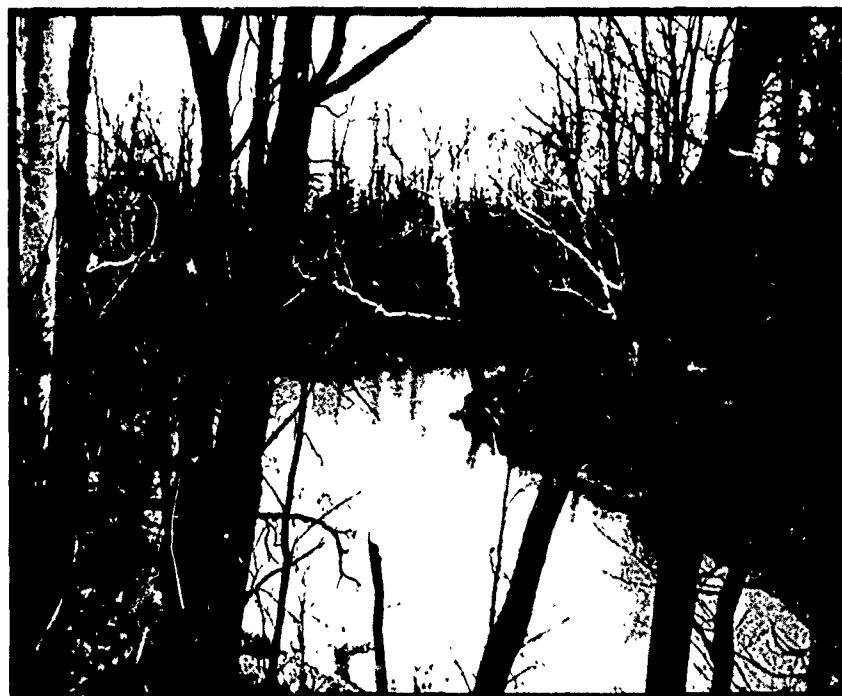
Figure 5 - Looking downstream from left bank at stream mile 19.8, Columbia, Ohio. (Note meandering stream).

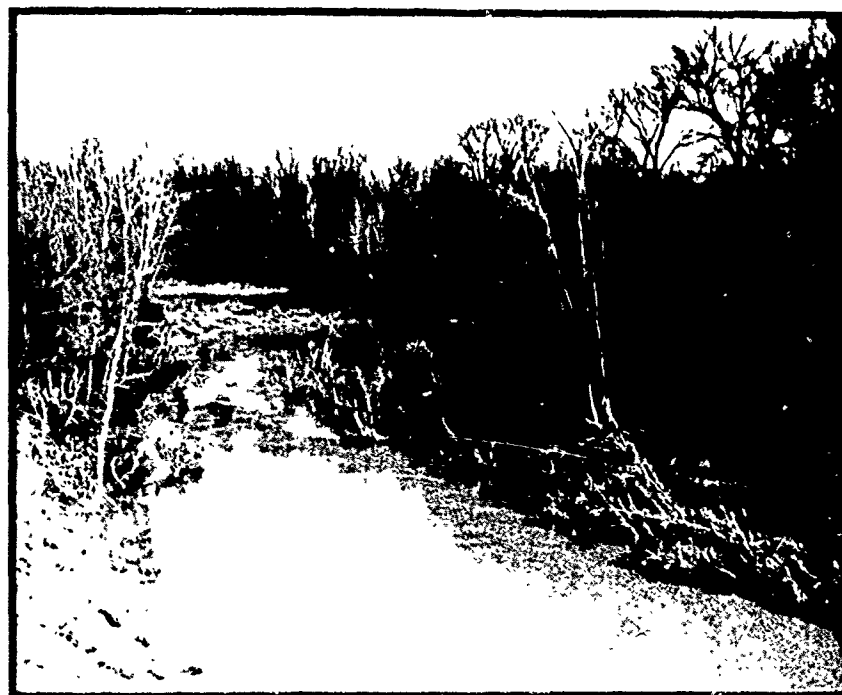
Figure 6 - Looking downstream from atop Royalton Road bridge, Columbia, Ohio, stream mile 21.9.

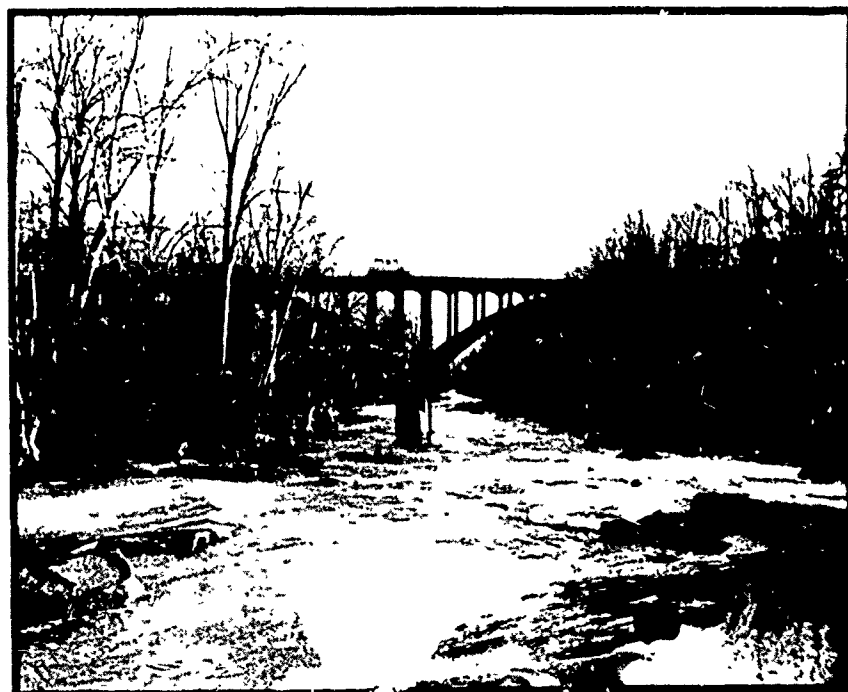
Figure 17 - Upstream face of Water Street bridge,  
stream mile 15.5

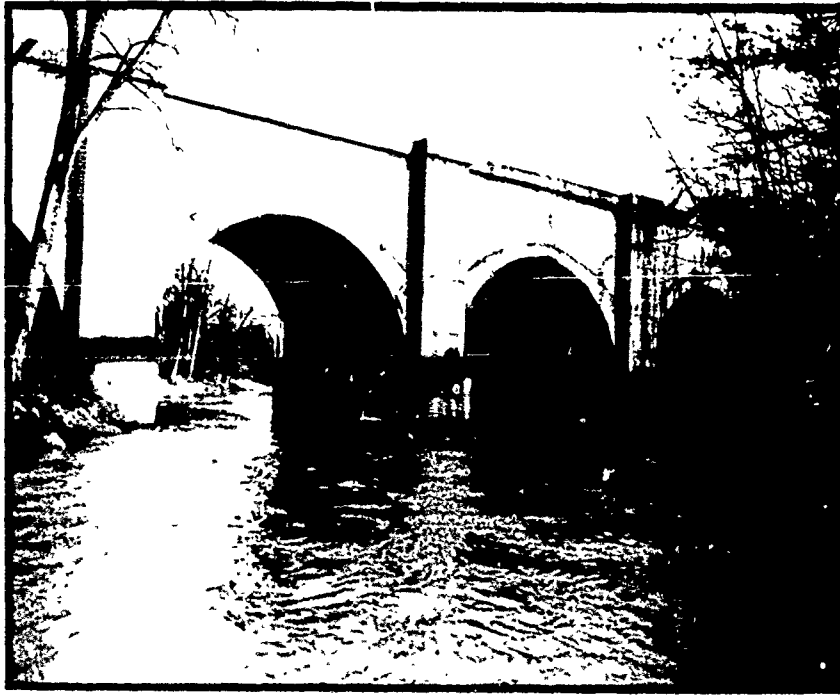
Figure 20 - Upstream face of Penn Central Transportation Company bridge, stream mile 16.9. Note skew of bridge.

OBSTRUCTIONS TO FLOOD FLOWS - Inadequate bridge areas, abandoned dams, encroachments, and fills are some of the obstructions to flood flows. Other serious obstructions are bends in the stream, irregularity of channel section, and heavy brush, weeds, and large trees growing on the channel banks and extending into the stream. Figures 20 through 22 show obstructions which tend to reduce floodway capacity and increase river stages.

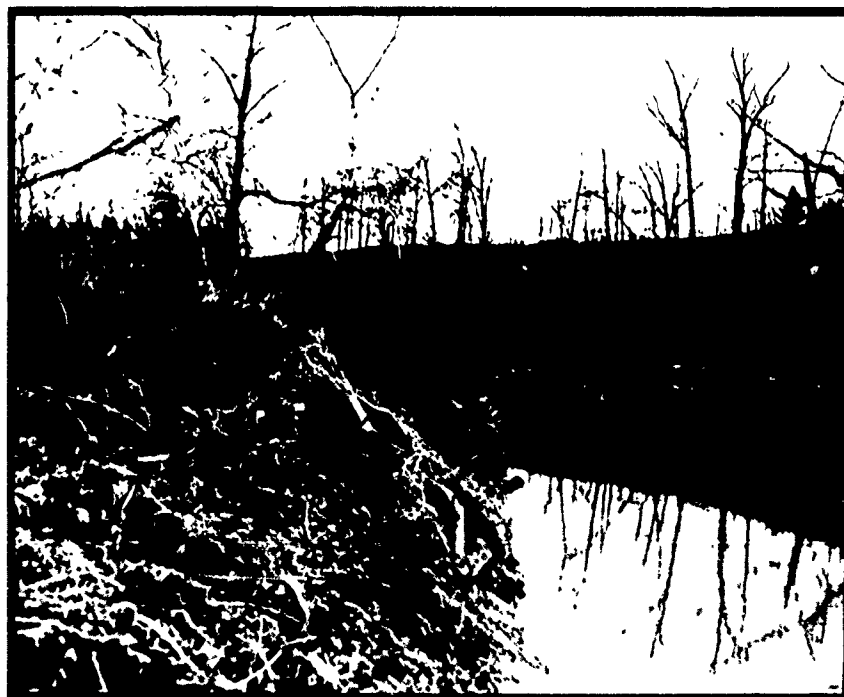
Figure 22 - Looking upstream at stream mile 18.4 from right bank. Note dumping area and encroachment.
