# FLOOD PLAIN INFORMATION LEVEL

TONAWANDA CREEK AND ITS  
AFFECTED TRIBUTARIES

## ERIE AND NIAGARA COUNTIES

CORPS OF ENGINEERS, U.S. ARMY  
BUFFALO DISTRICT

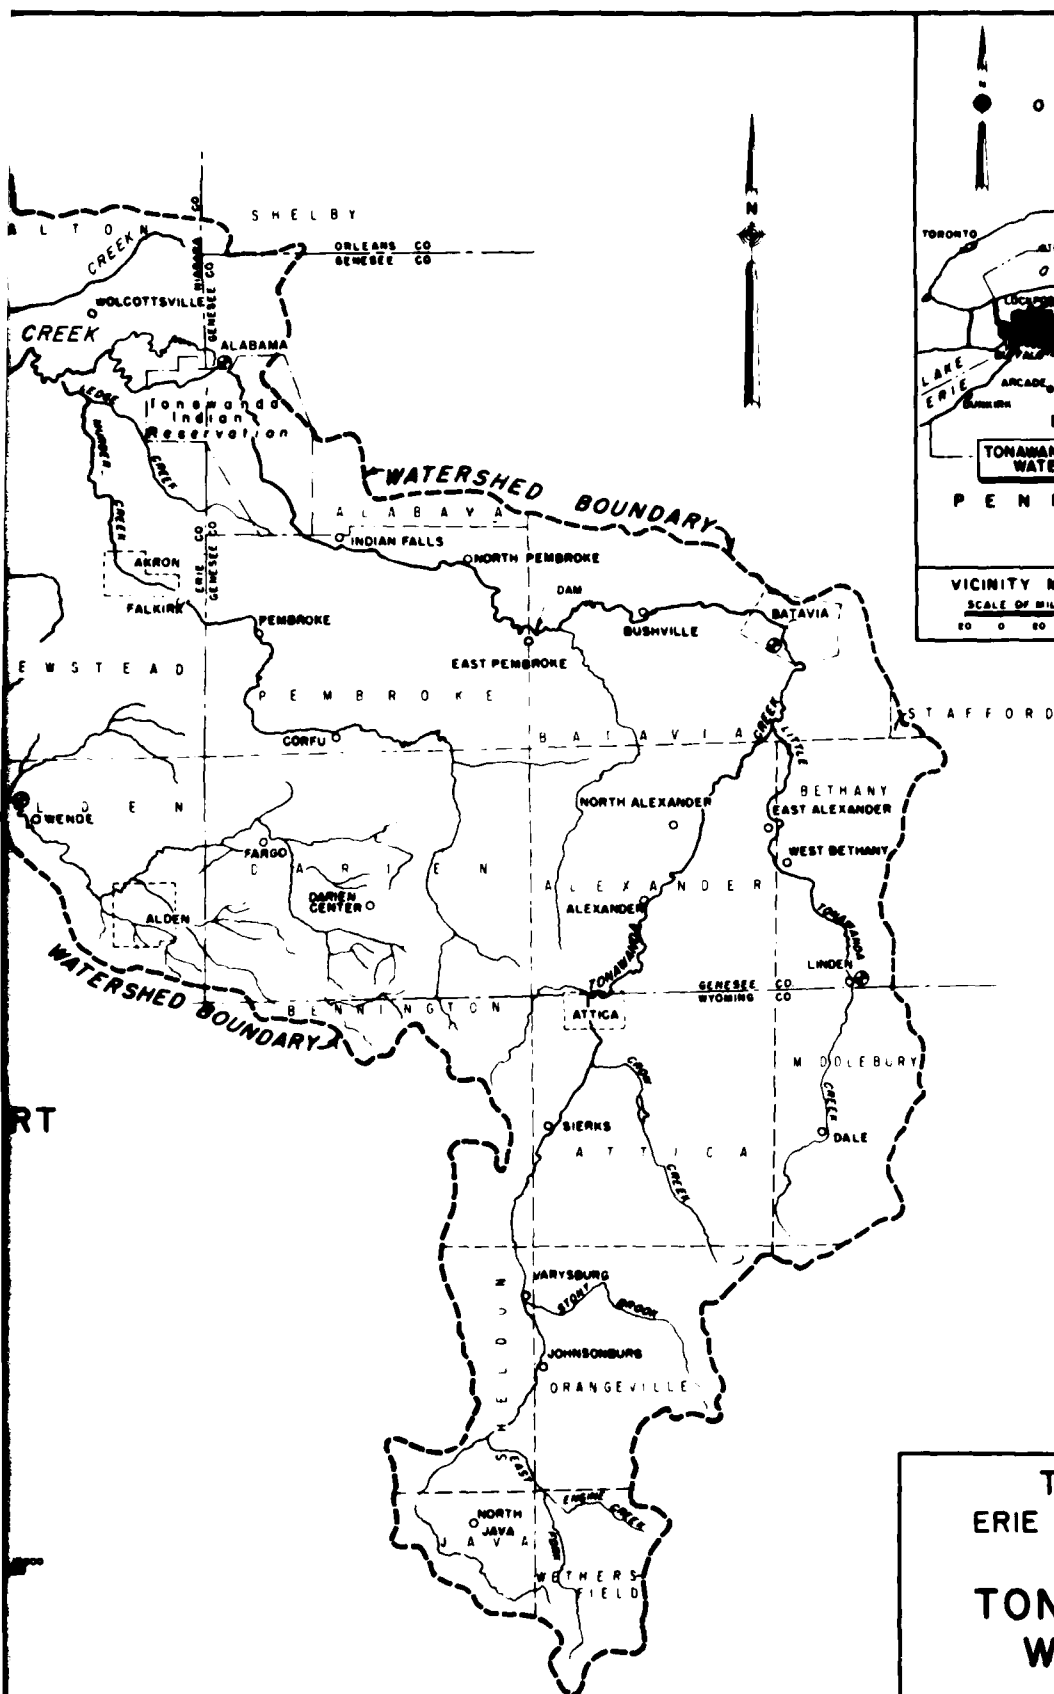
## TONAWANDA CREEK WATERSHED MAP

REACH COVERED BY THIS REPORT

RECORDING GAGE

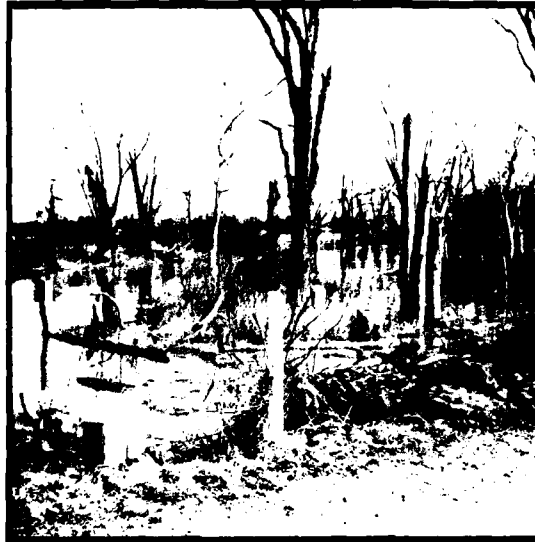
Figure 2. Example of partly overgrown channel as shown along Kelkenberg Road near mile 24.4.

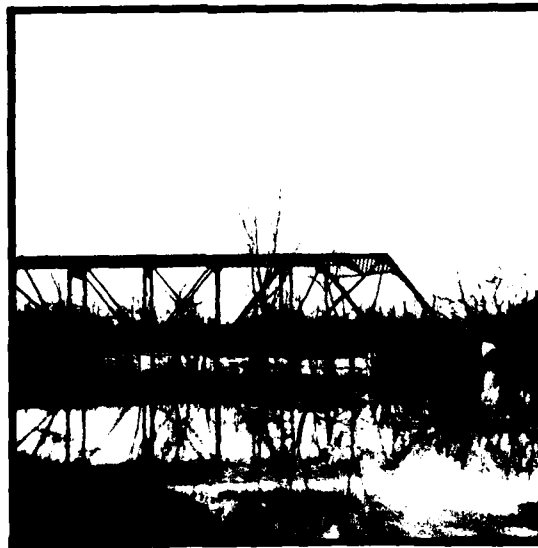
Figure 3. A view of Tonawanda Creek just upstream of the Block Church Road bridge at mile 28.25 shows trees and brush in channel during a medium-high flow.

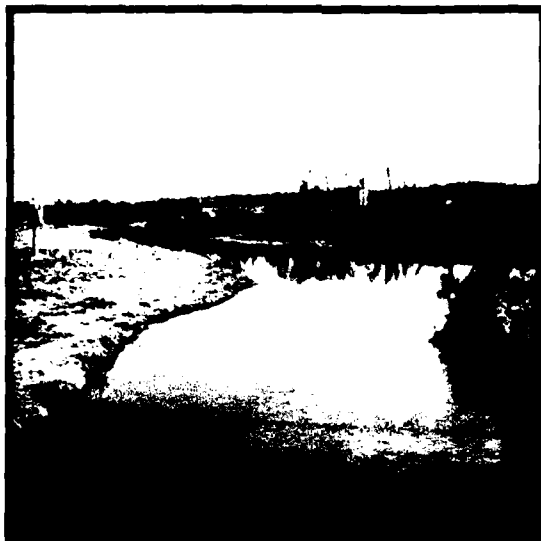
Figure 4. View of the Ransom Creek channel looking upstream from the New Road bridge at mile 3.0.

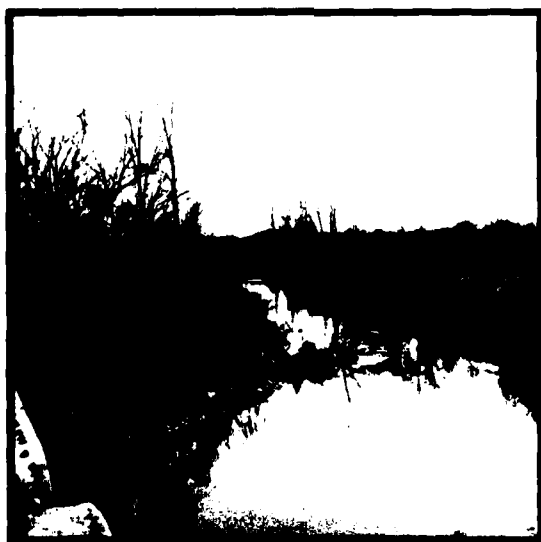
Figure 5. View of the Ransom Creek channel just downstream of the New Road bridge at mile 3.0. Note the large variance in channel width within the same area. In order for channel improvements to be effective they should be extended to the mouth.

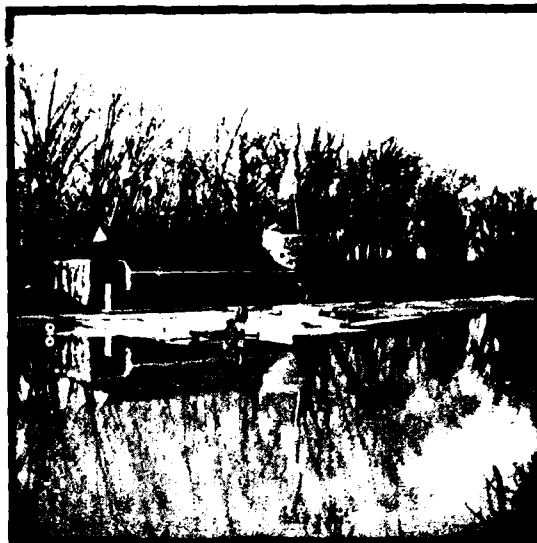
Figure 6. This example of low damage development within the flood plain is located at the Ellicott Island Park near mile 3.3 along Tonawanda Creek.

a scattering of residential homes. Upstream from the city of Tonawanda to the confluence of the Barge Canal, much of the area is developed for recreational use such as parks, public boat marinas and golf courses as shown in figures 6 and 7 on page 30. Although the flood of 1904 caused a great deal of damage due to the former dam in Tonawanda, little damage has been suffered by individuals in this area since. An occurrence of the Standard Project Flood would cause wide spread flooding in this entire reach.

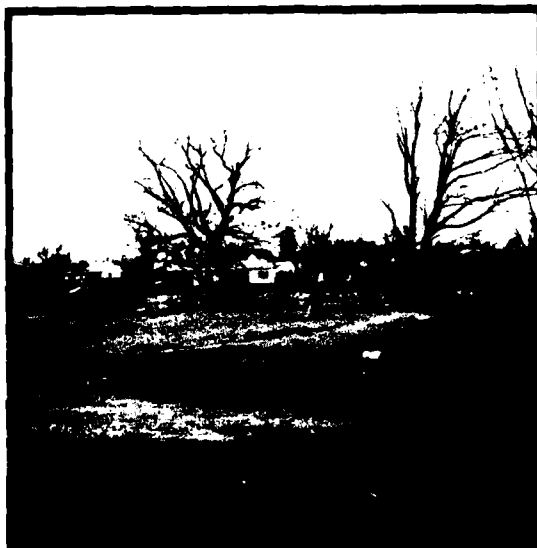
Figure 7. Another type of low damage development within the flood plain is shown in this photograph of the Creekside Golf Course along Tonawanda Creek near mile 5.2.

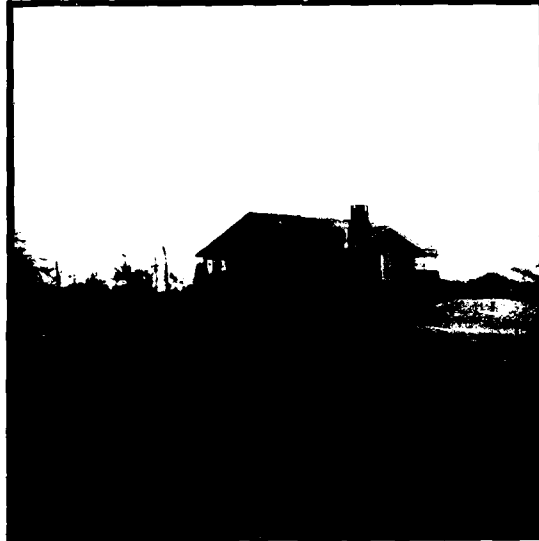
Figure 8. Example of construction on natural ground, but wisely protected even against the Standard Project Flood by placing fill around home. Residence is located on Smith Road along Ransom Creek near mile 2.5.

plain as shown in figures 8 and 9 on page 31, while others are built level with the existing terrain. The 1960 flood caused much damage and many residential units were affected. The Intermediate Regional Flood and the Standard Project Flood would cause serious conditions in this reach, especially near the mouth of Ransom Creek where the Standard Project Flood would be approximately six feet higher than the 1960 flood. This is due to backwater from Tonawanda Creek.

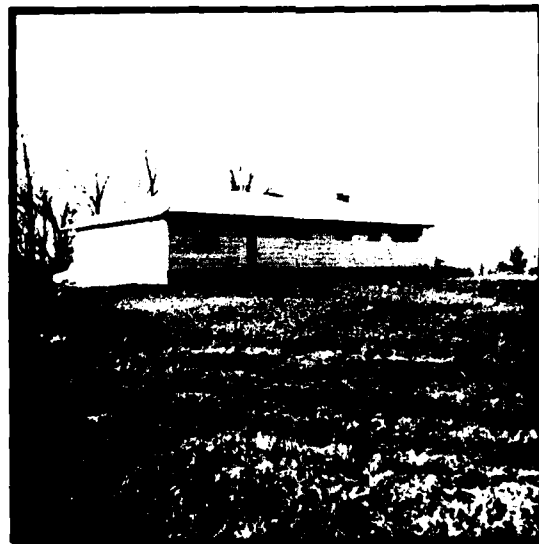
Figure 9. Another example of good construction within the flood plain is shown by this home which was built entirely upon fill. Although the ground around this home would be flooded, the structure is high enough to be protected even against the Standard Project Flood. It is located on Rapids Road near mile 23.0 along Tonawanda Creek.

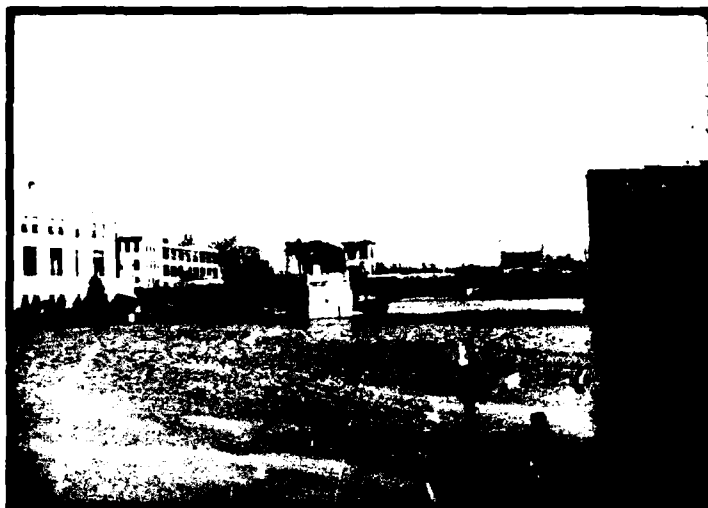
Figure 10. Looking upstream at the Main Street bridge over Tonawanda Creek at mile 0.25. Note the low steel of the right bank span is much lower than the left bank span.

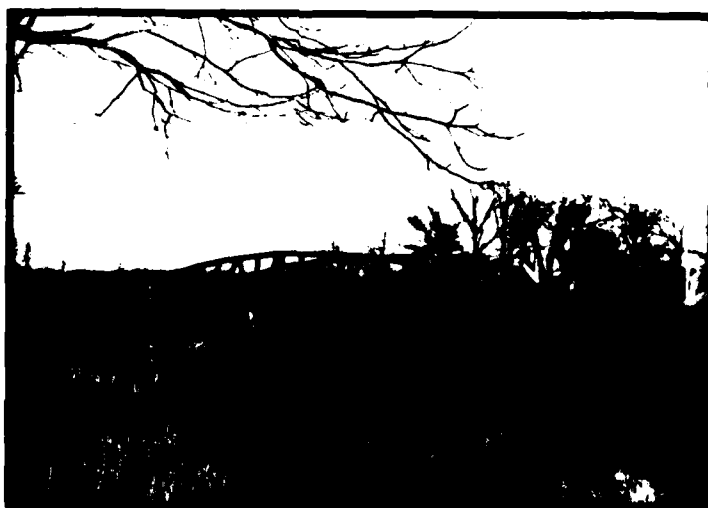
Figure 11. View of the Foot Road bridge over Tonawanda Creek at mile 37.7. Bridge opening is large enough to pass flood discharges.

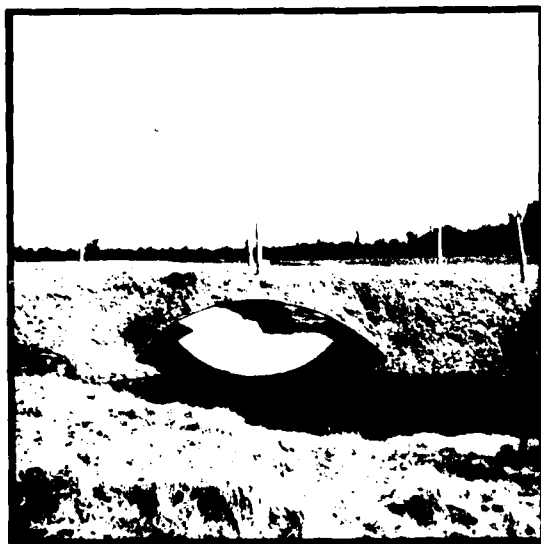
Figure 13. This photograph shows the relatively small cross sectional area of the Kenfield Road culvert over Black Creek at mile 6.6. Future bridge construction should consider data provided in this report.

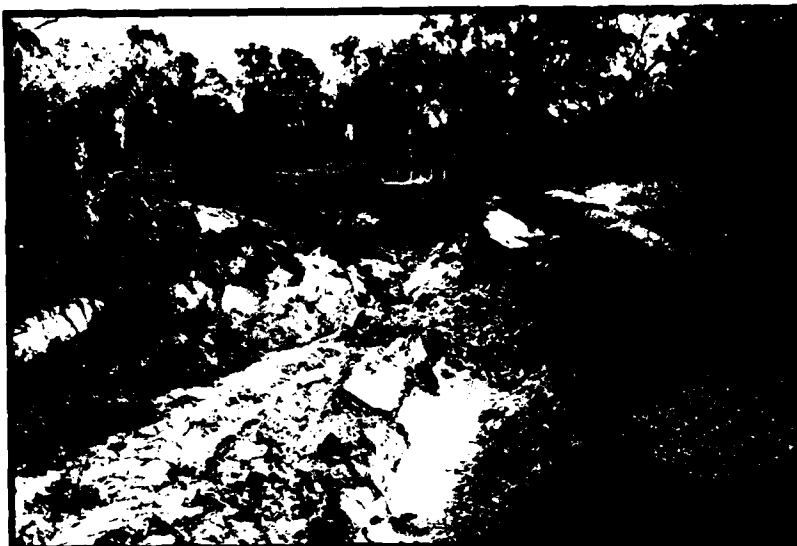
Figure 16. This bank slide which occurred in 1956, took place one-half mile upstream of New Road bridge along Tonawanda Creek. It exemplifies one of the many types of obstructions to flood flows.

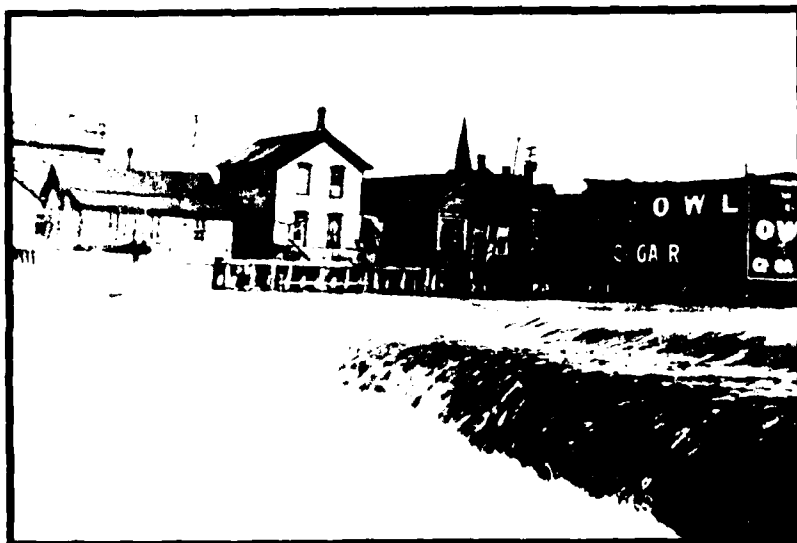
Figure 17. Another type of obstruction to flood flows was the dam in the City of Tonawanda formerly located upstream of the Main Street bridge.

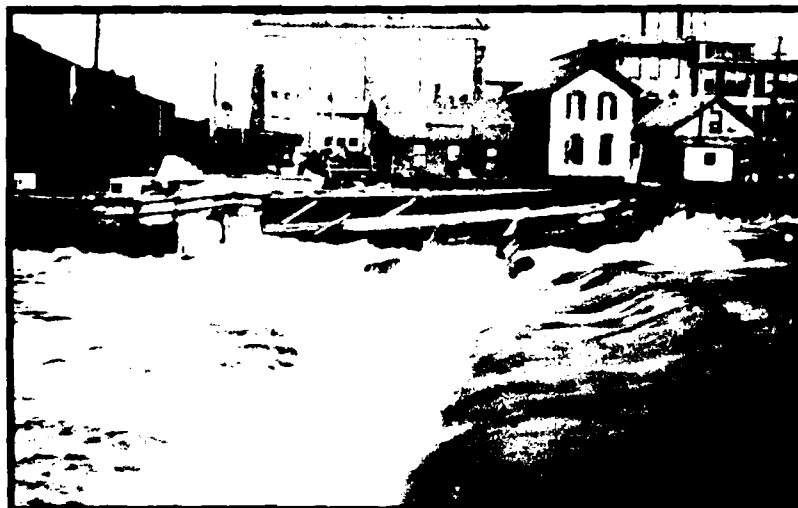
Figure 18. View of damaged canal boats during the 1916 flood. Photograph also shows former dam located at mile 0.3 in the City of Tonawanda.

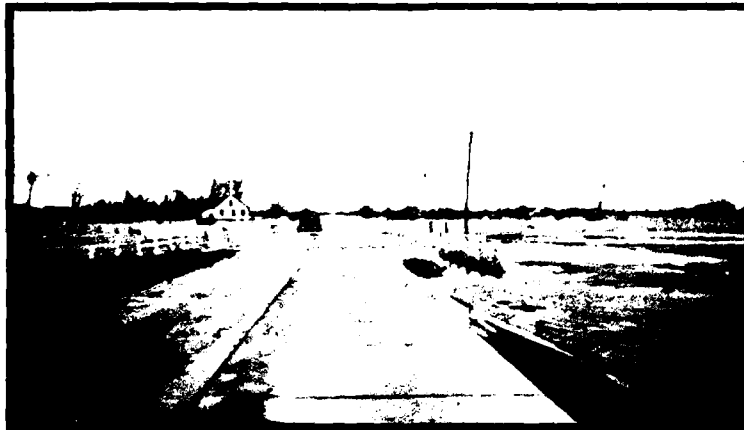
Figure 20. Looking north along Millersport Highway toward Ransom Creek at mile 2.6 during the April 1940 flood.

placed their chickens and small animals in hay barns. All tools and equipment were placed in the sheds and lumber fastened down. Still with all this preparation many suffered losses in their basements, barns and fields. The flood water stayed over the land for almost a week. During this high water period, six families from the Ransom - Black Creeks area had to move from their homes. The flood damage in the Beeman, Black and Ransom Creeks area was estimated at \$10,700. Figures 20 and 21 on page 55 show typical flooding in the area.

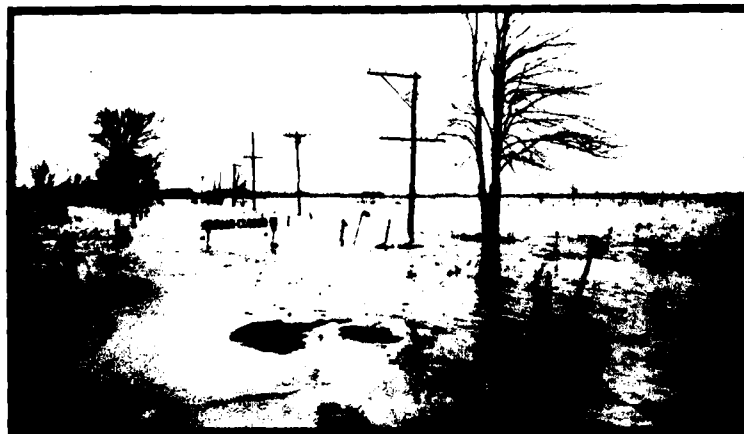
Figure 21. Extensive flooding is shown in photograph looking north along New Road toward Smith Road. Photograph was taken at mile 3.0 along Ransom Creek during the April 1940 flood.

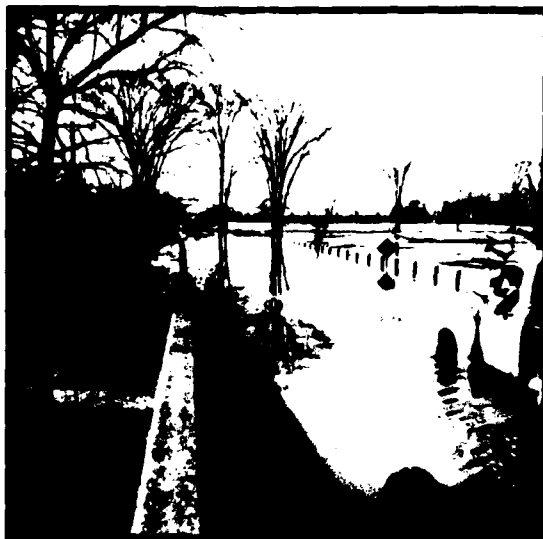
Figure 22. Photograph shows overbank flooding during the February 1954 flood near the confluence of Beeman and Tonawanda Creeks.

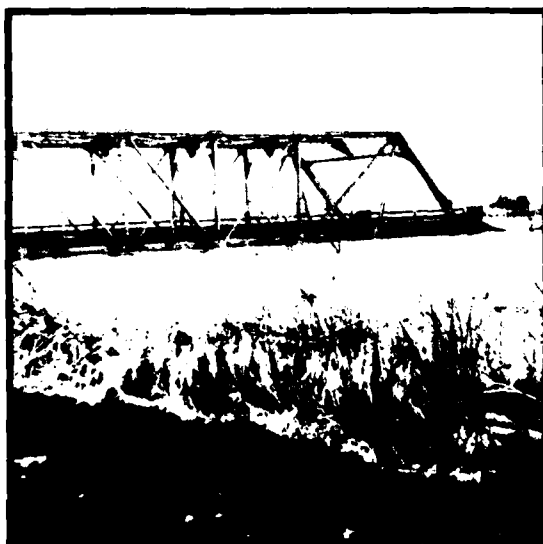
Figure 23. Looking downstream at the Block Church Road bridge over Tonawanda Creek at mile 28.25 during the March 1956 flood.

on the stage-frequency curve at Hopkins Road. Estimated loss attained during the flood was set at \$121,000. Figure 23 on page 58 shows flood waters against the low steel of the Block Church Road bridge over Tonawanda Creek during the March 1956 flood. Figure 24 on page 59 shows the widespread flooding in the Route 93 - Wolcottsville area, while figure 25 shows the extent of Mud Creek overflow in the Simms Road area during the March 1956 flood.

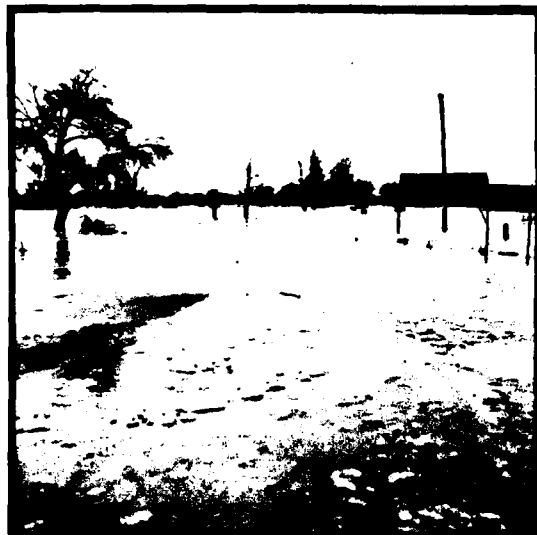
Figure 24. Looking west on Route 93 from intersection with Wolcottsville Road. Photograph was taken during the March 1956 flood near mile 34.3 along Tonawanda Creek.

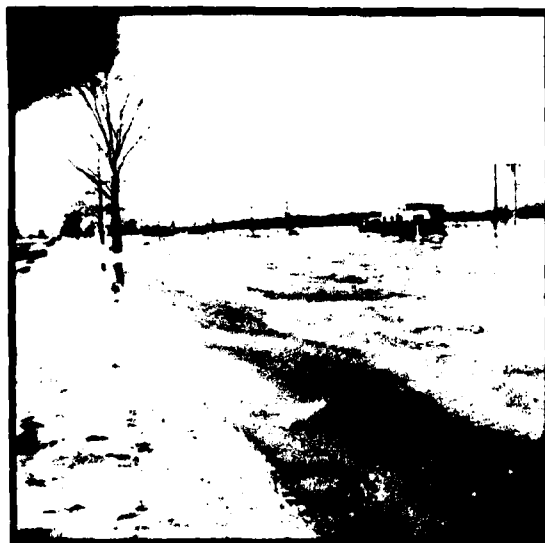
Figure 25. Looking northwest from Simms Road near the Mud Creek bridge at mile 8.9. Photograph shows about 6" of water surrounding the trailers during the March 1956 flood.

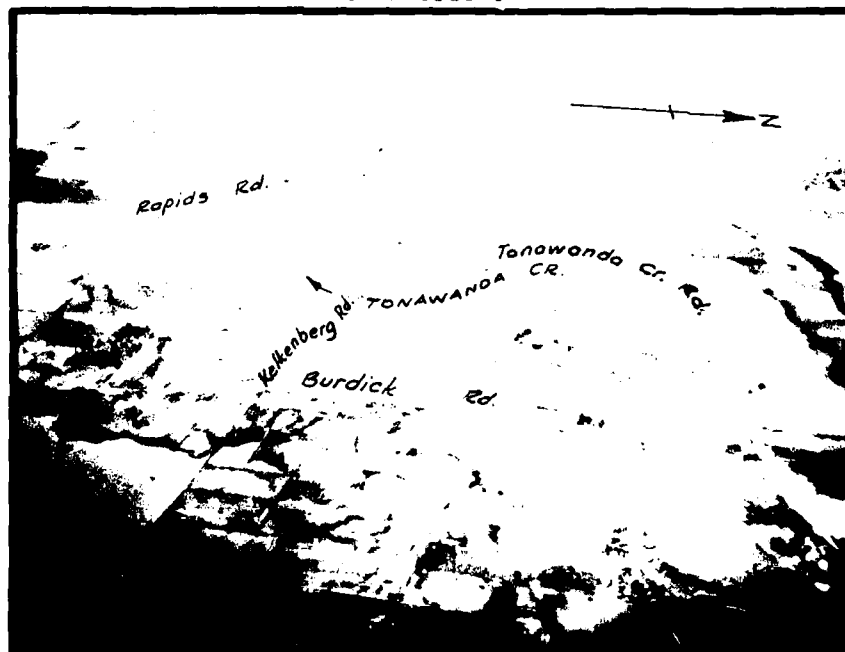
Figure 27. The extent of Tonawanda Creek overflow is shown by this photograph taken during the 1960 flood in the vicinity of Burdick Road near mile 27.

Figures 26 through 29 on pages 62 and 63 show typical conditions during the flood along Tonawanda Creek. Figures 30 and 35 on pages 64 through 66 are indicative of the inundated areas along Black and Ransom Creeks during the 1960 flood.

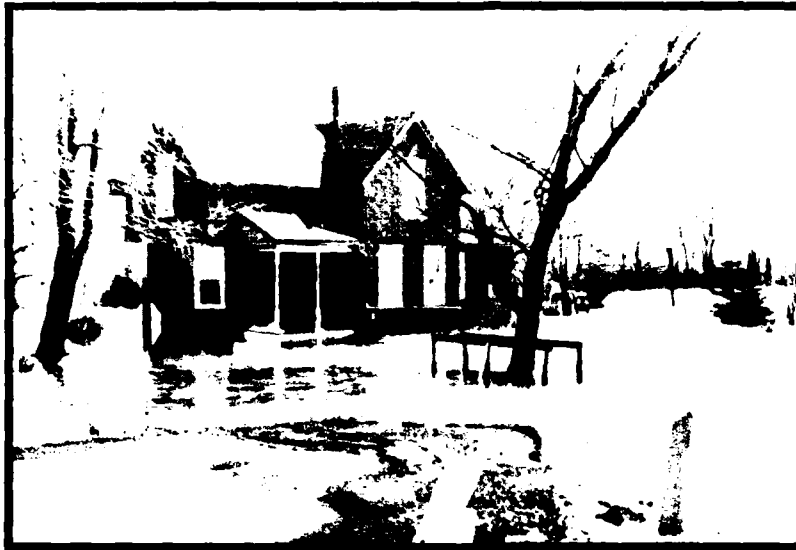
Figure 28. Residence at Goodrich and Brauer Roads inundated by 1960 flood water from Tonawanda and Black Creeks.

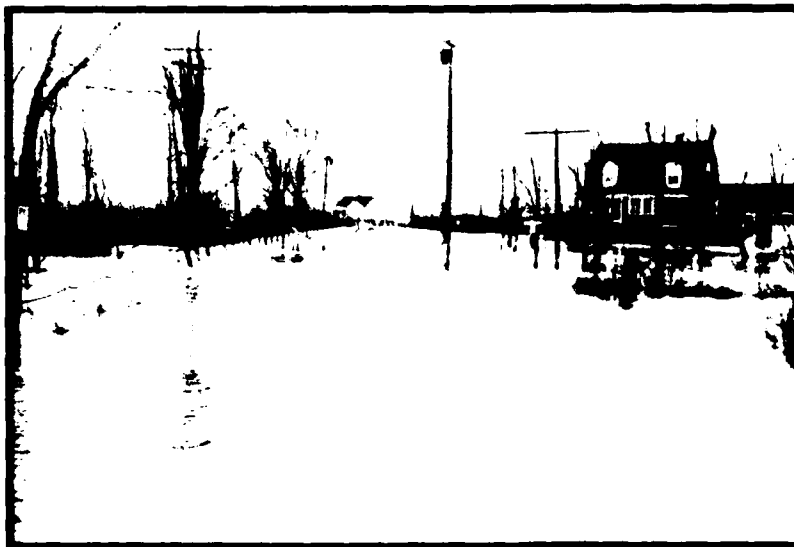
Figure 29. Photograph shows intersection of Tonawanda Creek Road (Route 268) and Brauer Road. This location near mile 21.3 is one of the initial points where Tonawanda Creek flood waters break over the bank.

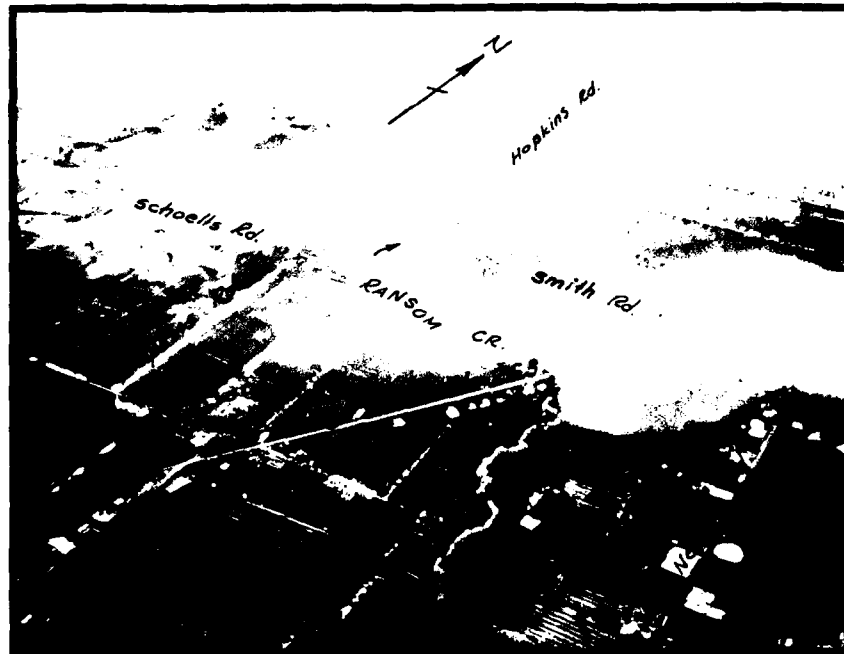
Figure 30. Aerial view of flooding along Ransom Creek in the vicinity of Millersport Highway during the 1960 flood.

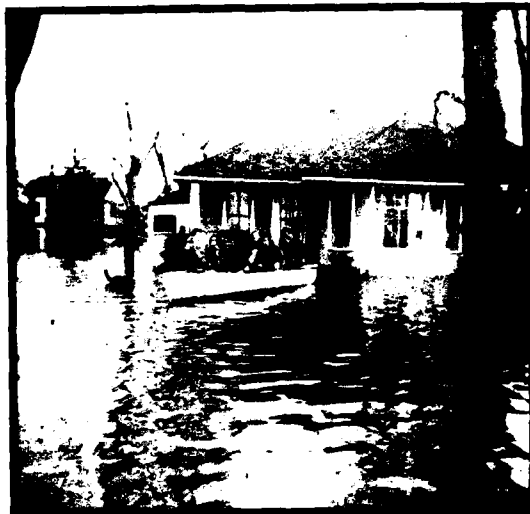
Figure 34. Inundated residence on New Road near mile 3.0 along Ransom Creek during the 1960 flood.

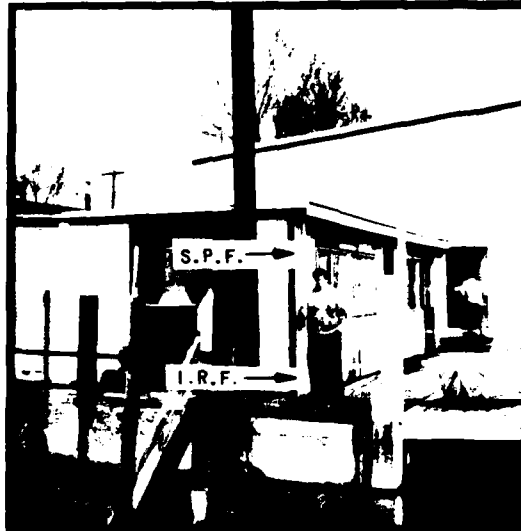
Figure 37. MARINE SALES & SERVICE - TONAWANDA CREEK. The flood heights for the Standard Project Flood and the Intermediate Regional Flood are indicated by arrows at a Marine Sales and Service building near mile 0.9 along Tonawanda Creek.

Figures 37 through 46 on pages 76 through 80 show the approximate heights that would be reached by the Standard Project Flood, the Intermediate Regional Flood and the 1960 flood at various locations and on structures presently existing within the flood plain covered by this report.

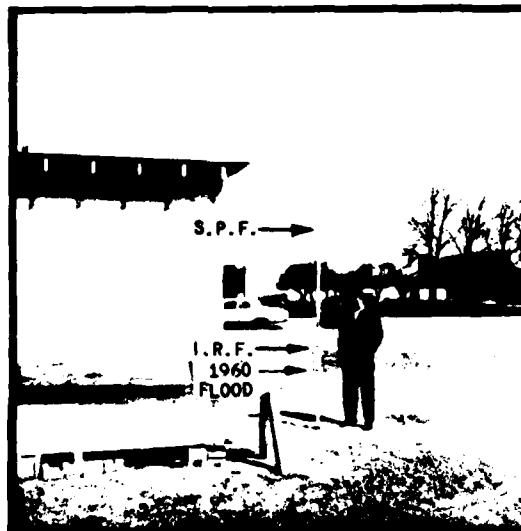
Figure 38. PARK AND MARINA - TONAWANDA CREEK. The flood heights for the Standard Project, Intermediate Regional and the 1960 flood are shown at the Niagara County West Canal Park and Marina near mile 5.2 along Tonawanda Creek.

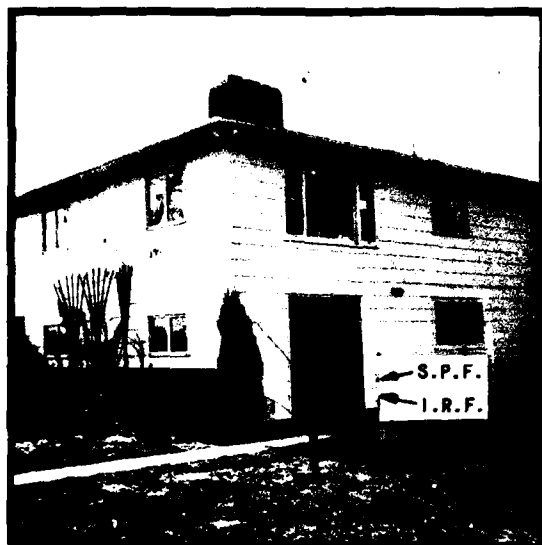
Figure 39. KOEPEL ROAD - TONAWANDA CREEK  
Arrows indicate the height of the Standard Project and Intermediate Regional Floods at a Koepsel Rd. residence located near mile 36.5 along Tonawanda Creek.

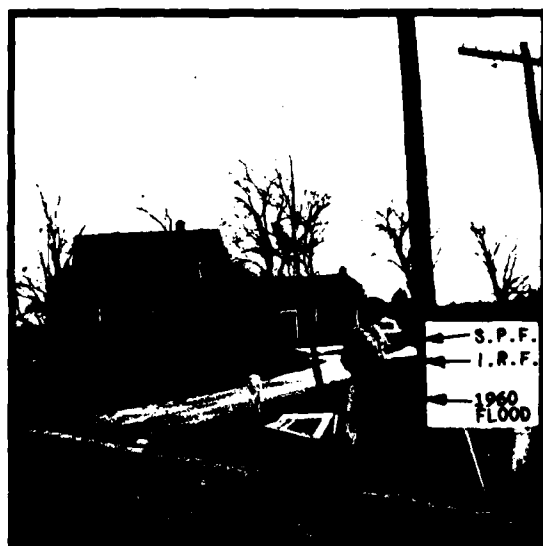
Figure 40. ROUTE 268 AND BRAUER RD. - TONAWANDA CREEK. The flood heights for the Standard Project, Intermediate Regional and the 1960 flood are shown near the intersection of Route 269 and Brauer Rd. at mile 21.3 along Tonawanda Creek.

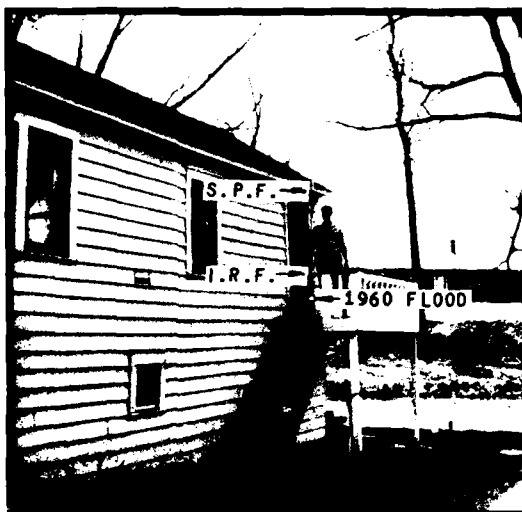
Figure 41. COTTAGE NEAR MOUTH OF RANSOM CREEK  
The Standard Project, Intermediate Regional and 1960 flood heights are shown on a cottage near the mouth of Ransom Creek.

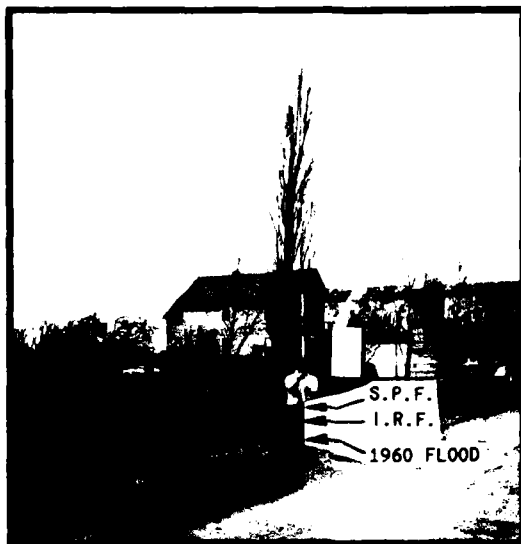
Figure 43. WESTFAILINGER ROAD - BLACK CREEK  
The relative flood heights for the Standard Project, Intermediate Regional and the 1960 flood are indicated by arrows at the Westfailinger Rd. bridge at mile 5.9 over Black Creek.

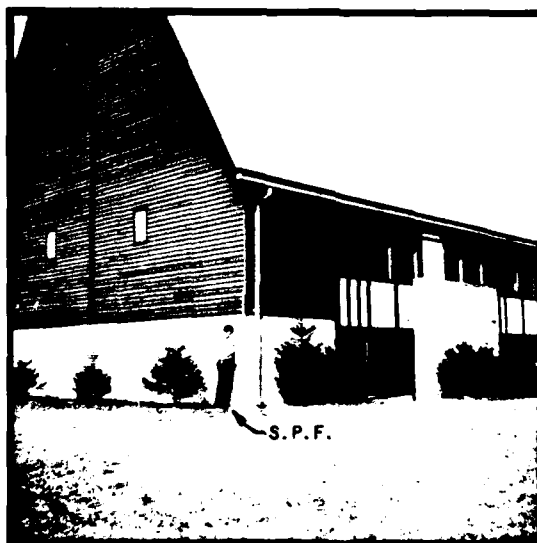
Figure 44. ST. PAULS LUTHERAN CHURCH - BLACK CREEK. The height of the Standard Project Flood would be approximately at the base of St. Pauls Lutheran Church near mile 8.8 along Black Creek. Construction upon fill such as this will prevent flood damage.

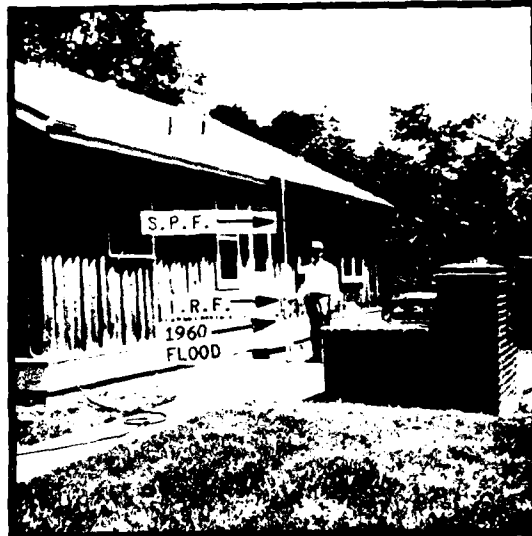
Figure 45. CONFLUENCE OF TONAWANDA & MUD CREEKS  
The relative flood heights for the Standard Project, Intermediate Regional and the 1950 flood are indicated at a residence near the confluence of Tonawanda Creek and Mud Creek.

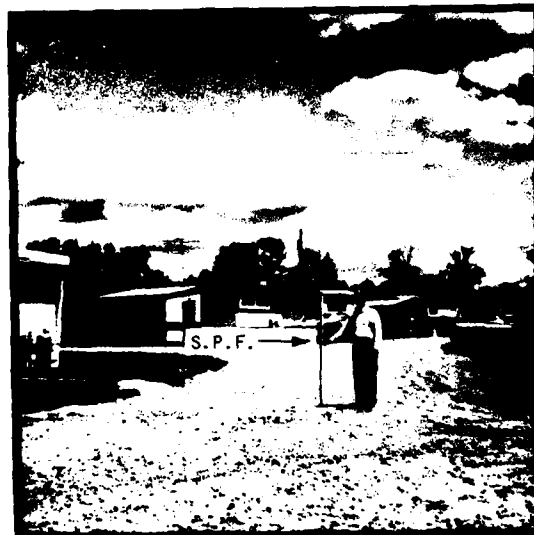
Figure 46. MOBILE HOME PARK - MUD CREEK  
The height of the Standard Project flood is indicated by an arrow at a Mobile Home Park along Mud Creek near mile 2.5. Most of the 75 trailers in the park would be destroyed by this flood.
