AFWAL-TR-80-4176

RELATIONSHIP OF INTERFACIAL COMPATIBILITY TO DURABILITY OF ADHESIVE-BONDED JOINTS

Boeing Military Airplane Company
Boeing Company
Seattle, Washington 98124

**TECHNICAL REPORT AFWAL-TR-80-4176
FINAL REPORT FOR PERIOD
SEPTEMBER 1978 TO SEPTEMBER 1980**

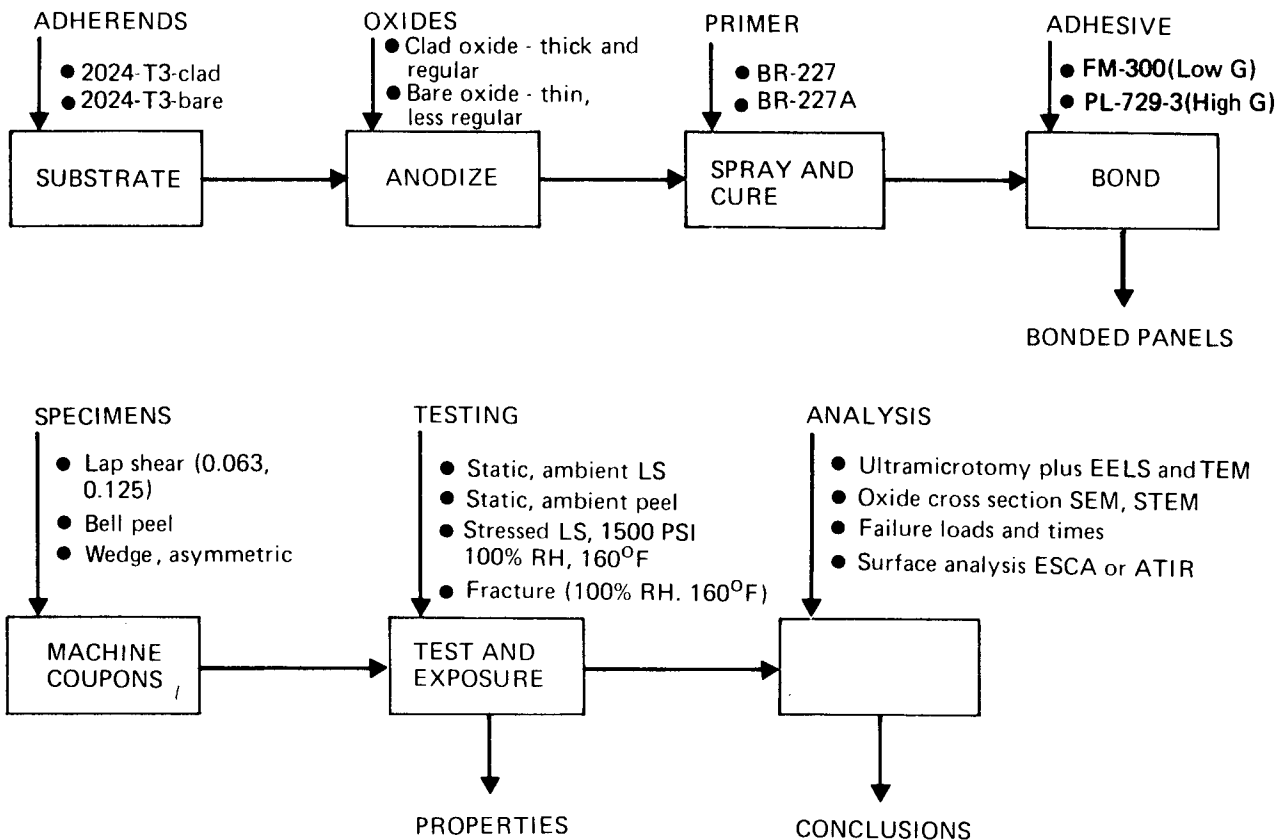
Figure 7. Task IV Test Plan

The wedge test evaluates the fracture toughness of the adhesive joint. The sustained-stress test evaluates the load-carrying capacity of the joint during environmental exposure.

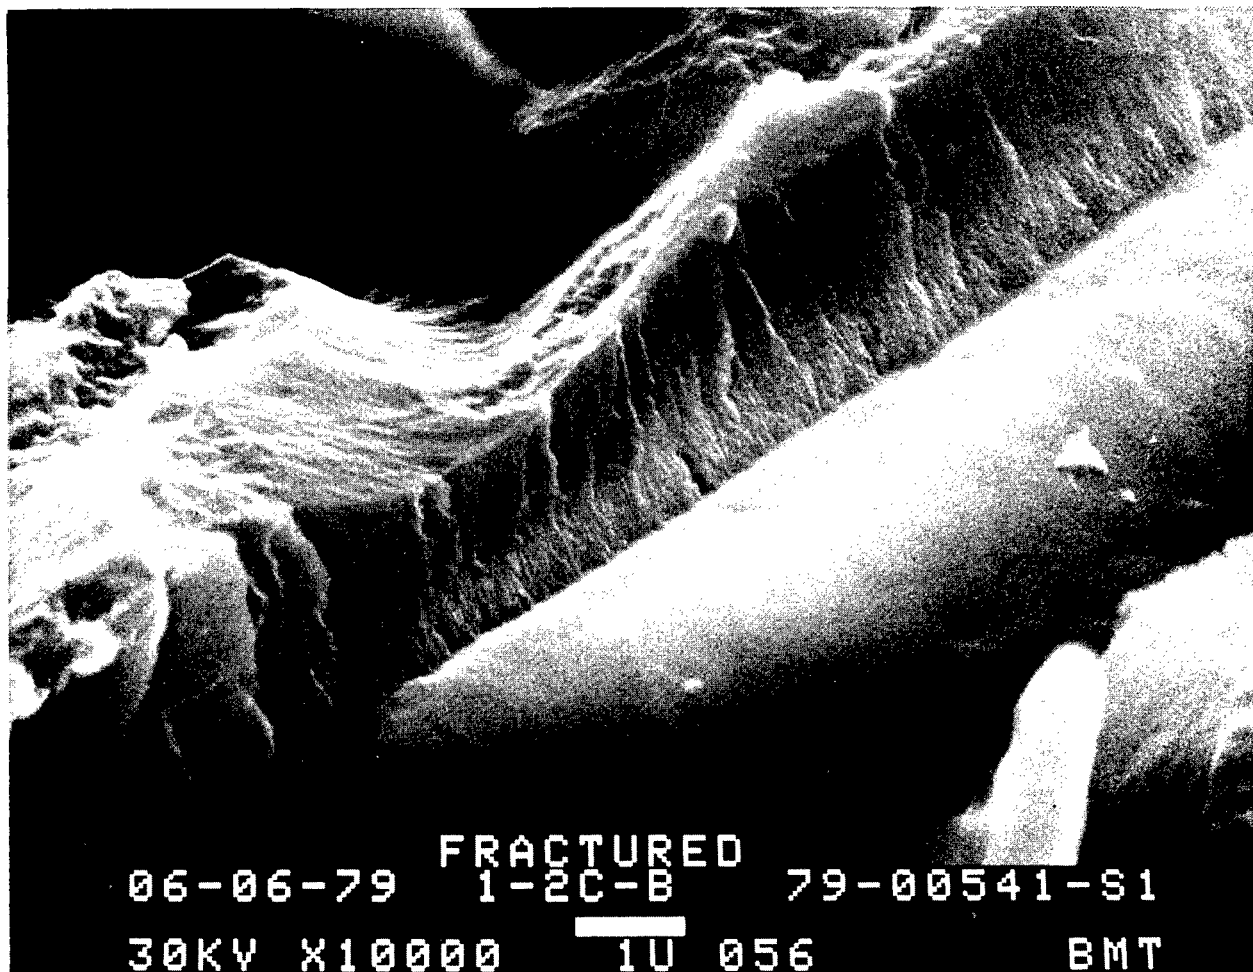
Figure 32. Transverse View of Failed Specimen—2024-T3-Clad, PAA Oxide, BR-227 Primer, FM-61 Adhesive

Figures 32 and 11 are transverse SEM views of the failure surface generated on 2024-T3 clad PAA with BR-227 and FM-61 at 10,000 and 50,000 magnifications, respective-

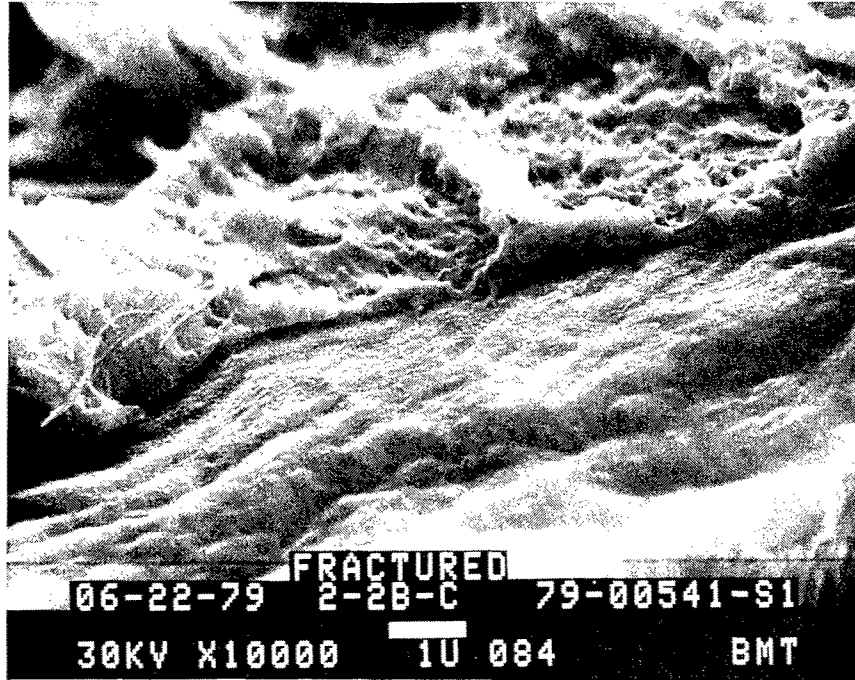
Figure 42. Transverse View of PL-728/PL-729-3 Failure Surface on 2024-T3-Bare FPL

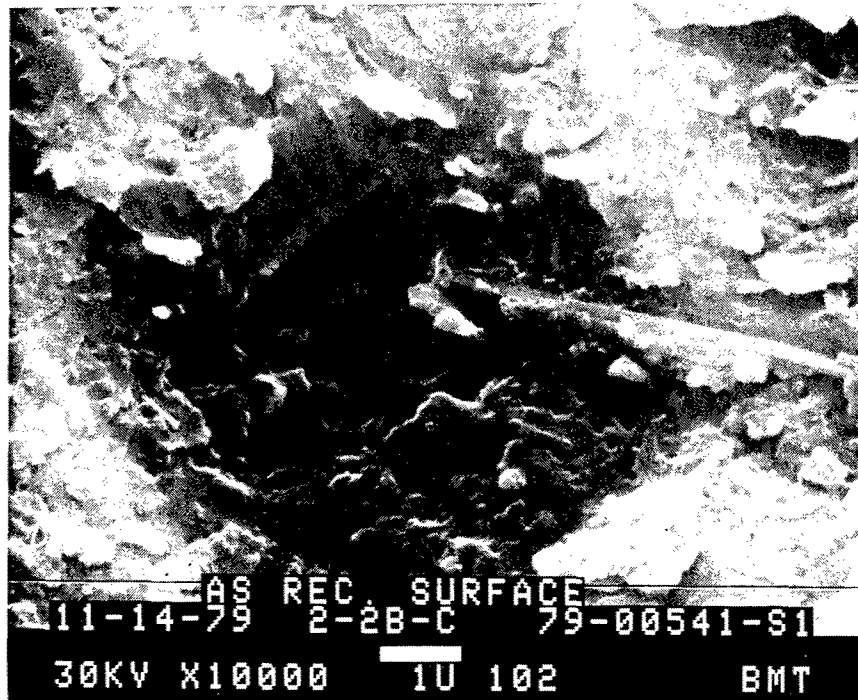
Figure 46. Failure Surface of PL-728/PL-729-3 on 2024-T3-Bare FPL

The PL-728 failed surface on the FPL oxide, Figure 46, shows a fracture surface with fewer of the small cavities observed for the PAA oxide case, Figure 43. The matrix shows plastic flow, but to a lesser degree than the PL-728 on the PAA oxide. These differences could be due partly to compositional gradients in the PL-728 primer.

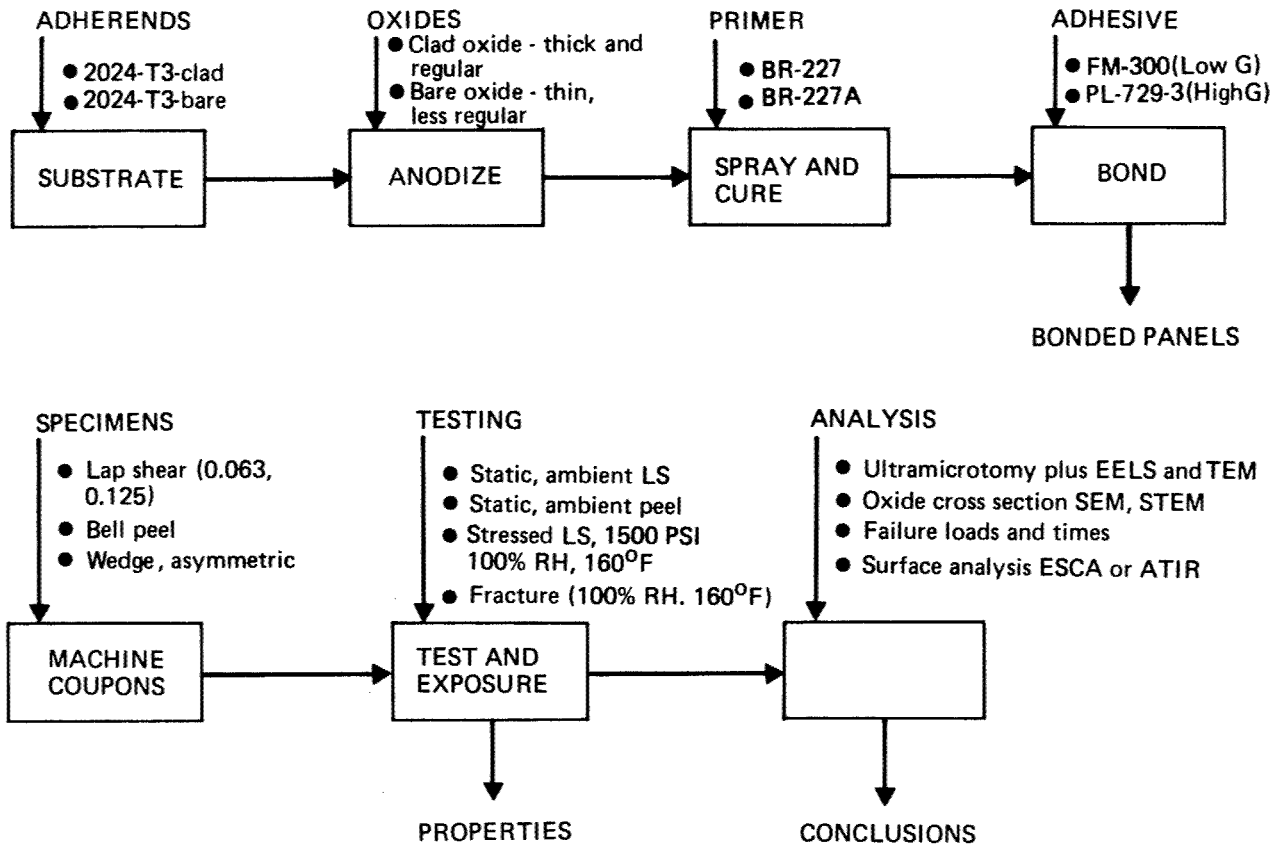
Figure 50. Task IV Test Plan

Figure 50 shows the overall test plan for Task IV.

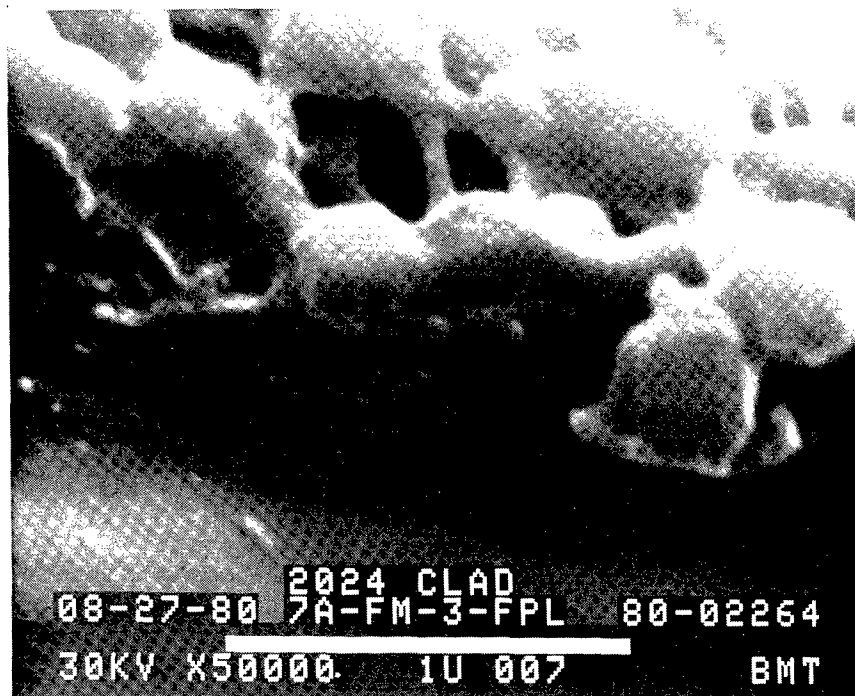
Figure 53. Transverse View of BR-227A/FM-300 on 2024-T3-Clad FPL

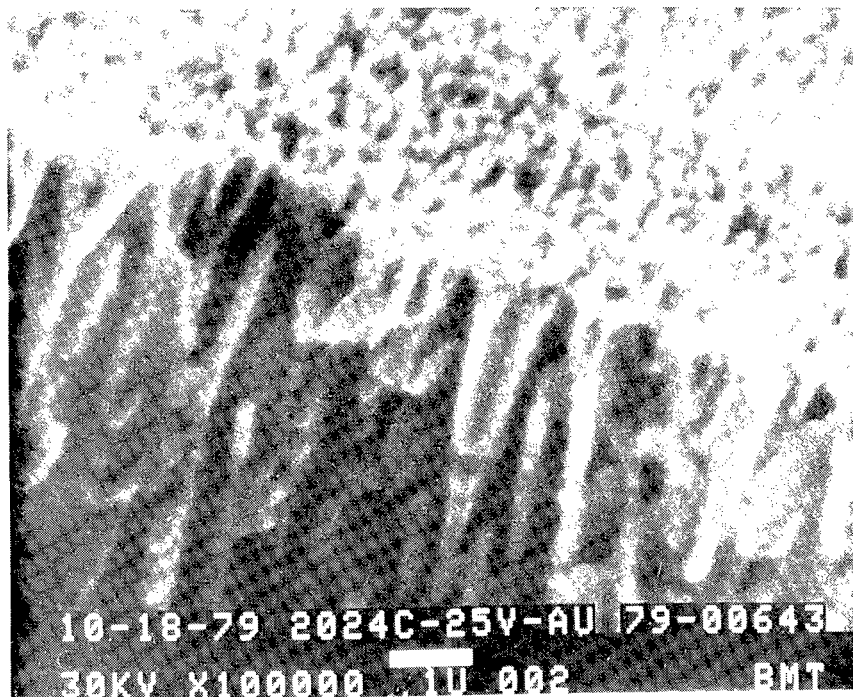
Figure A-7. SEM Photomicrograph of PAA Oxide on 2024-T3-Clad, Au/Pd Coated, Fractured Specimen x100,000

SEM photomicrographs of PAA oxide on 2024-T3 clad are shown in Figures A-5, A-6, and A-7. The detail enhancement due to coating technology improvements is striking when compared to Figures A-2 and A-3. The oxide cell walls and branching are resolvable at higher magnifications than were obtainable earlier.

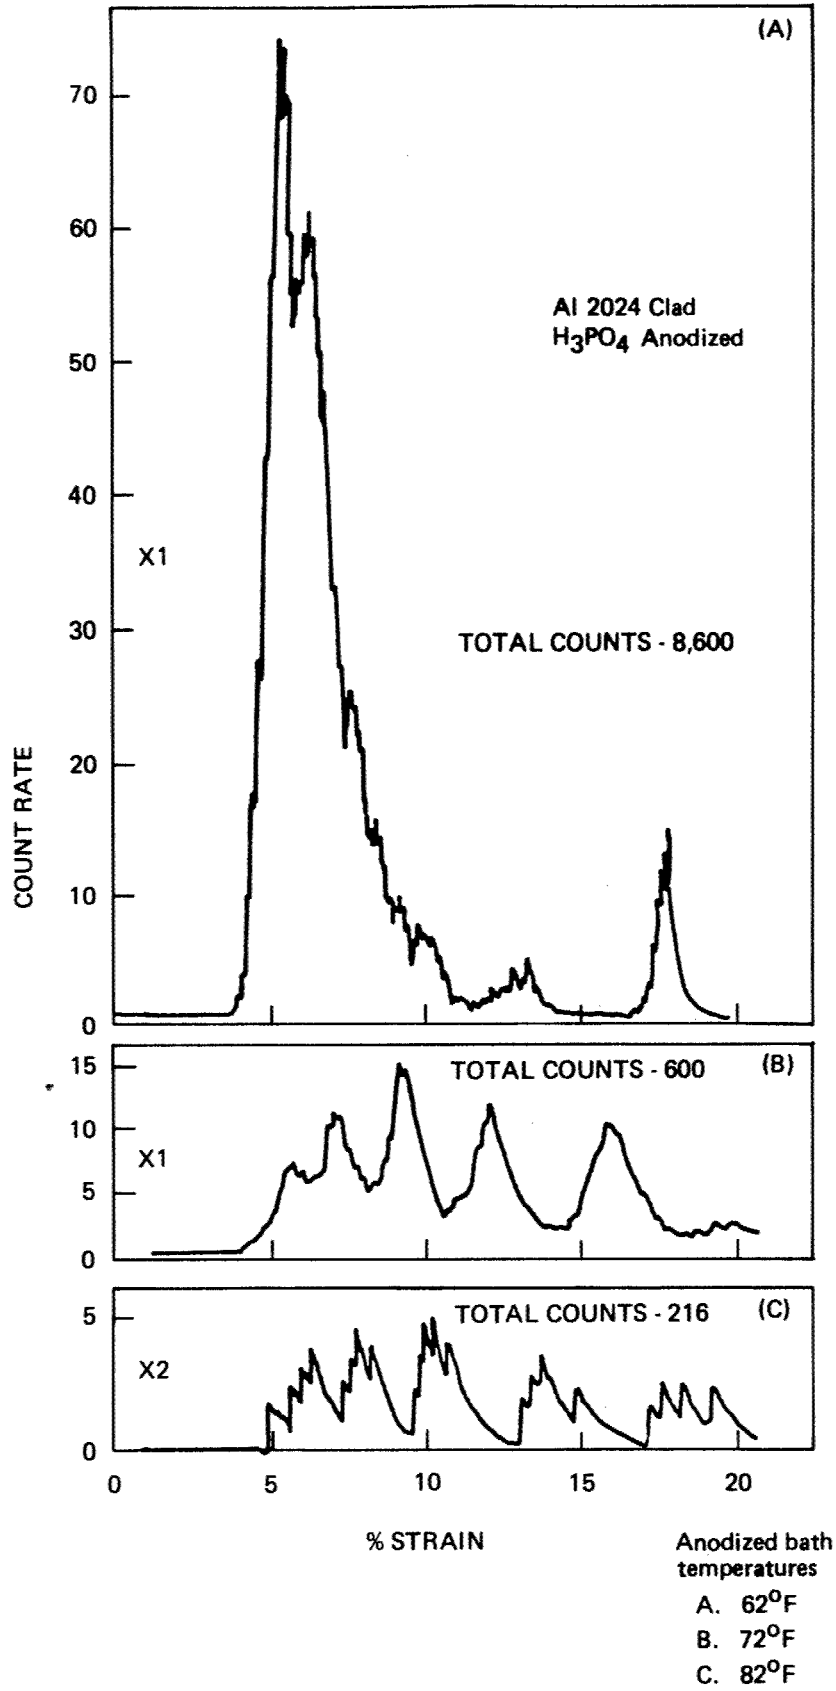
Figure D-1. Typical Electron Emission Curves (Count Rate vs Strain)

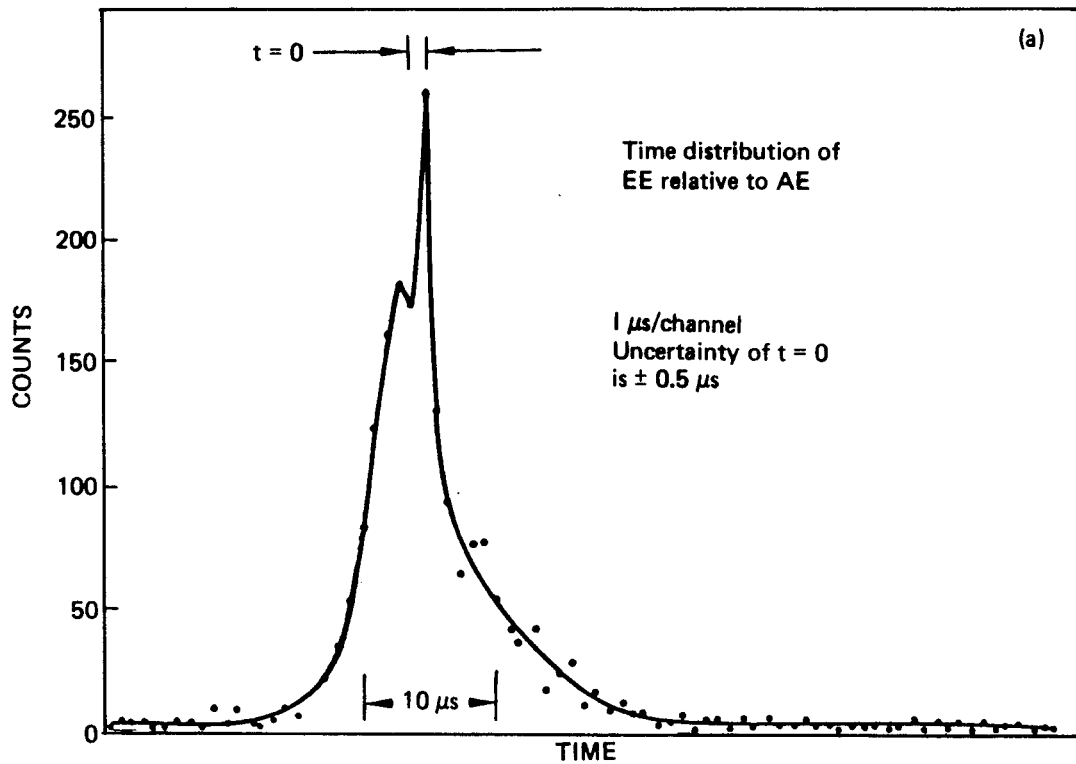
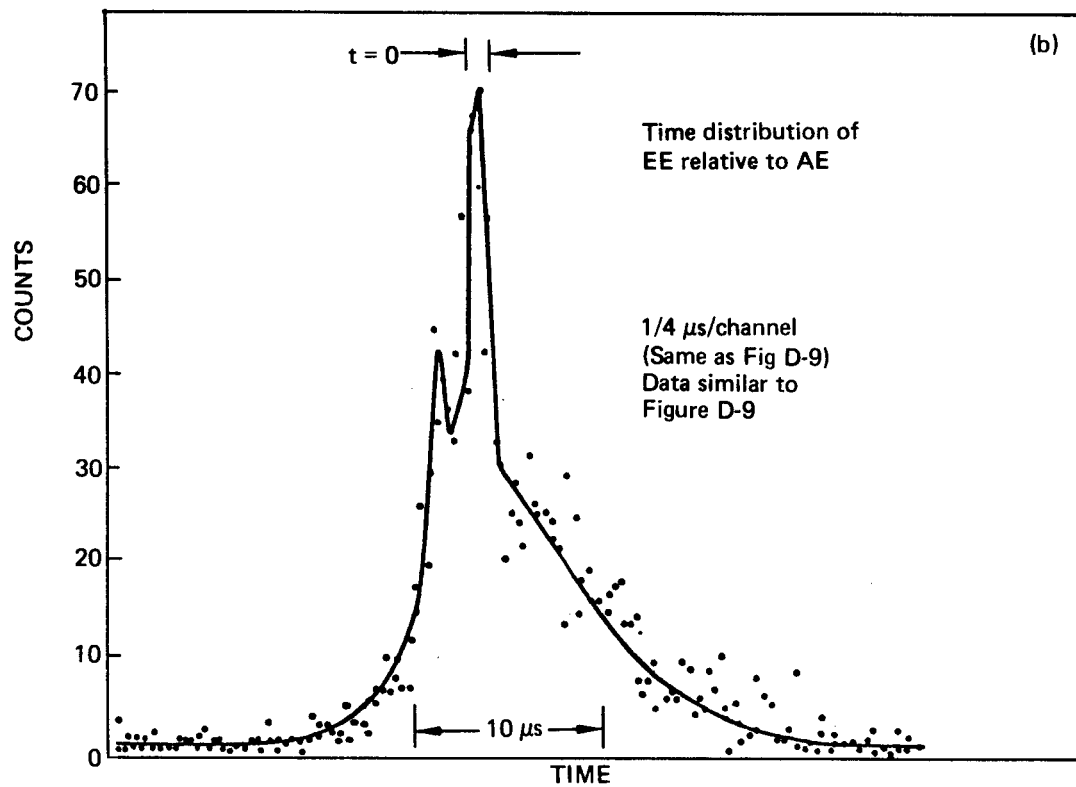
Figure D-6. Distribution of EE in Time Relative to AE

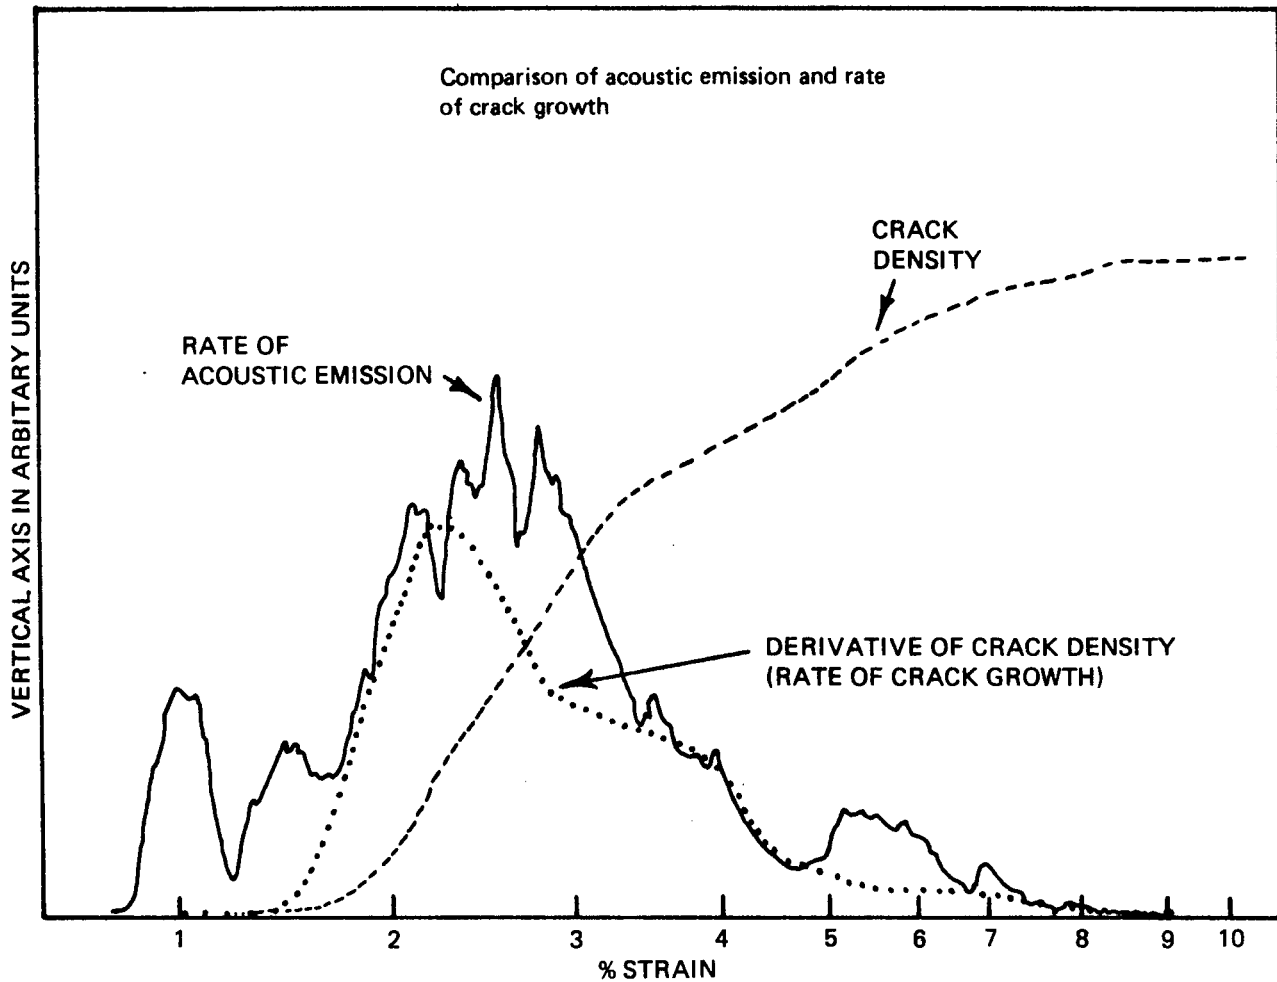
Figure D-7. AE Count Rate and Rate of Crack Growth vs Strain

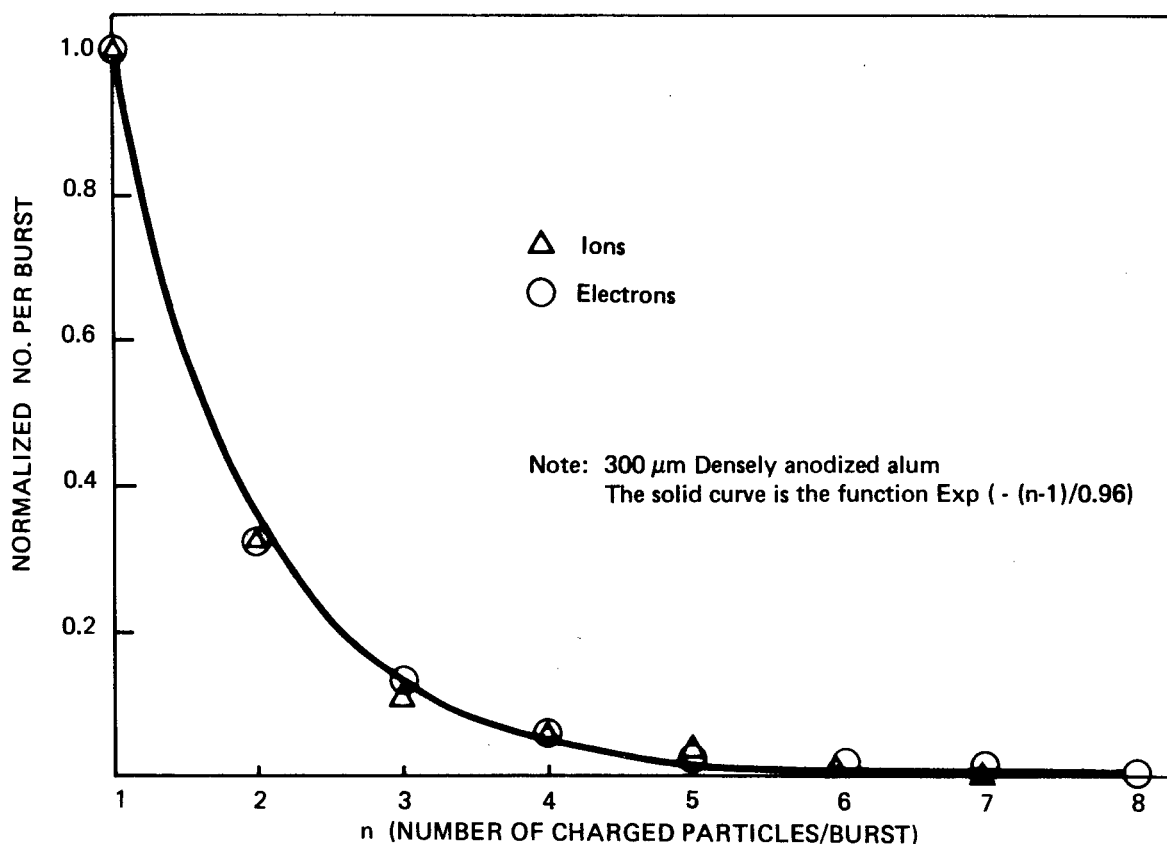
Figure D-9. The Distribution of the Number of Electrons and Number of Ions Emitted Per Burst

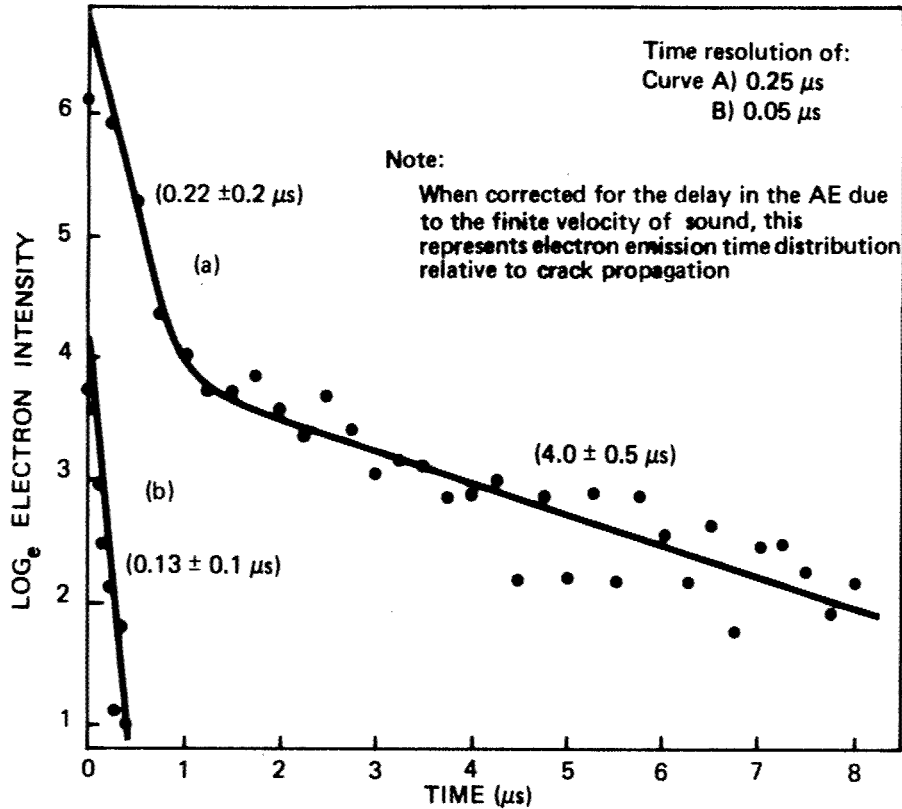
Figure D-11. Distributions in Time of the Electrons Relative to the AE Signal

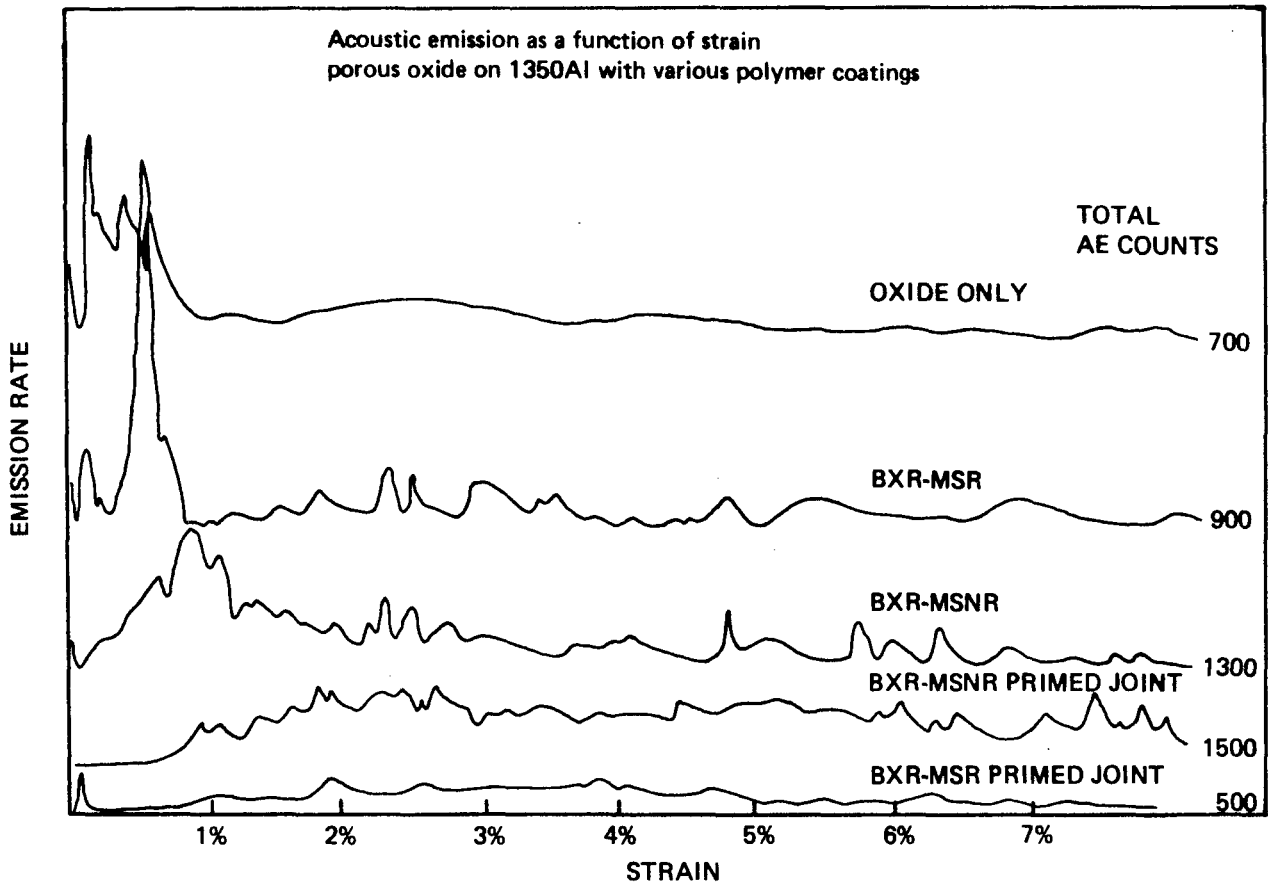
Figure D-13. Acoustic Emission Curves for H_3PO_4 Anodized Aluminum (1350) with Various Polymer Coatings used in Adhesive Bonding of Aluminum
