FLOOD PLAIN INFORMATION
EAST BRANCH ROCKY RIVER
CITY OF NORTH ROYALTON & HINCKLEY TOWNSHIP

CUYAHOGA AND MEDINA
COUNTIES OHIO

BY
CORPS OF ENGINEERS, U.S. ARMY
BUFFALO DISTRICT

JUNE 1974

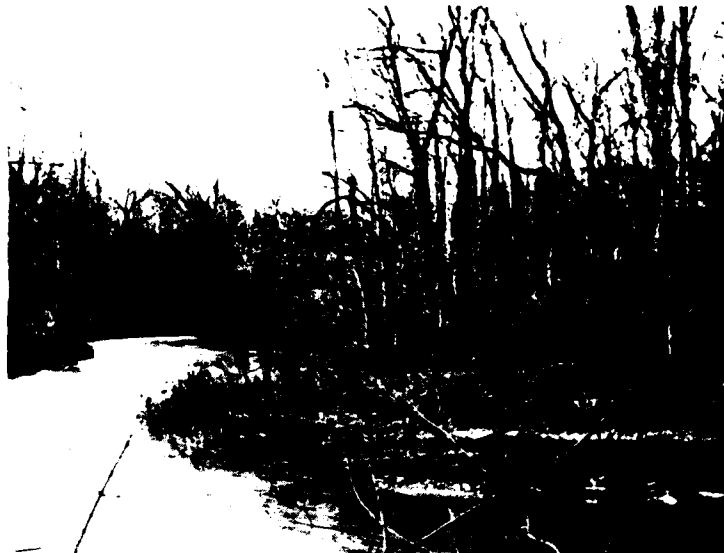
FIGURE 2 — Brush covered banks and wooded overbanks at river mile 26.98.

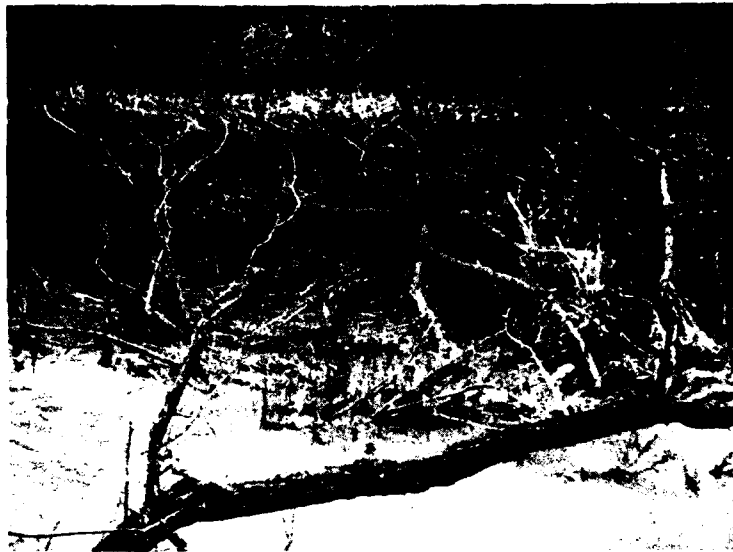
FIGURE 4 — Fallen trees in channel at river mile 28.98.

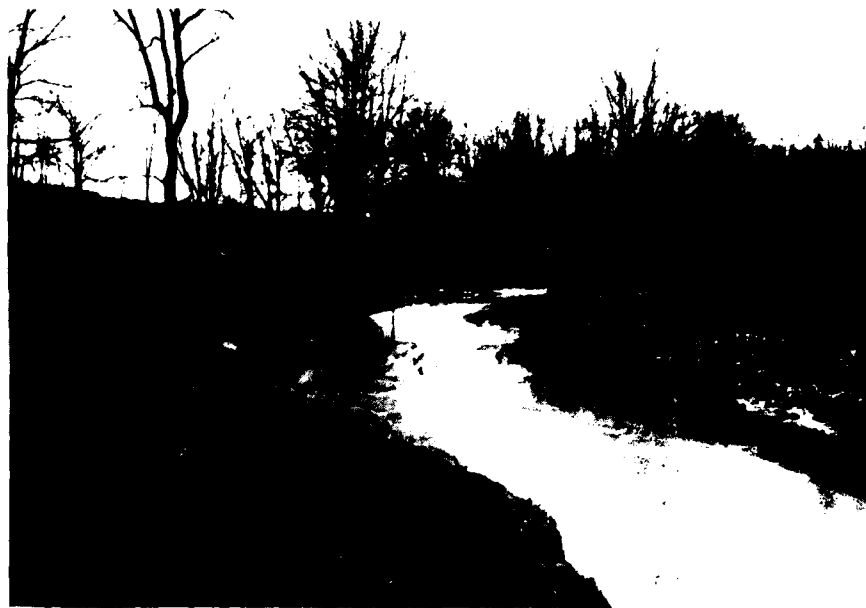
FIGURE 9 — Channel conditions through golf course area at river mile 31.62.

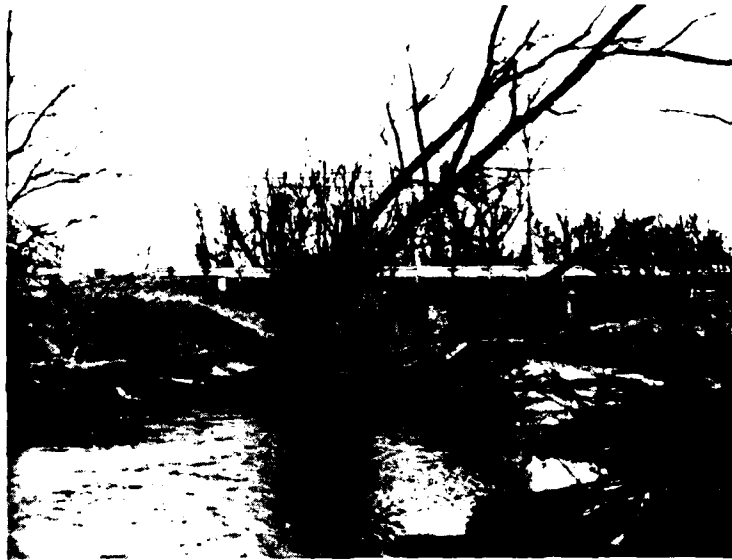
FIGURE 13 — Partial channel blockage and small island at river mile 35.35.

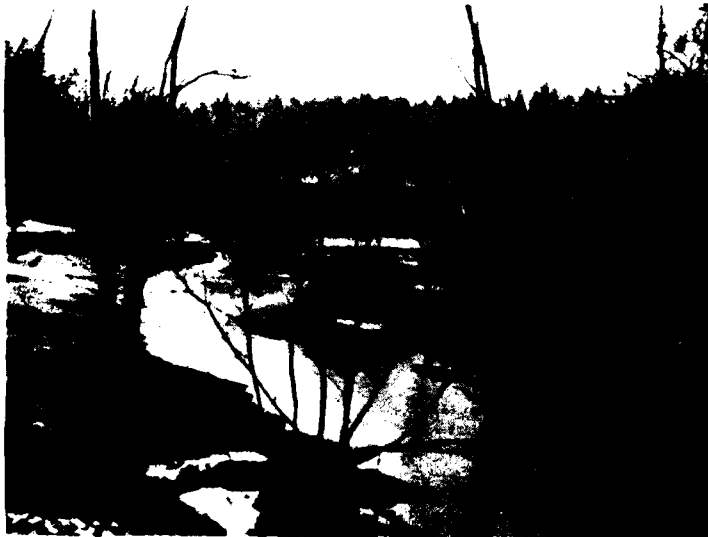
FIGURE 15 — Upstream view from Bellus Road bridge with Hinckley Dam in background. River mile 36.36. Note picnic grounds along shoreline.

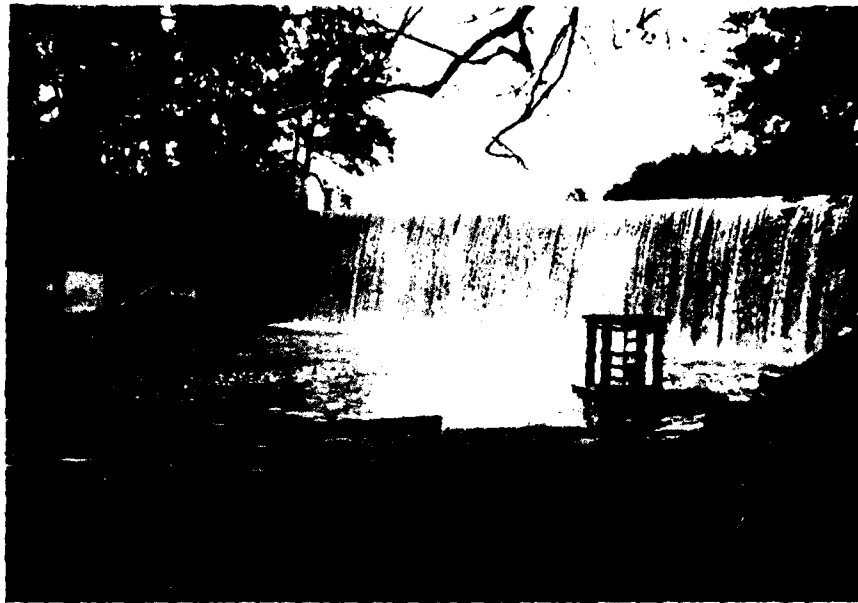
FIGURE 18 — Hinckley Dam and swimming area, river mile 36.49.

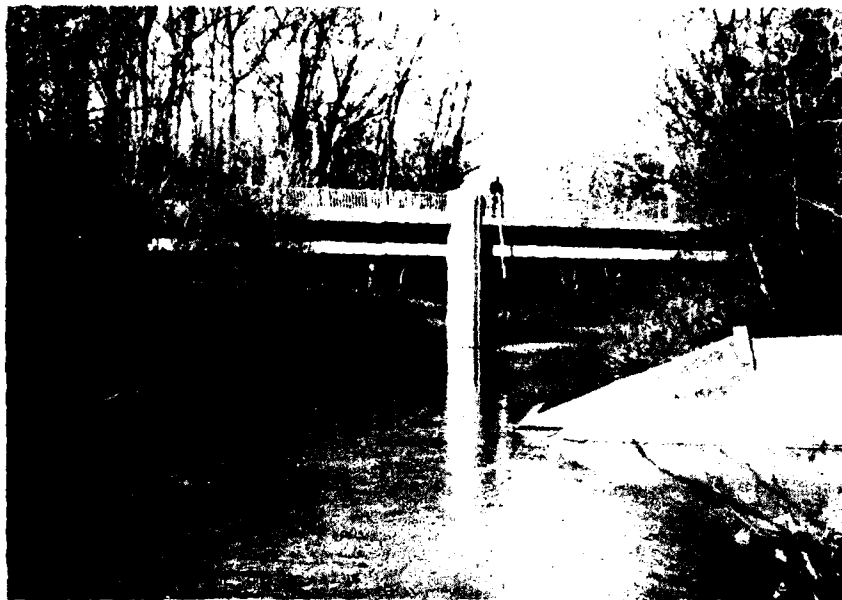
FIGURE 19 — View of upstream face of West 130th Street bridge looking downstream. River mile 25.85.

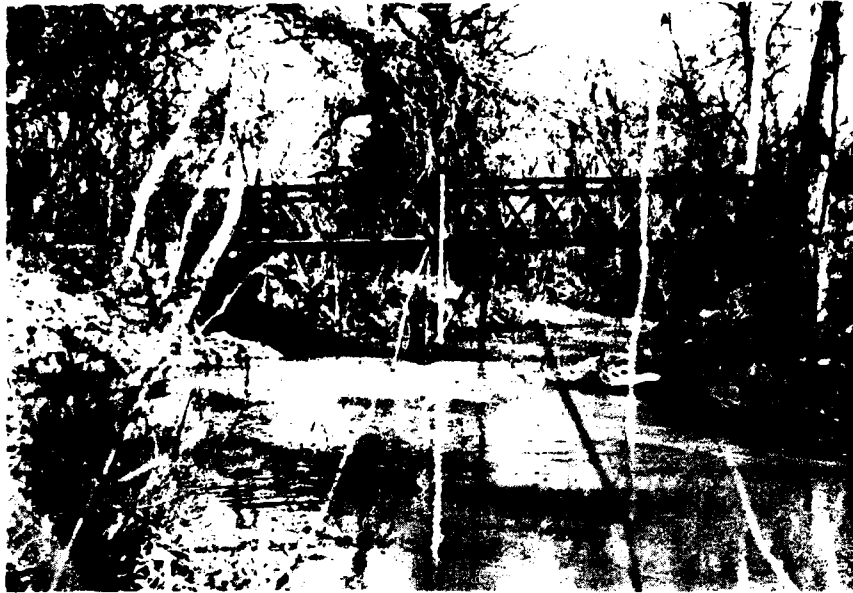
FIGURE 22 — View of private road bridge looking upstream at river mile 20.78.

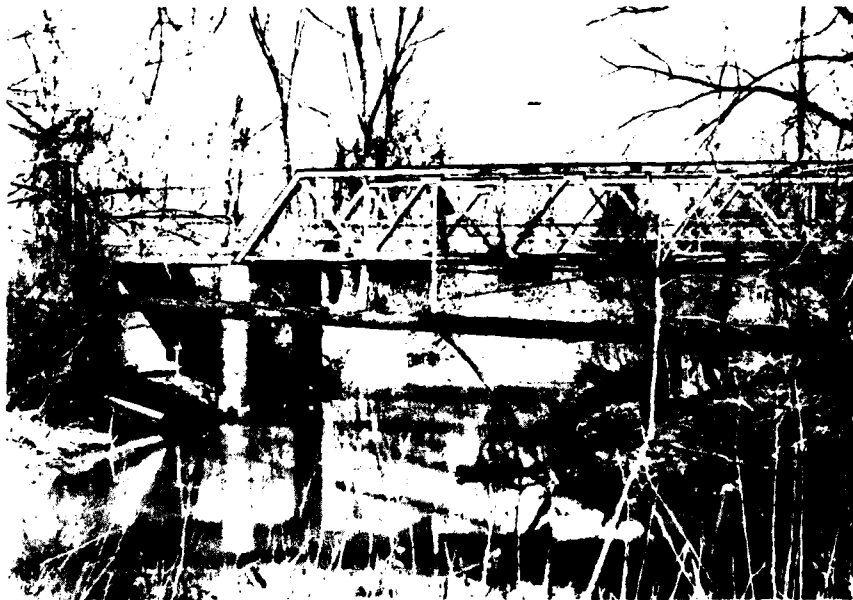
FIGURE 23 — Boston Road bridge at river mile 31.15. Looking downstream at upstream face.

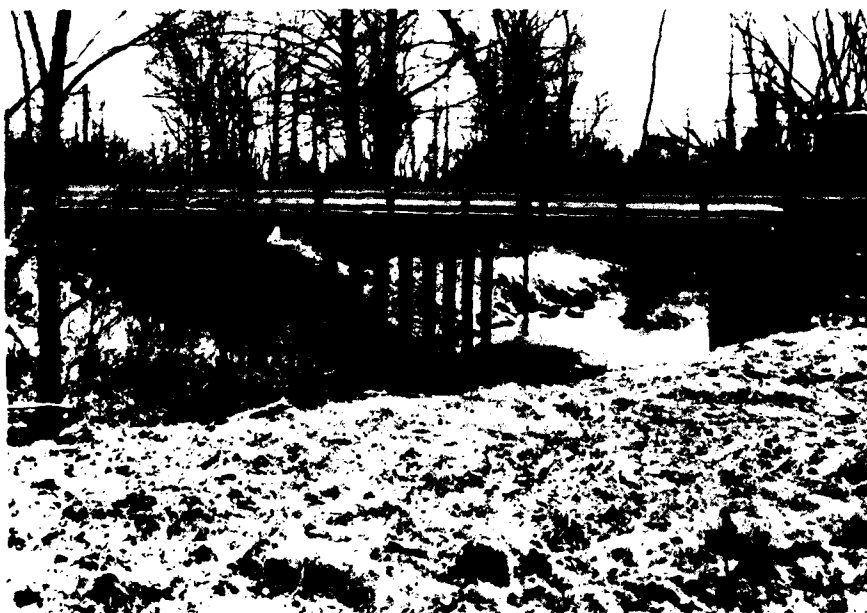
FIGURE 25 — View of downstream face of Route 303 bridge at river mile 35.32.

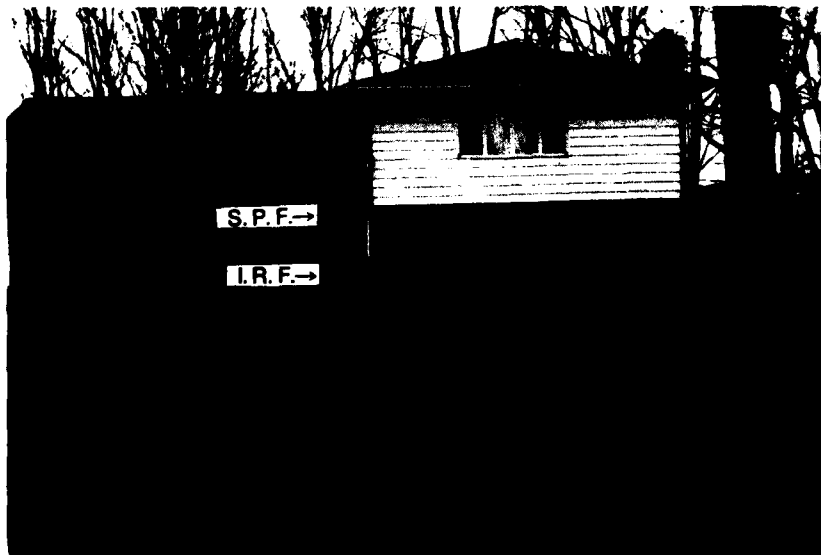
FIGURE 29 — Heights of the Standard Project and Intermediate Regional Floods are shown by arrows on this home on Mattingly Road, river mile 32.7.

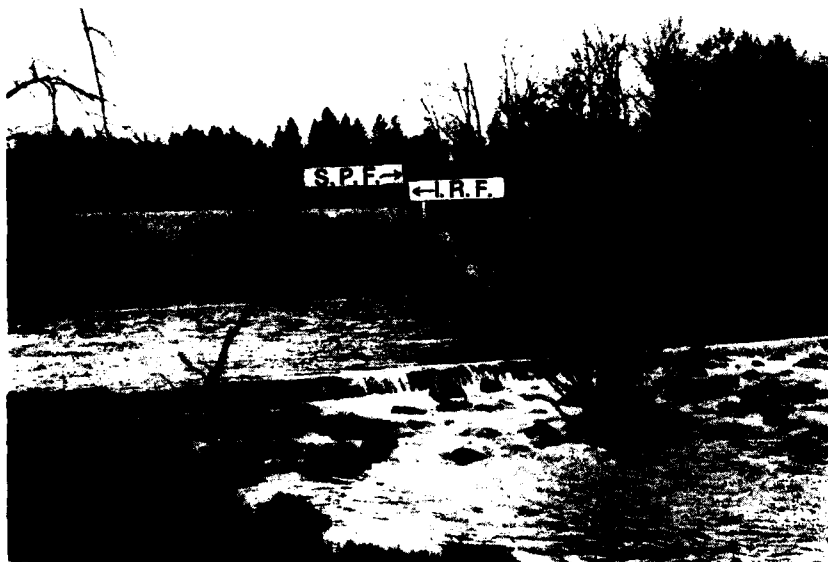
FIGURE 31 — Heights of flooding at Hinckley Lake dam, river mile 36.49 are shown by the arrows for the Standard Project and Intermediate Regional Floods.
