FLOOD PLAIN INFORMATION
 CHITTENANGO CREEK,
 BRIDGEPORT,
 ONONDAGA AND MADISON
 COUNTIES,
 NEW YORK.

BY
 CORPS OF ENGINEERS, U. S. ARMY
 BUFFALO DISTRICT

JUNE 1971

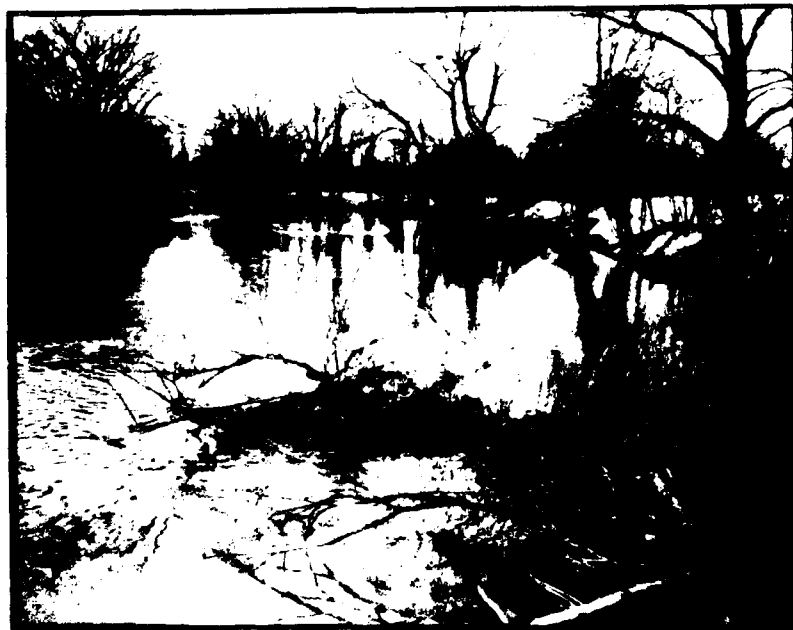
Figure 6 - Looking downstream from Sxbow Road at
growth in channel.

OBSTRUCTIONS TO FLOOD FLOWS - When debris collects at the upstream side of bridges, flows are severely retarded. Chittenango Creek in the study area has a relatively flat gradient and has a congested meandering channel of low capacity. A natural rock weir in the channel of Chittenango Creek, near Bridgeport, causes backwater flooding of Cicero Swamp during low flood flows but has little effect on the higher flows. Figures 5 and 6 show growth in the channel which could significantly reduce the amount of flow as a result of collecting debris.

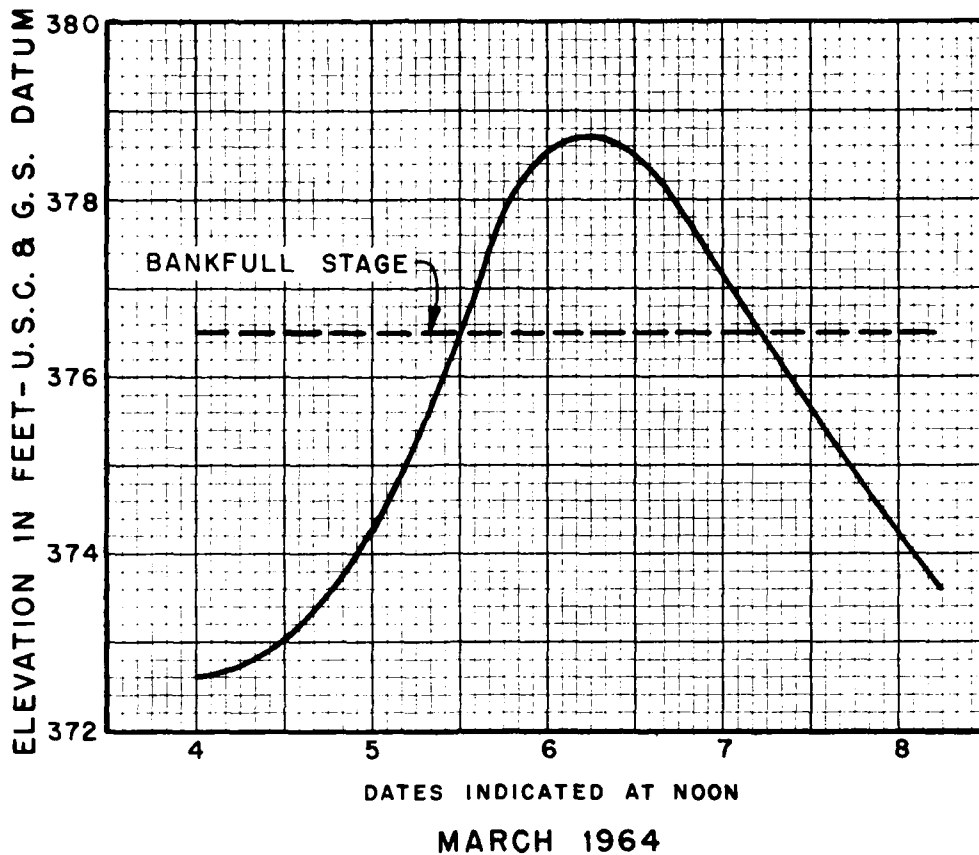
STAGE HYDROGRAPH WAS DERIVED USING THE DISCHARGE MEASUREMENTS TAKEN DURING THE MARCH 1964 FLOOD.

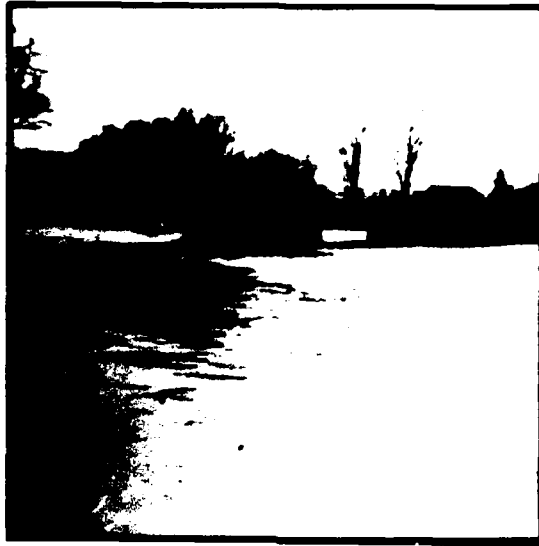
Figure 9 - Looking north at upstream face of N.Y.S. Route 31 bridge in Bridgeport. March 1964 flood.

MARCH 1964 - A low pressure system in the Mississippi Valley produced a cold front that began moving toward Syracuse. At the same time, warm moist air began moving up from the Gulf of Mexico. These two systems clashed over the plains of southern Illinois. The low pressure deepened and with it came wind and rain. In the Syracuse area the temperature rose into the 60's and was accompanied by 60-mile per hour winds. This combination caused considerable flooding within the study area. Figures 7-10 show flooding conditions that occurred in March 1964.

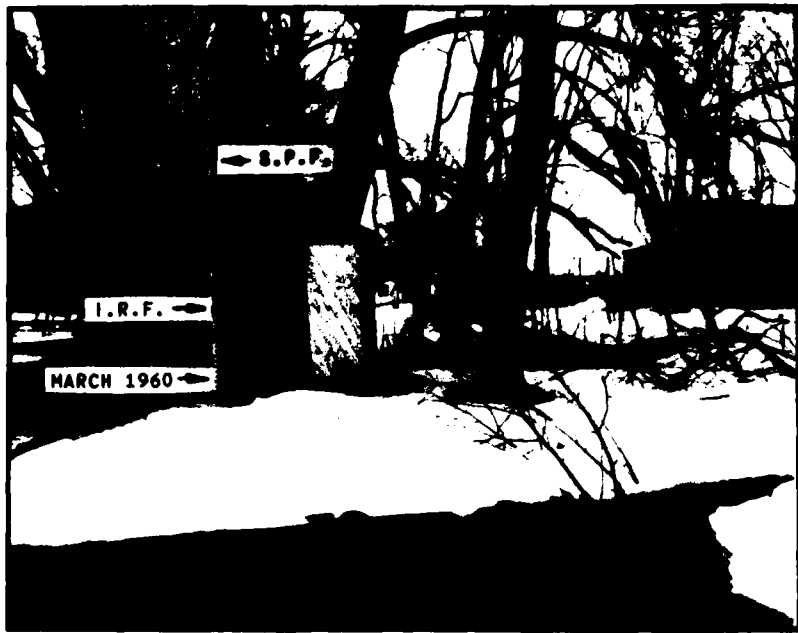
Figure 12 - Arrows indicate the heights of the Standard Project, Intermediate Regional, and March 1960 floods, stream mile 0.5.

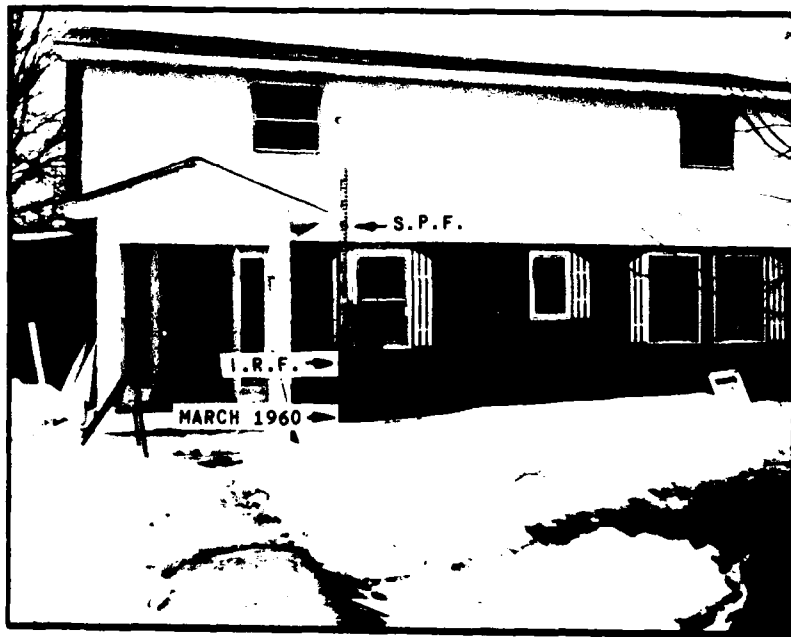
Figure 13 - Arrows indicate the heights of the Standard Project, Intermediate Regional, and March 1960 floods at residence on Hitchcock Road, stream mile 1.8.

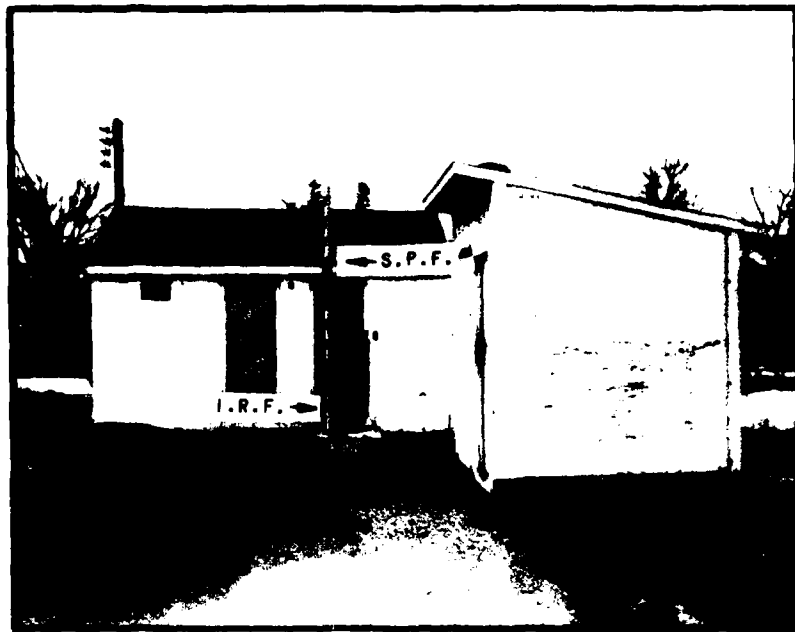
Figure 14 - Arrows indicate the heights of the Standard Project and Intermediate Regional floods at pump house just downstream of N.Y.S. Route 31, stream mile 3.4.

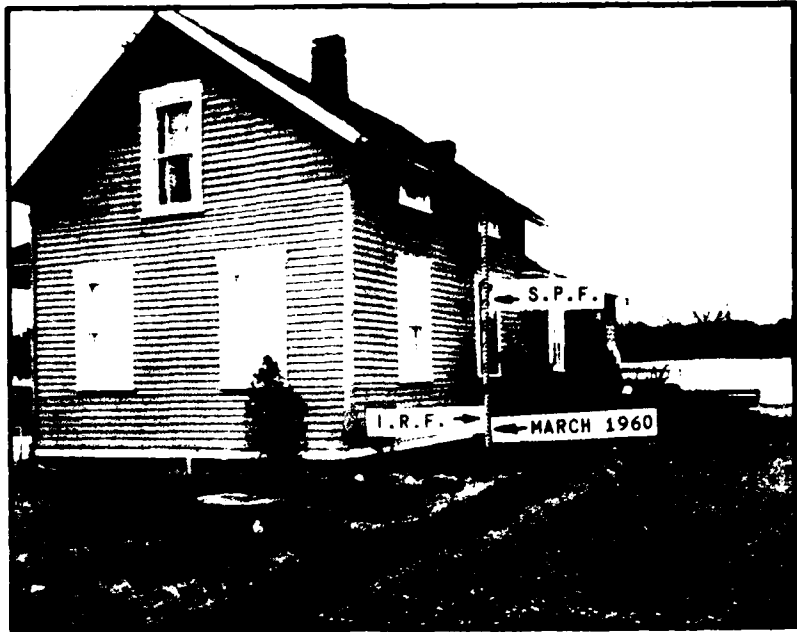
Figure 16 - Arrows indicate the heights of the Standard Project, Intermediate Regional, and March 1960 floods at residence on N.Y.S. Route 298, stream mile 4.7.
