# FLOOD PLAIN INFORMATION

## CUYAHOGA RIVER

## CITY OF KENT

BY  
 CORPS OF ENGINEERS, U. S. ARMY  
 BUFFALO DISTRICT  
 MAY 1972

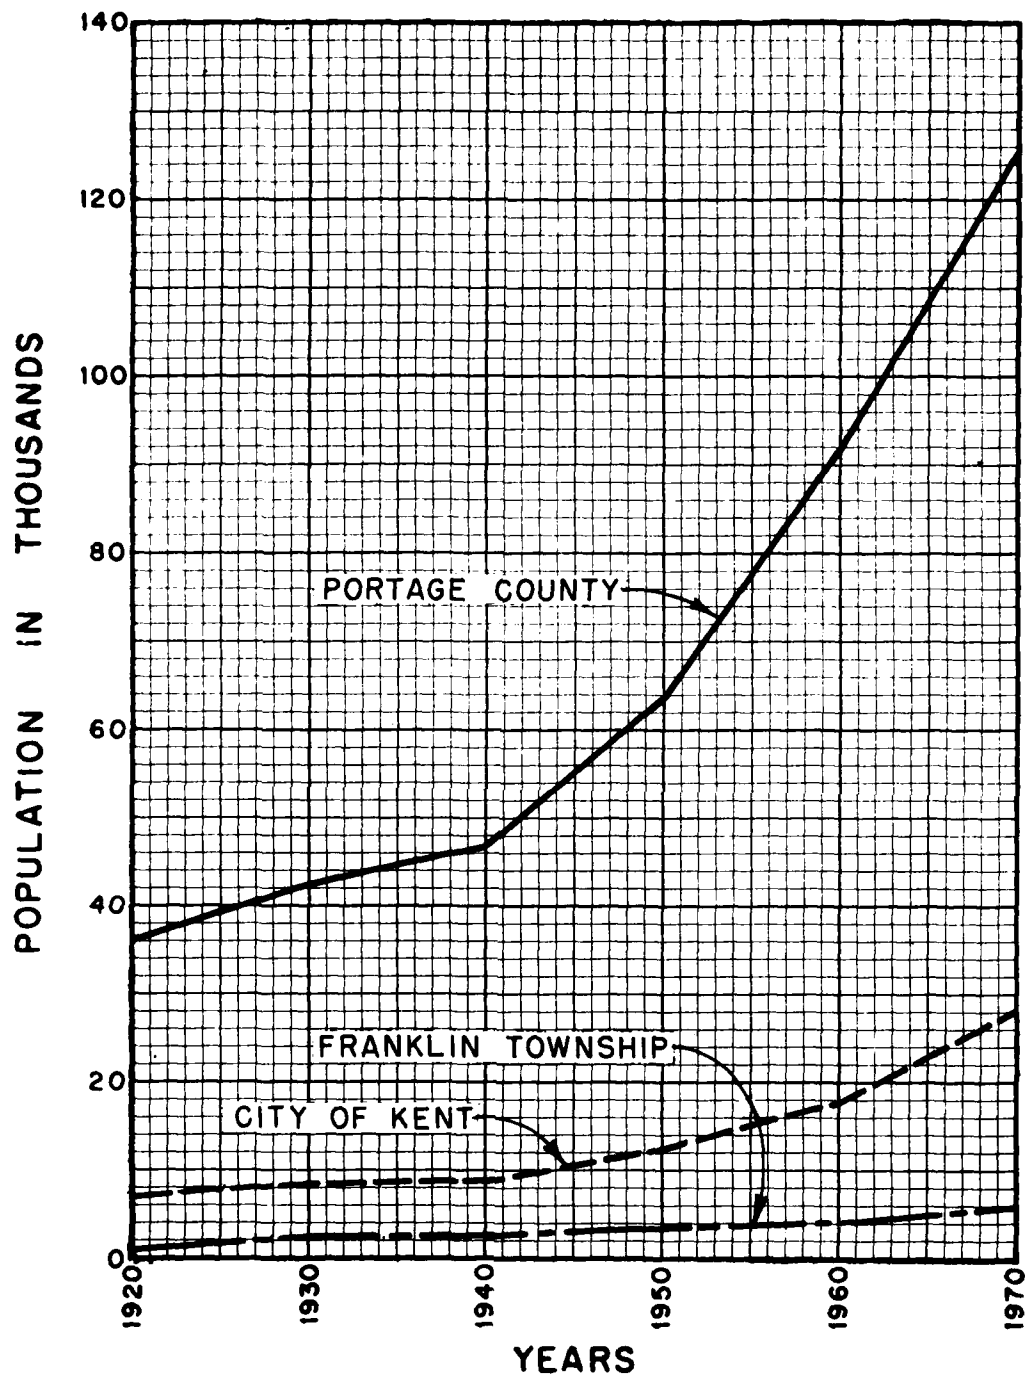
POPULATION TRENDS

POPULATION - Figure 1 illustrates the population trends for the individual communities in the study area. Since 1950, the population has increased 112%.

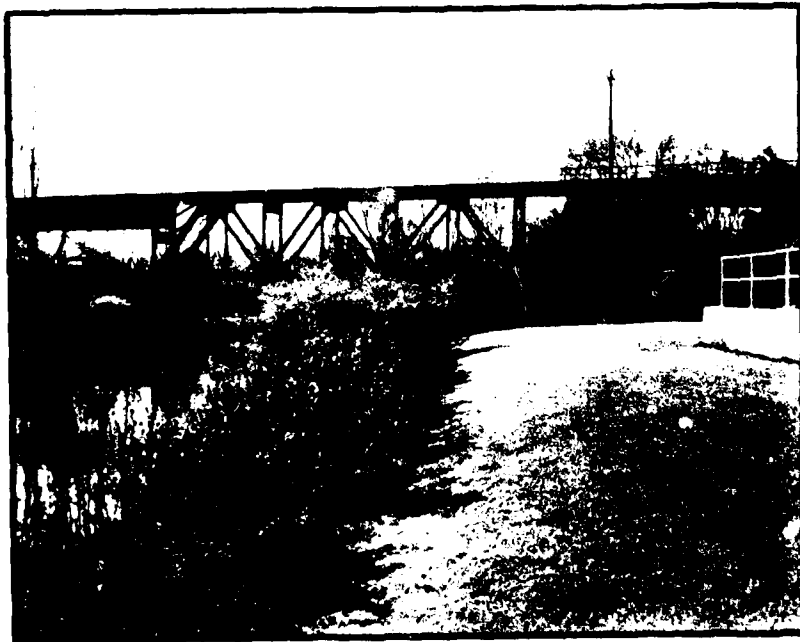
Figure 3 Upstream face of Norfolk and Western Rail-  
way bridge, stream mile 53.95.

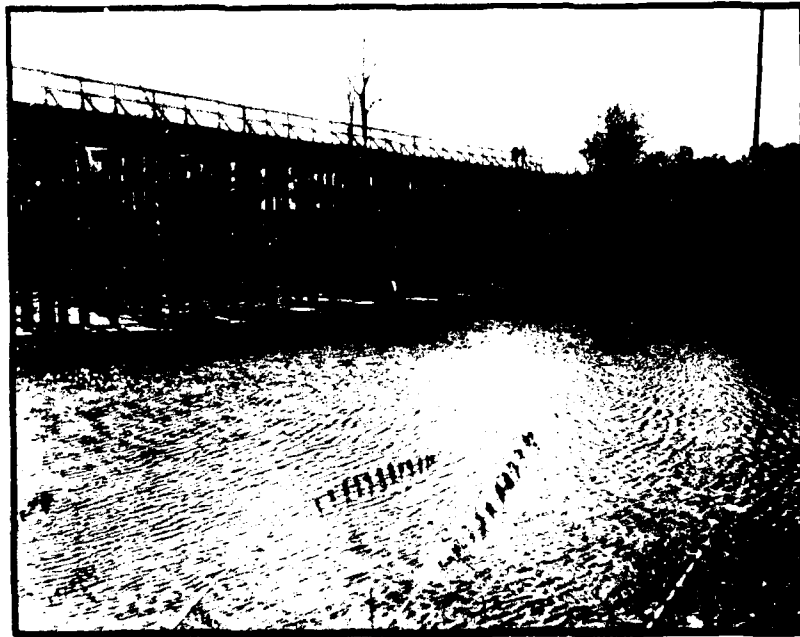
Figure 5 Upstream face of Norfolk and Western Railway bridge, stream mile 54.18.

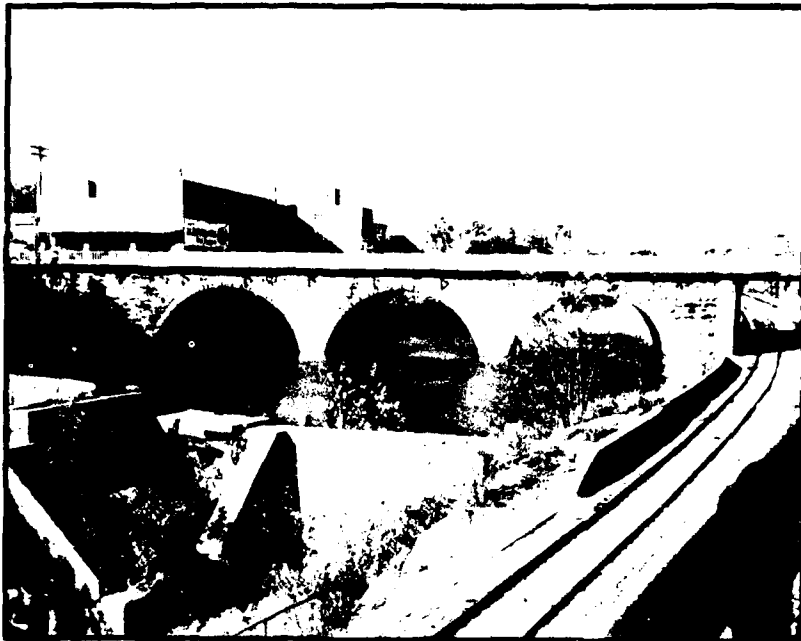
Figure 8 Downstream face of West Main Street bridge, stream mile 55.00.

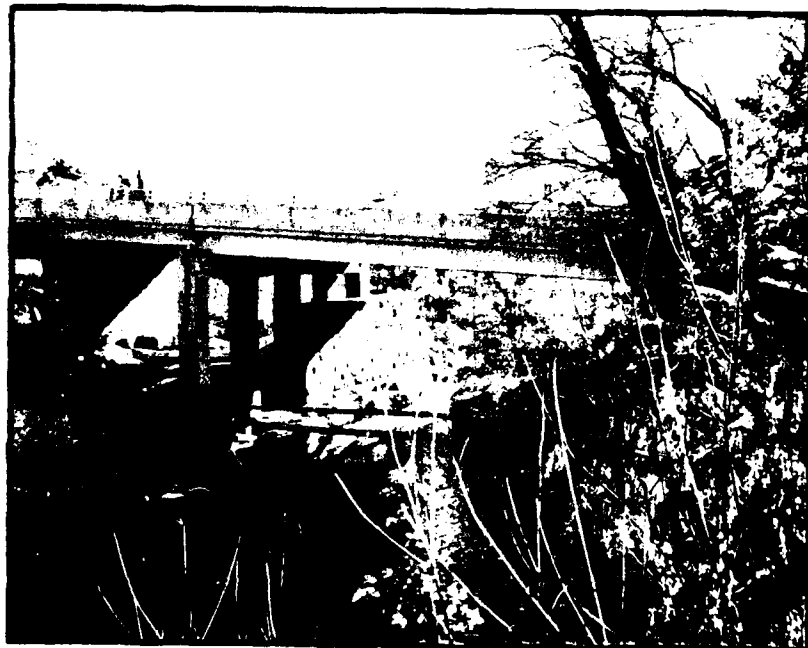
Figure 9 upstream face of Crain Avenue bridge, stream mile 55.35. Note pipelines which are obstructions to high flows.

OBSTRUCTIONS TO FLOOD FLOWS - Inadequate bridge areas, abandoned dams, encroachments, and fills are some of the obstructions to flood flows. Other serious obstructions are bends in the stream, irregularity of channel section, and heavy brush, weeds, and large trees growing on the channel banks and extending into the stream. Figures 20 and 21 show typical obstructions in the study area, which tend to reduce floodway capacity and increase river stages.

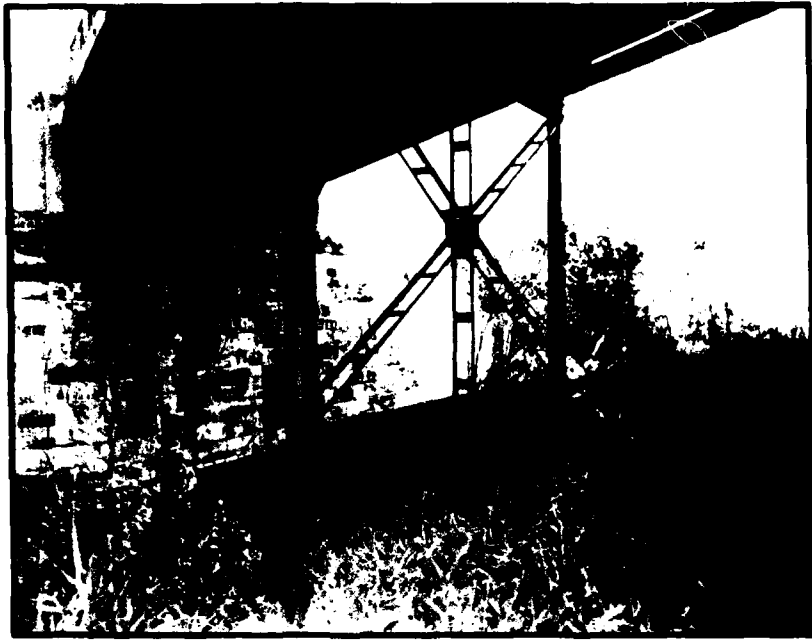
Figure 14 Downstream side of Brady Lake Road bridge,  
stream mile 0.45.

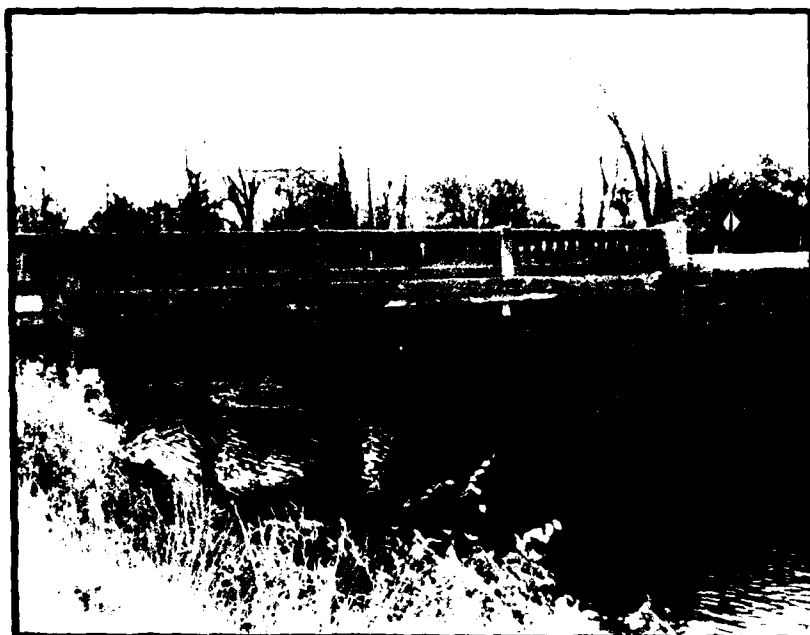
Figure 16 Upstream face of West Main Street bridge, stream mile 1.60.

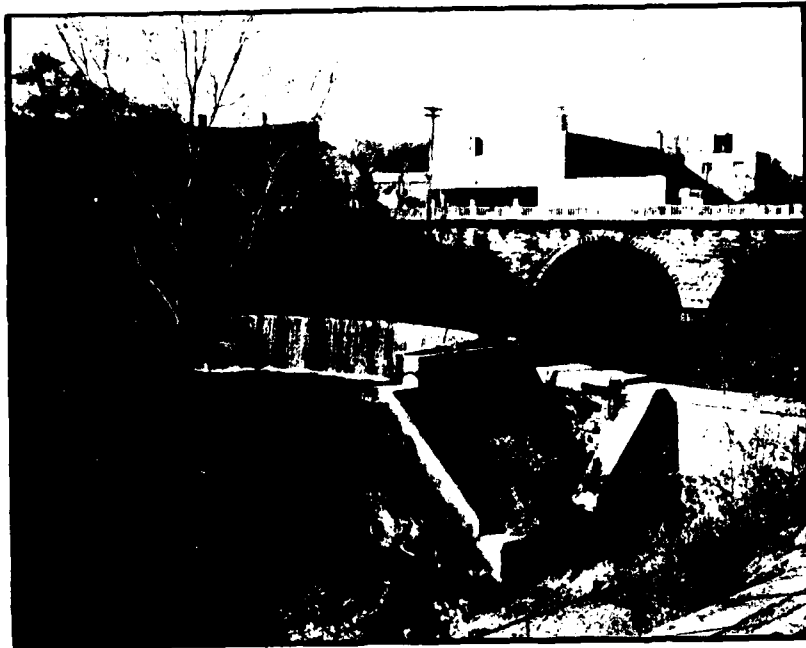
Figure 18 Looking upstream at Dam located at stream mile 54.96. West Main Street is in the background. Photograph taken in November 1971.

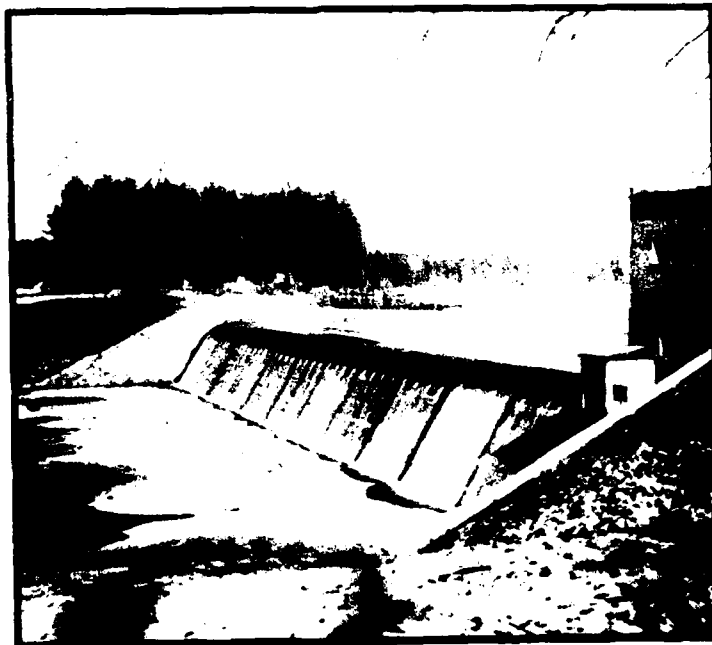
Figure 19 Looking upstream at Lake Rockwell Dam at stream mile 58.10. Photograph taken in February 1972.

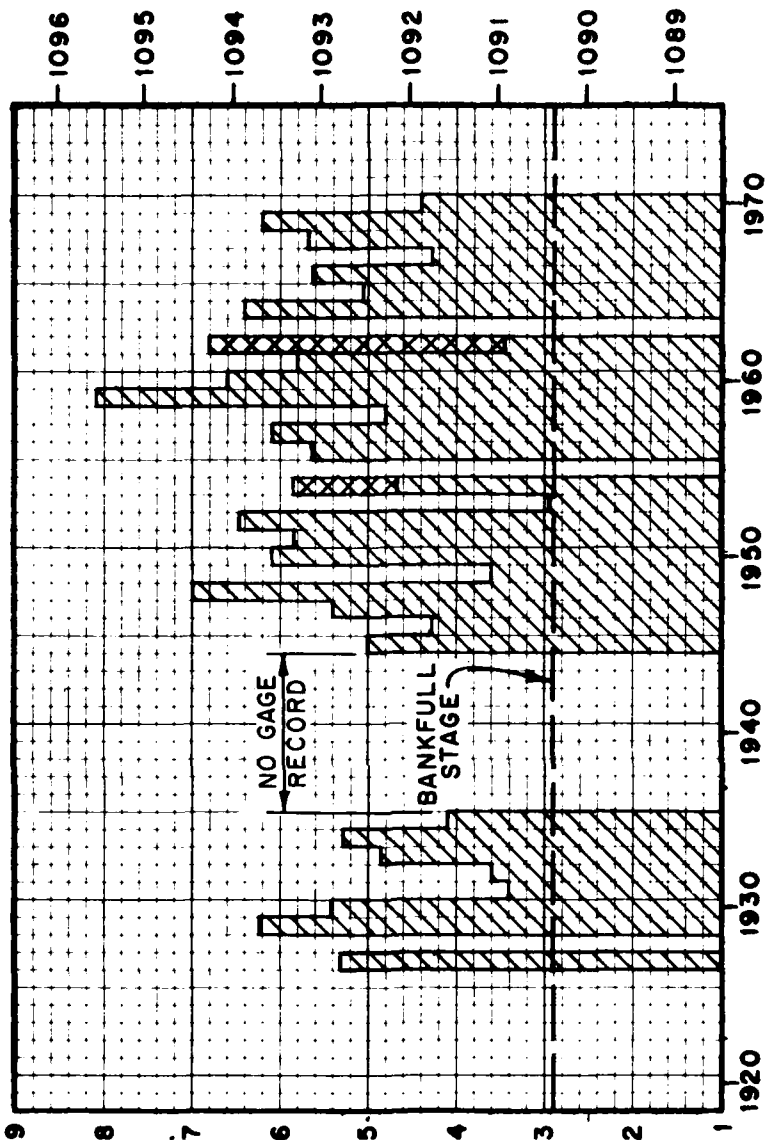
**CUYAHOGA RIVER AT HIRAM RAPIDS, OHIO**  
 Stream gage at mile 75.80 Drainage Area, 151 Sq. Mi.  
 Zero of gage, Elevation 1087.46 U.S.C. & G.S. Datum.

**CUYAHOGA RIVER**  
**CITY OF KENT AND**  
**FRANKLIN TOWNSHIP, OHIO**  
**FLOOD PLAIN INFORMATION REPORT**  
**FLOODS ABOVE**  
**BANKFULL STAGE**  
 U. S. ARMY ENGINEER DISTRICT, BUFFALO  
 MAY 1972

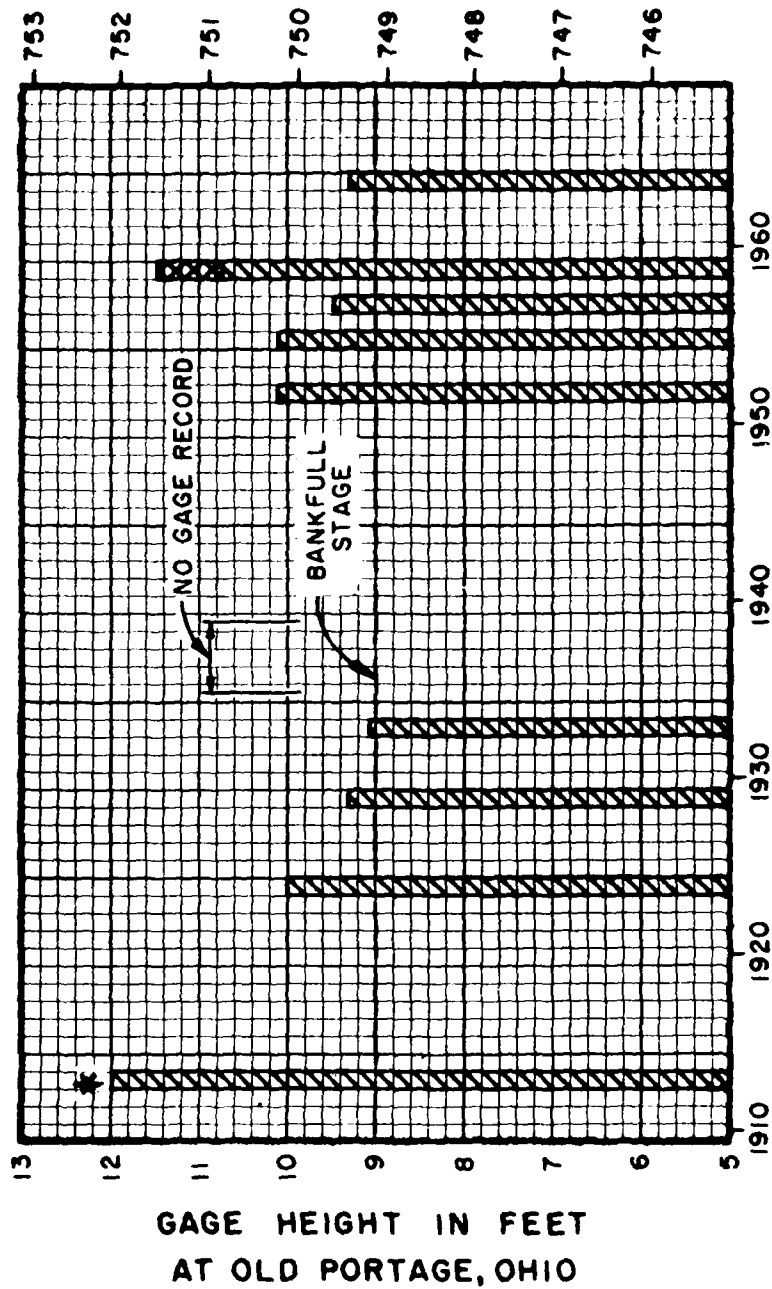
CUYAHOGA RIVER AT OLD PORTAGE, OHIO  
 Stream gage at mile 40.27 Drainage Area, 404 Sq. Mi.  
 Zero of gage, Elevation 740.11 U.S.C. & G.S. Datum

\* Indicates flood estimated by U.S. Army, Corps of Engineers.  
 Variation in shading on the bar graph indicates more than one flood during the year.

CUYAHOGA RIVER  
 CITY OF KENT AND  
 FRANKLIN TOWNSHIP, OHIO  
 FLOOD PLAIN INFORMATION REPORT  
**FLOODS ABOVE  
 BANKFULL STAGE**  
 U. S. ARMY ENGINEER DISTRICT, BUFFALO  
 MAY 1972

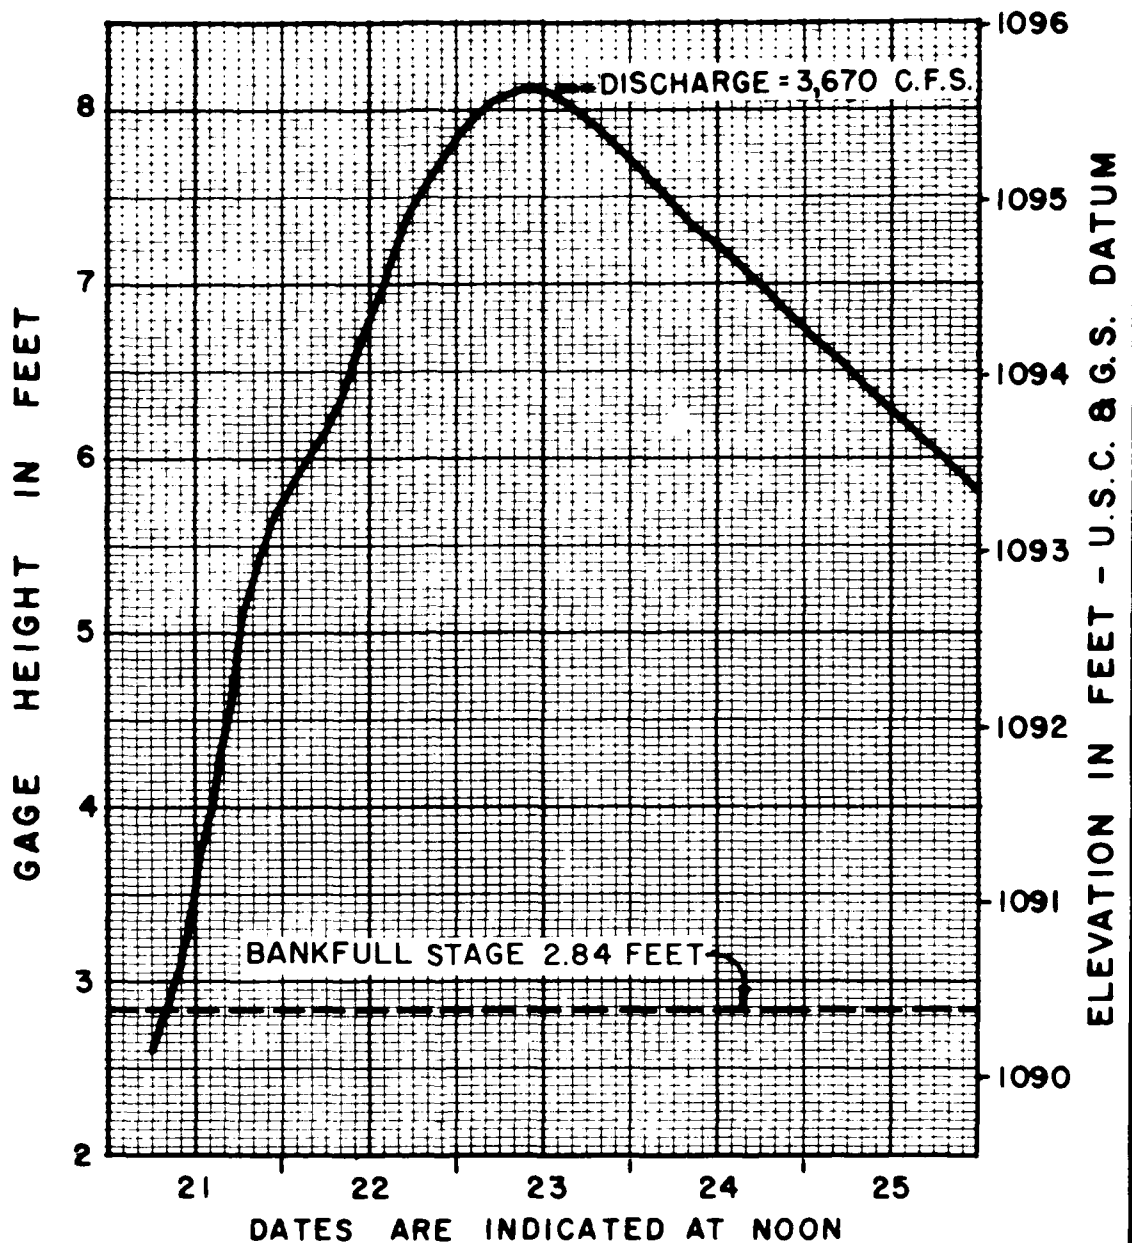
JANUARY 1959

**HIRAM RAPIDS, OHIO**

**STAGE HYDROGRAPH**

20-21 JANUARY 1959 - A storm developed from a large mass of cold air over northwestern Canada, a flow of warmer air from the southwest and the associated frontal system. Heavy rains began when the moisture-laden air from the south and the cold front converged. The storm was centered approximately 150 miles southwest of the Cuyahoga River basin. High water caused by two days of rain on 20-21 January 1959 inflicted damage in not only parts of Portage County but throughout the State of Ohio. More rain than usually falls in the whole month of January was dumped on the Akron area on these two days causing widespread damage to homes and highways. Some families were forced to evacuate their homes by boat. During January 1959 temperatures were several degrees below normal. When the temperatures reached  $-5^{\circ}$  on the 18th, the ground became frozen. At the Akron Sewage Works, 2.86 inches of rain fell during a 30-hour period on 20-21 January. In a 3-hour period on 21 January, 0.82 inch of rain fell. Although total rainfall for the storm was not excessive, intensities were high and runoff was increased by the frozen ground and the 6-inch snow cover on the basin. Following the rainfall, there was a warming trend which contributed snow melt. Rainfall averaged 2.34 inches over the entire basin; runoff from rainfall and snow melt averaged 2.94 inches. At the Hiram Rapids gage the January 1959 flood reached elevation 1095.57, U.S.C. & G.S. datum, which is approximately 5.3 feet above bankfull stage. At the Old Portage gage the January 1959 flood reached elevation 751.61, U.S.C. & G.S. datum, which is approximately 2.5 feet above bankfull stage.

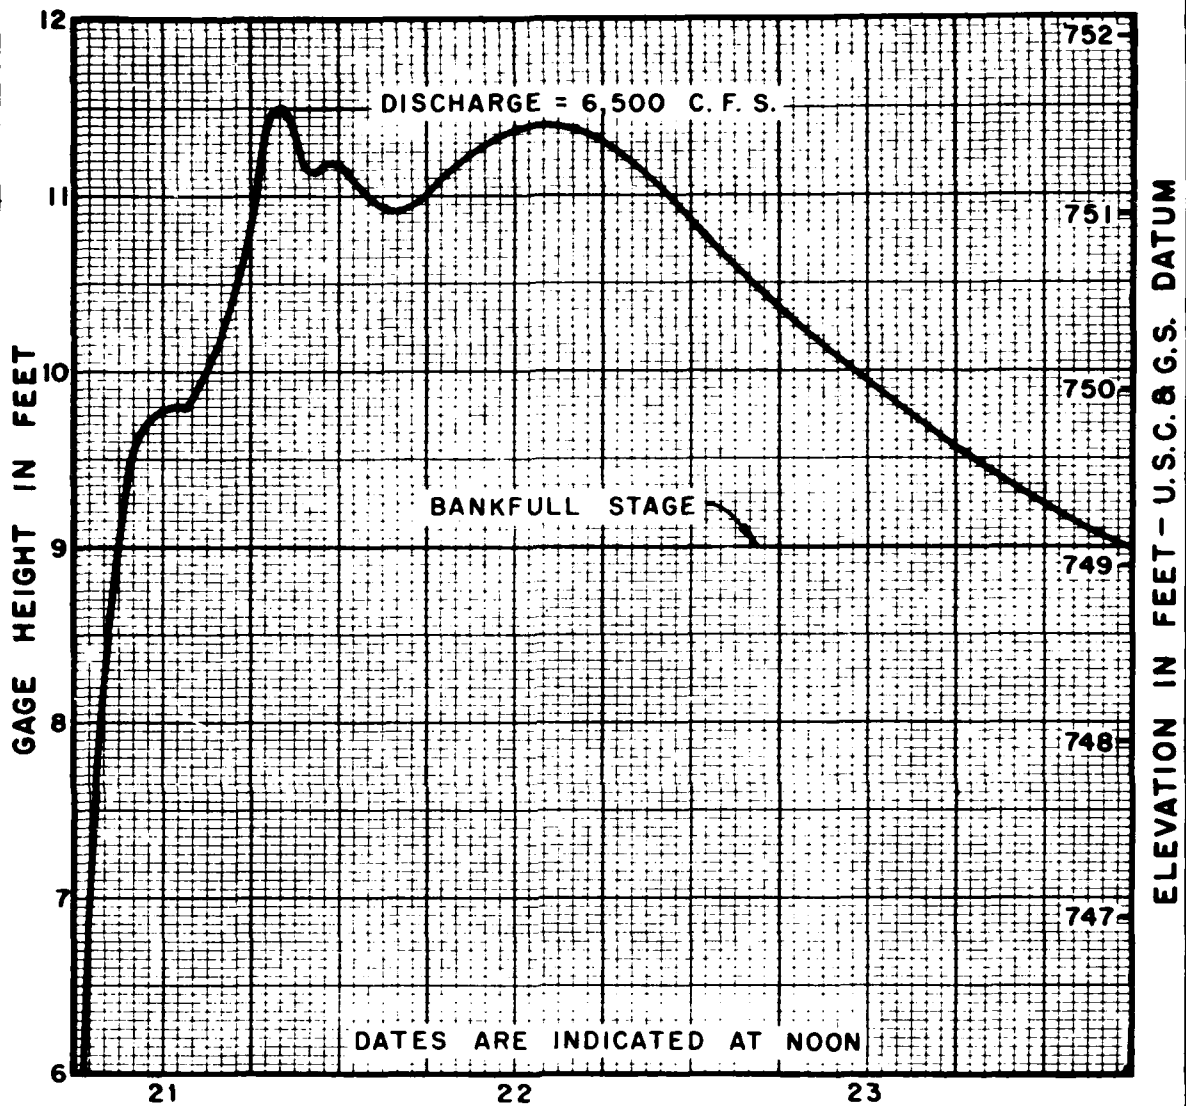
JANUARY 1959  
 OLD PORTAGE, OHIO

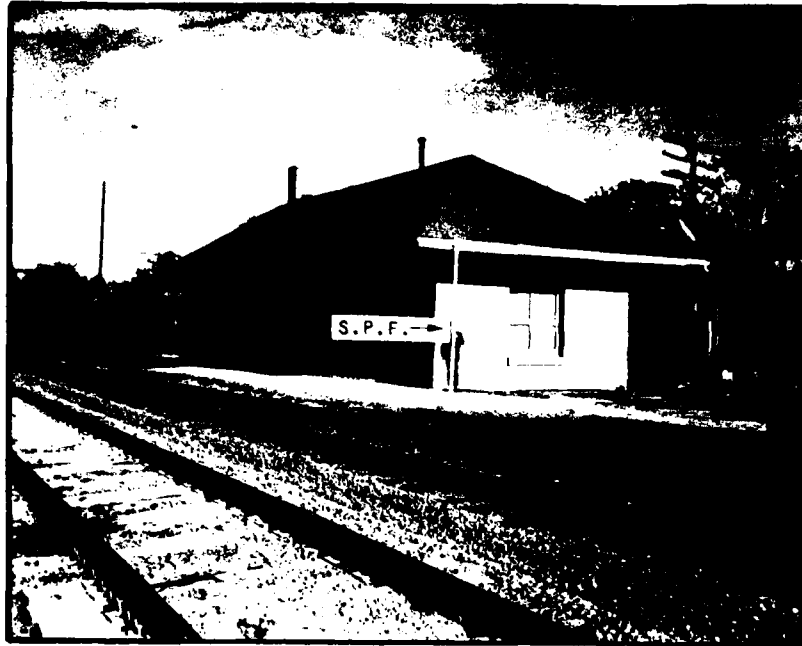
Figure 23 Low damage development which is compatible with wise flood plain useage. Arrow indicates the height of the Standard Project Flood Stream mile 54.58. Photograph taken in November 1971.

As soon as possible, local governments should develop and enforce flood plain regulations based on the information contained in this report. This report provides local governments with the necessary tools to control the extent and type of development which would be allowed to take place within the flood plain. Regulation of the flood plain can usually be carried out most effectively by a combination of the several regulatory methods ... zoning ordinances, subdivision regulations and building codes. Local governments can also police and maintain the floodway so as to insure against the overgrowth of brush, weeds, debris and large trees which obstruct flood flows. All of these factors result in increased river stages. The U. S. Army Corps of Engineers has prepared and is distributing to State, county and local governments for public dissemination two pamphlets, "Guidelines for Reducing Flood Damages" and "Introduction to Flood Proofing." The combination of data presented in this report and in the pamphlets will provide general guidelines for flood damage reduction in future development within the Cuyahoga River flood plain. Figure 22 lists the corrective and preventive measures described in the above mentioned pamphlets. The U. S. Army Corps of Engineers will distribute to State, county and local governments other helpful pamphlets as well as additions to existing pamphlets when they are developed. Figures 23 and 24 indicate the desired development of a flood plain.

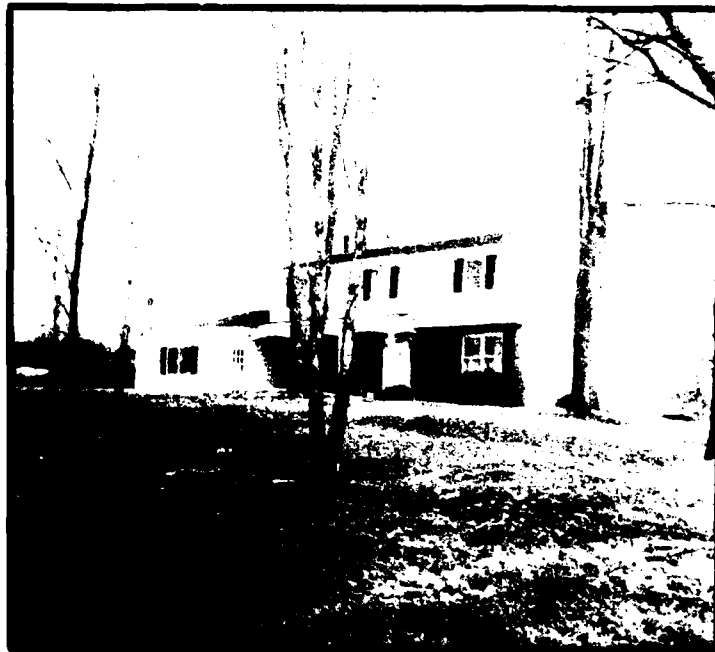
Figure 24 House, bordering Breakneck Creek at stream mile 3.05, built up to be well out of the range of the Intermediate Regional Flood or the Standard Project Flood. Photographs taken in February 1972.

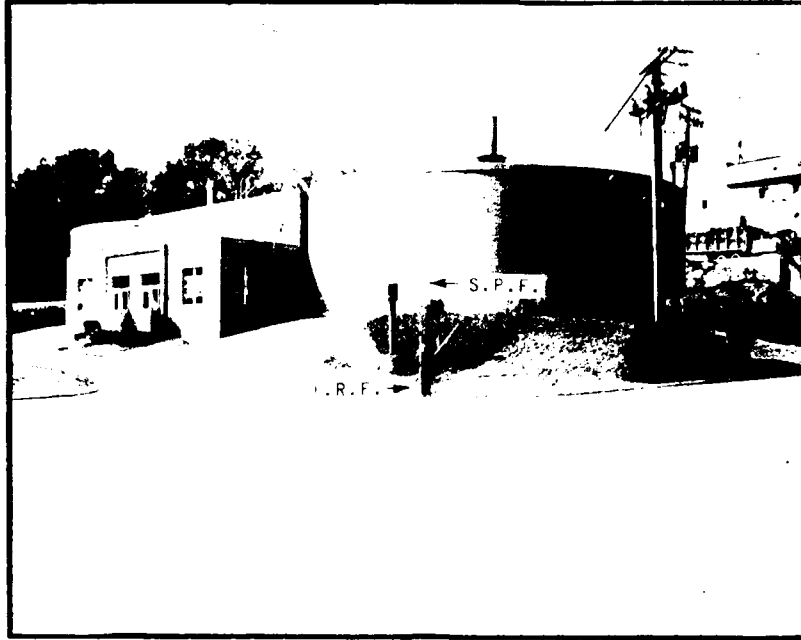
Figure 25 Arrows indicate the heights of the Intermediate Regional and the Standard Project floods at Sewage treatment plant, stream mile 54.0.

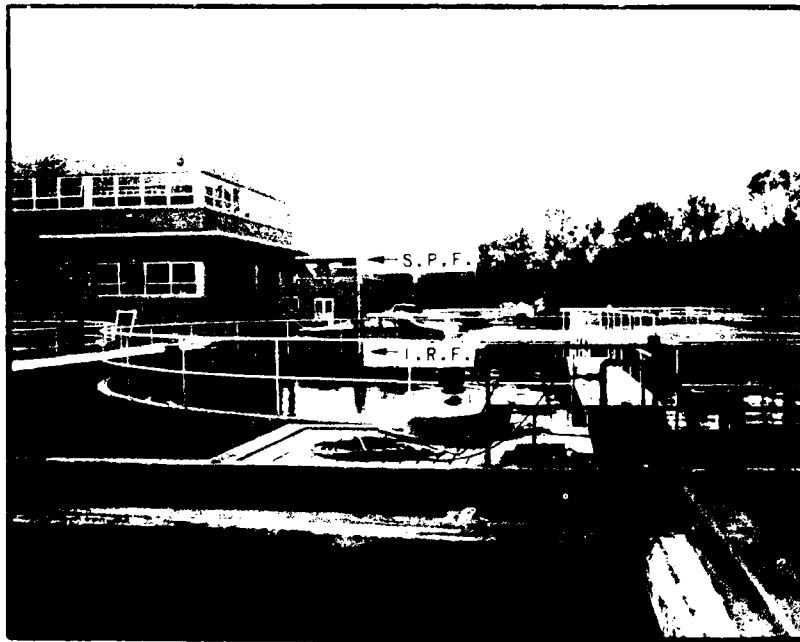
Figure 26 Arrows indicate the heights of the Intermediate Regional and the Standard Project floods at Sewage treatment plant, stream mile 54.0.

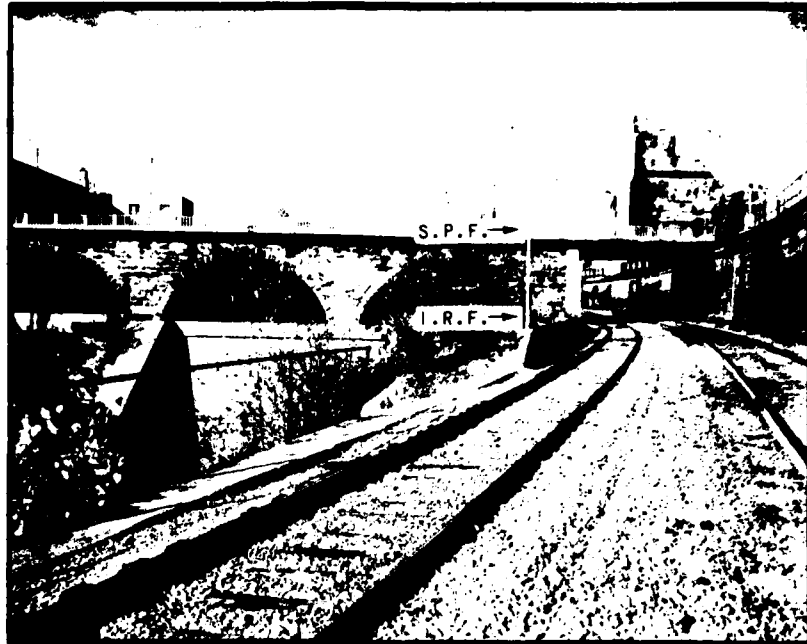
Figure 27 Arrows indicate the heights of the Intermediate Regional and the Standard Project floods just downstream of the West Main Street bridge, stream mile 55.0.

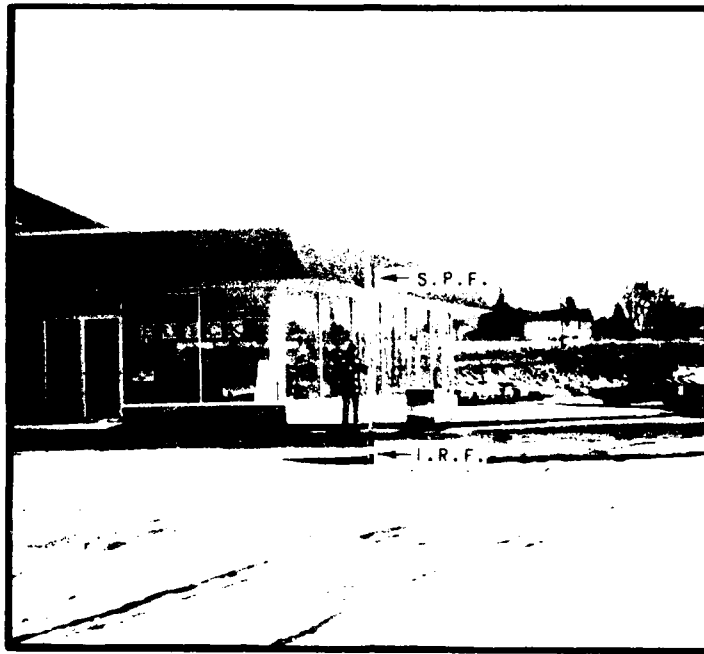
Figure 29 Arrows indicate the heights of the Intermediate Regional and the Standard Project floods at a car dealer on the downstream side of East Main Street bridge, stream mile 1.59. Photograph taken in January 1972.

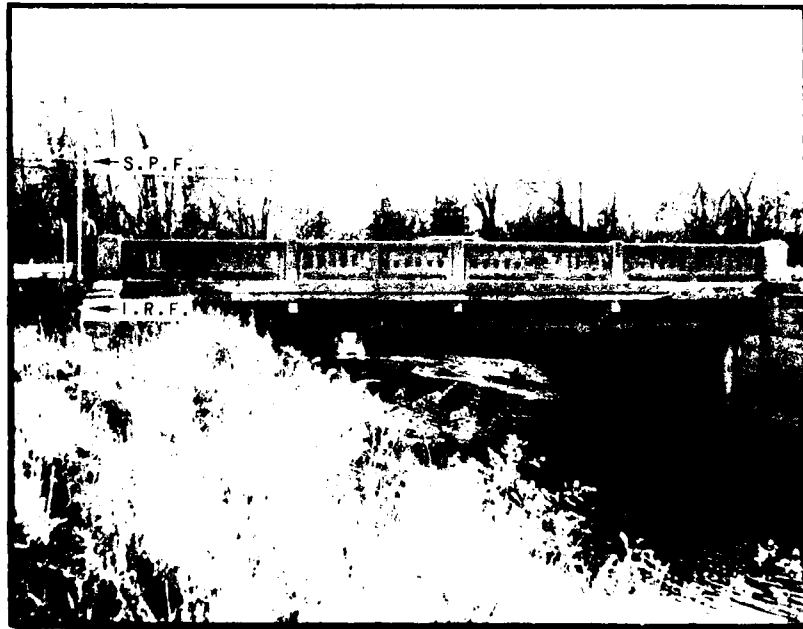
Figure 30 Arrows indicate the heights of the Intermediate Regional and the Standard Project floods at the East Main Street bridge, stream mile 1.6. Photograph taken in November 1971.

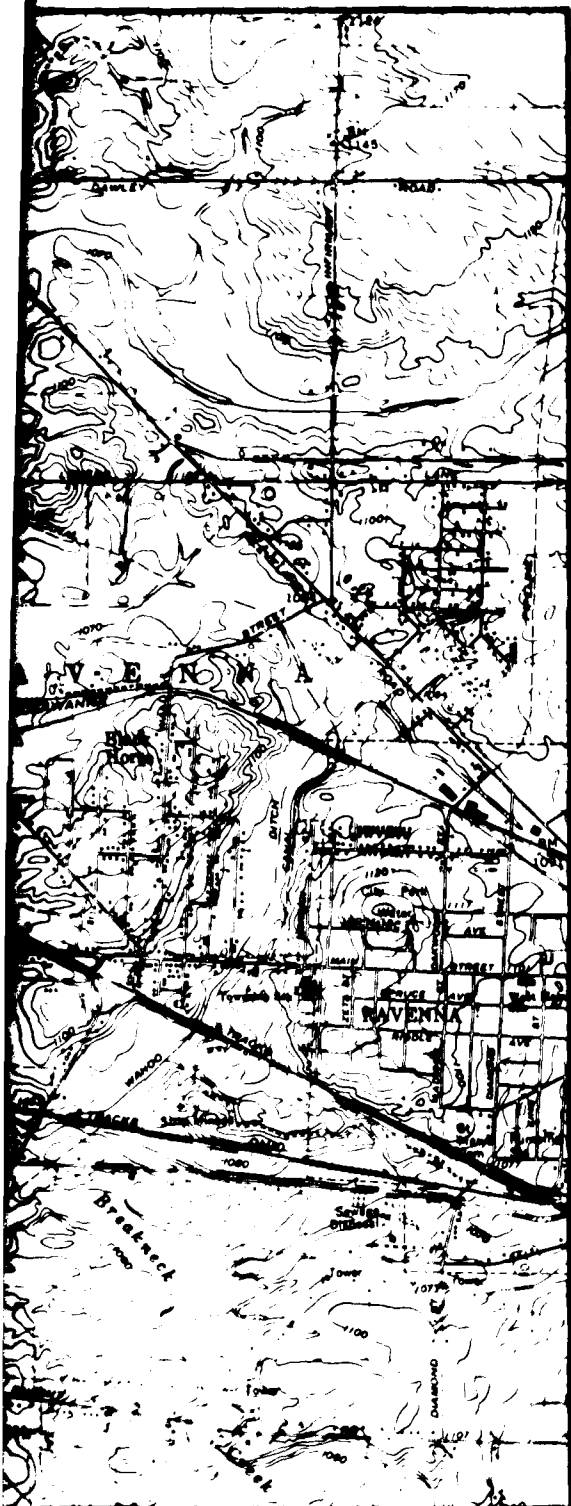
PLATE 8

CUYAHOGA RIVER  
CITY OF KENT AND  
FRANKLIN TOWNSHIP, OHIO  
FLOOD PLAIN INFORMATION REPORT  
INDEX MAP  
FOR FLOODED AREAS  
U S ARMY ENGINEER DISTRICT, BUFFALO  
MAY 1972
