# FLOOD PLAIN INFORMATION

## CUYAHOGA RIVER

## CITY OF KENT

BY  
 CORPS OF ENGINEERS, U. S. ARMY  
 BUFFALO DISTRICT  
 MAY 1972

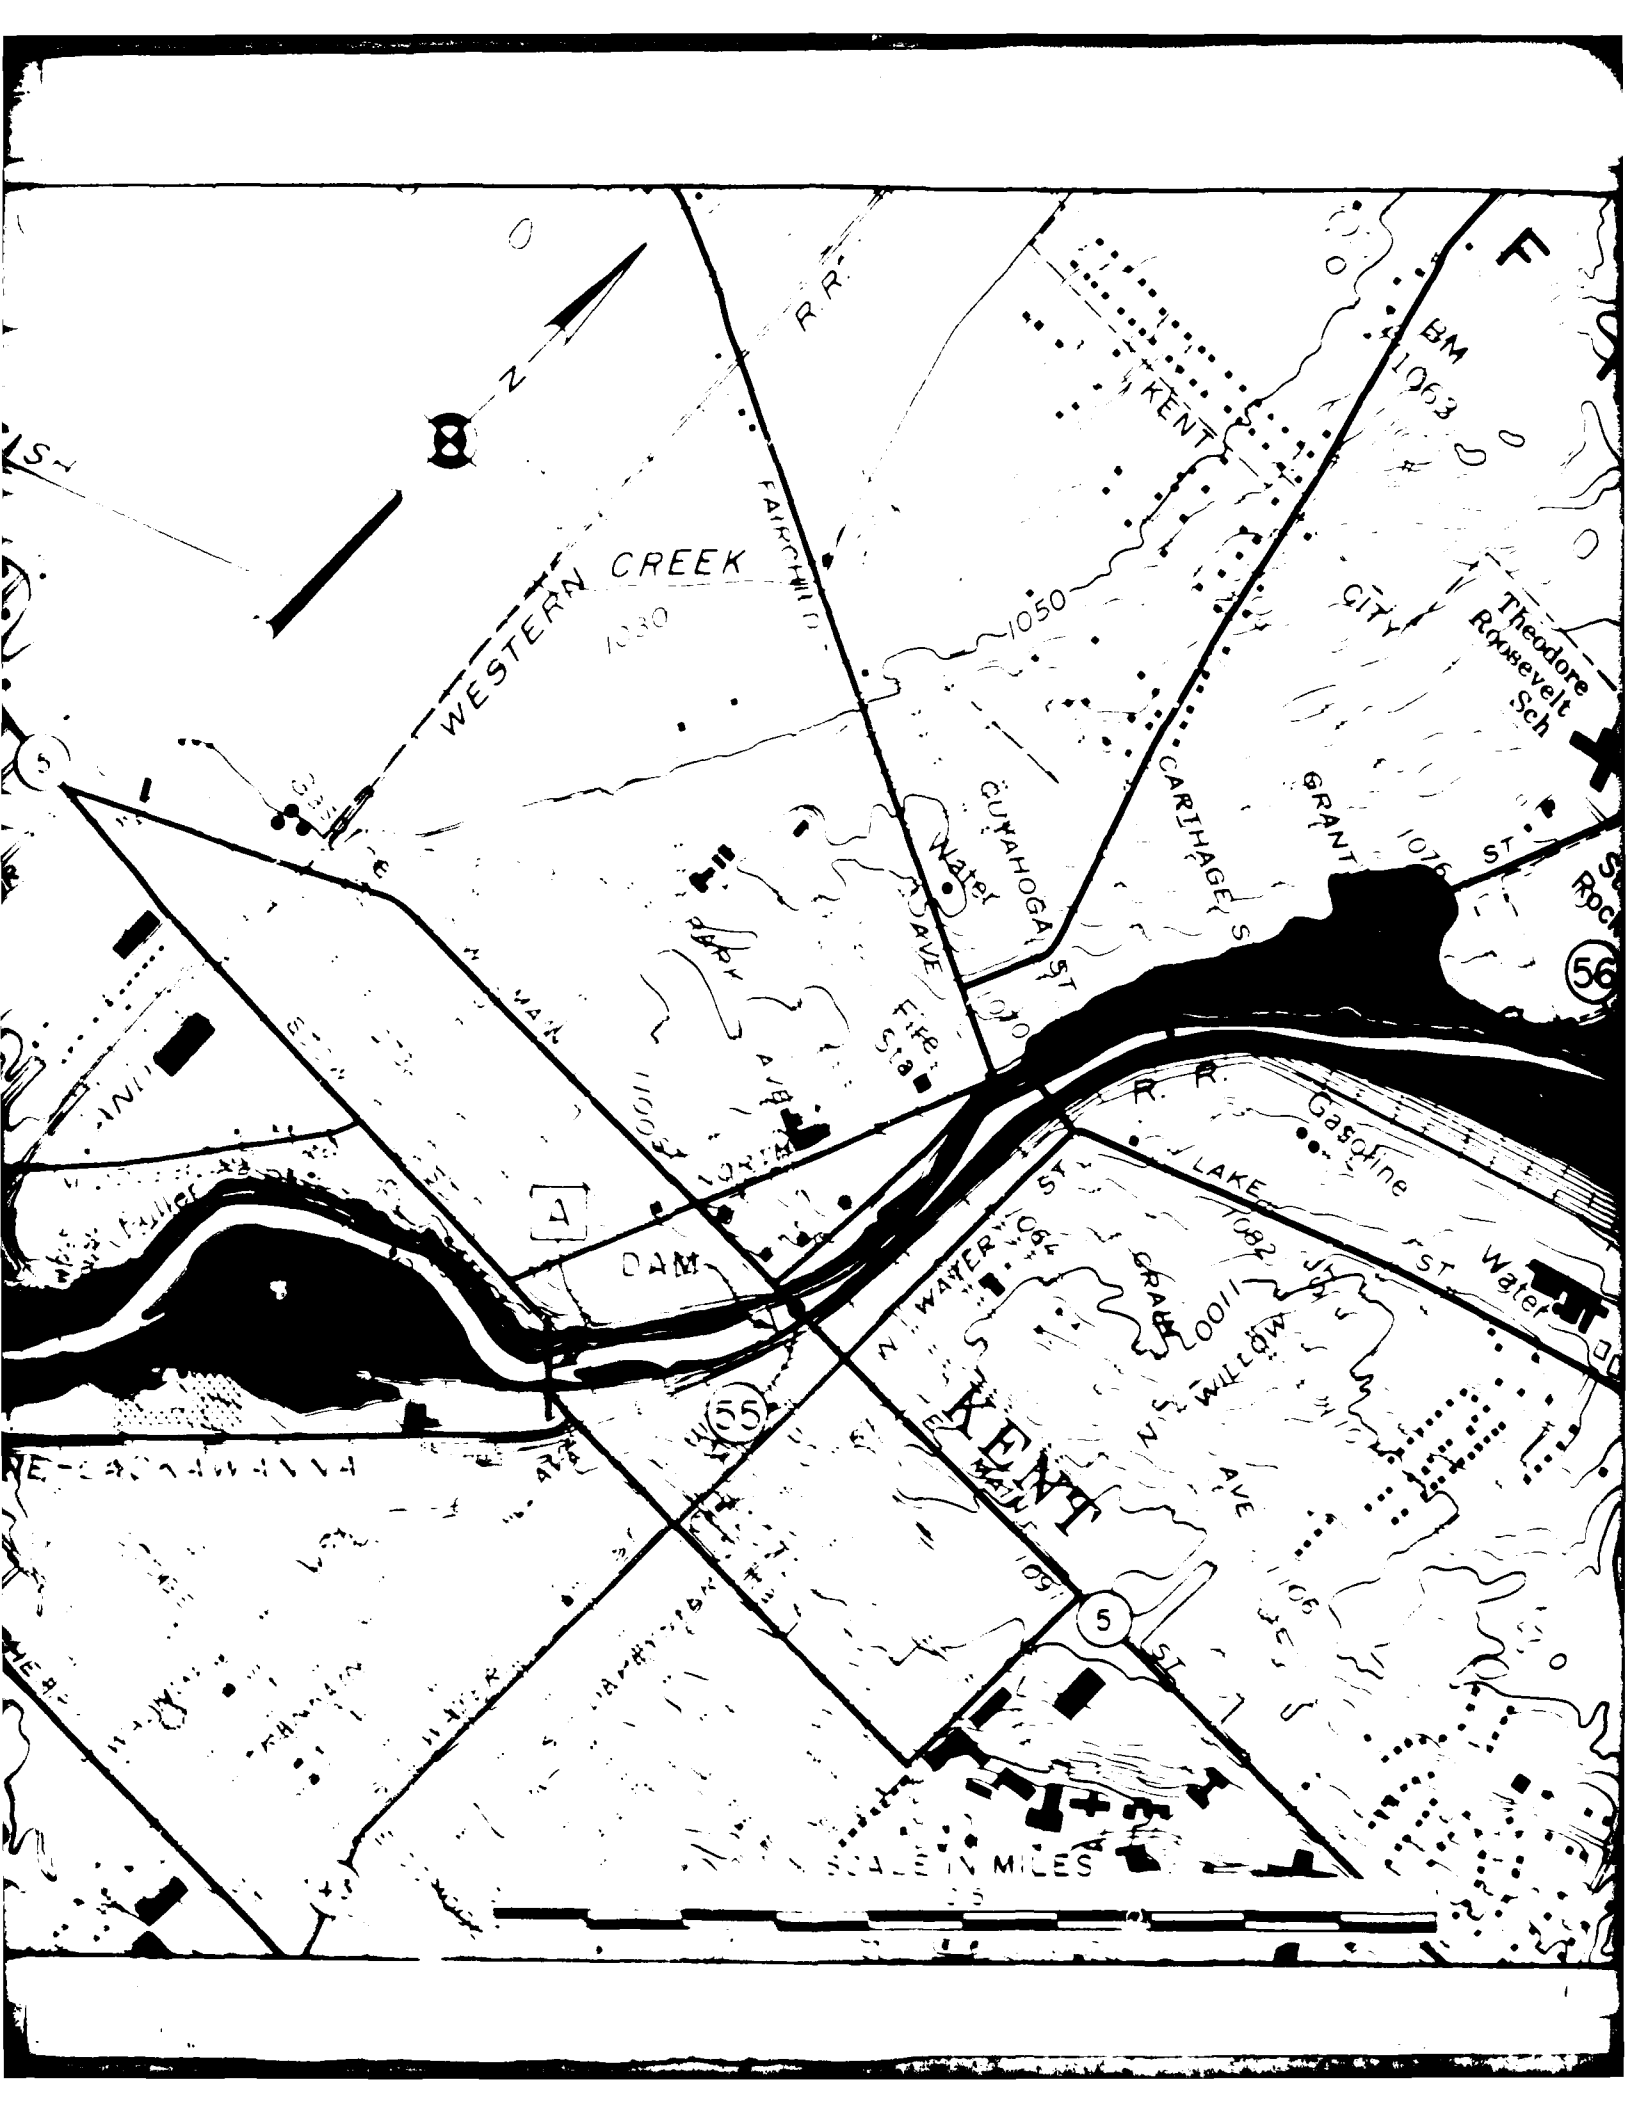
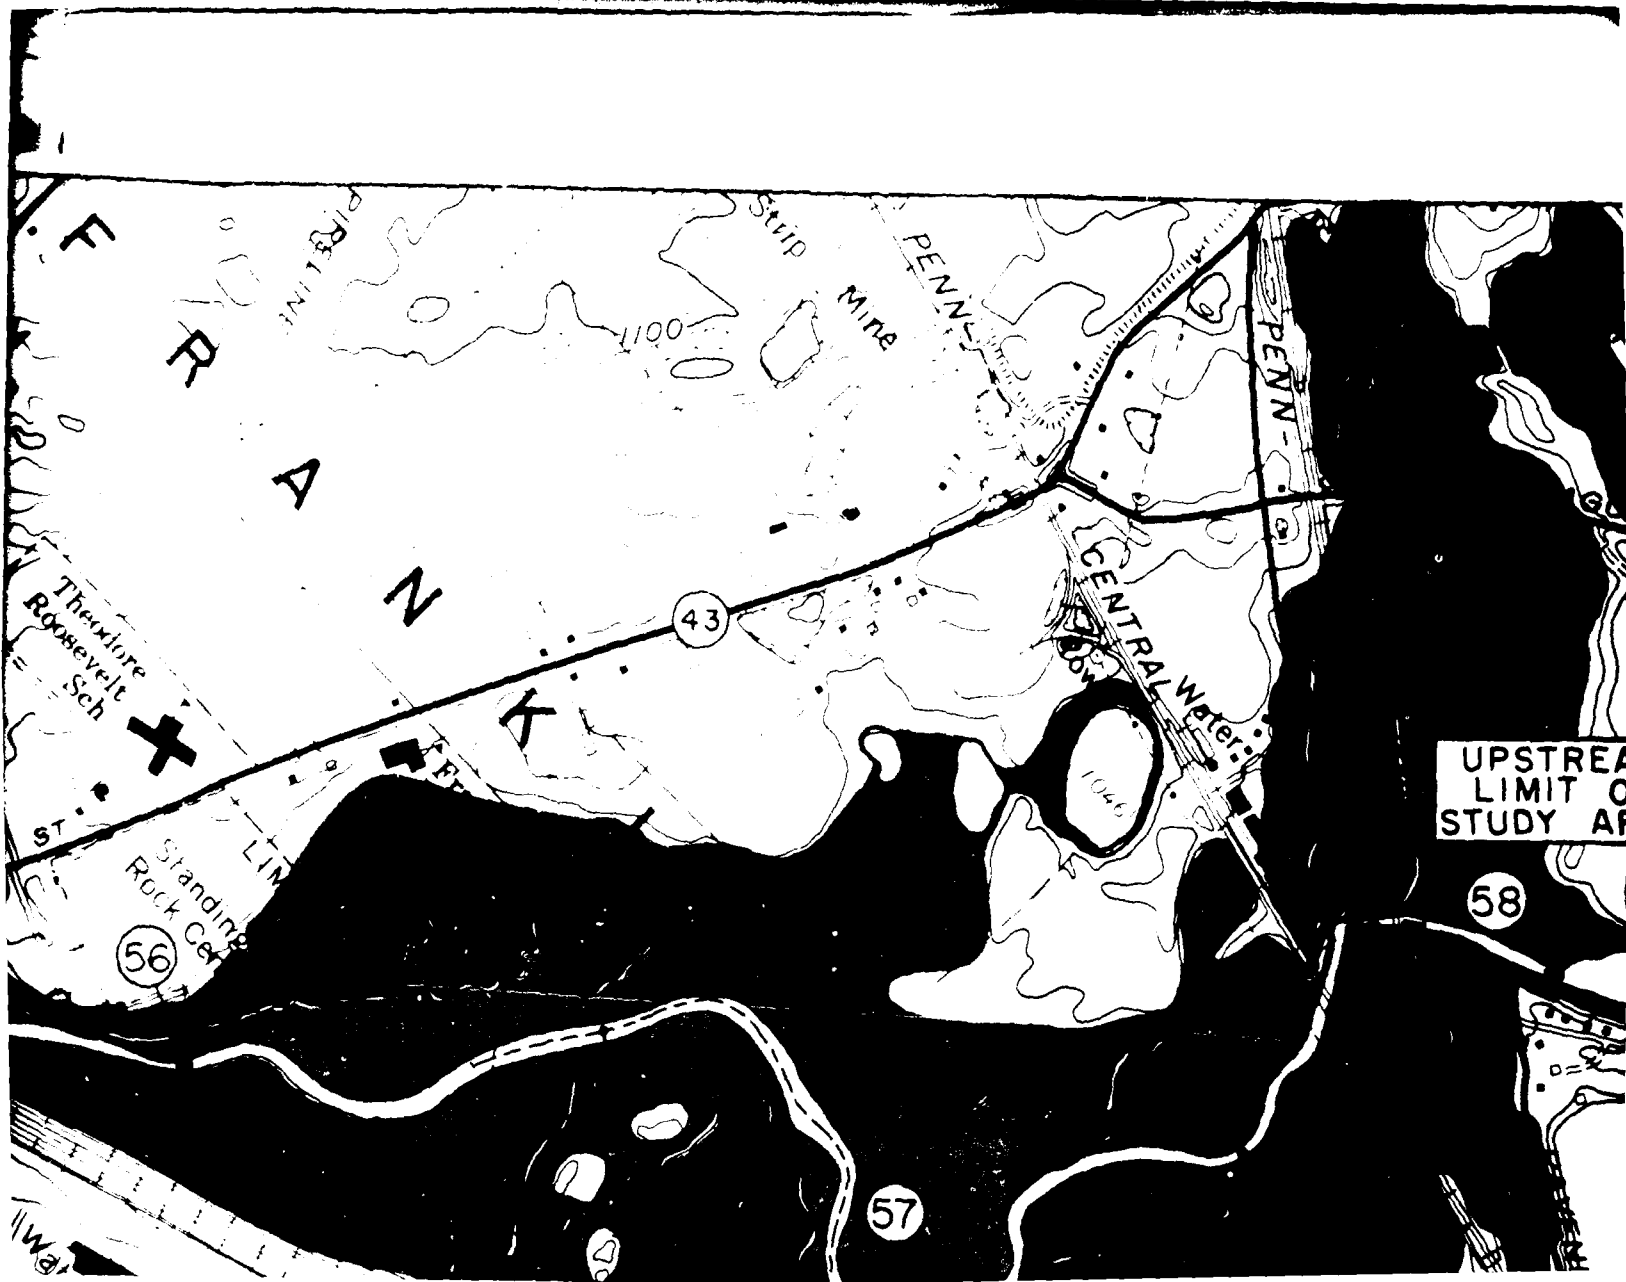
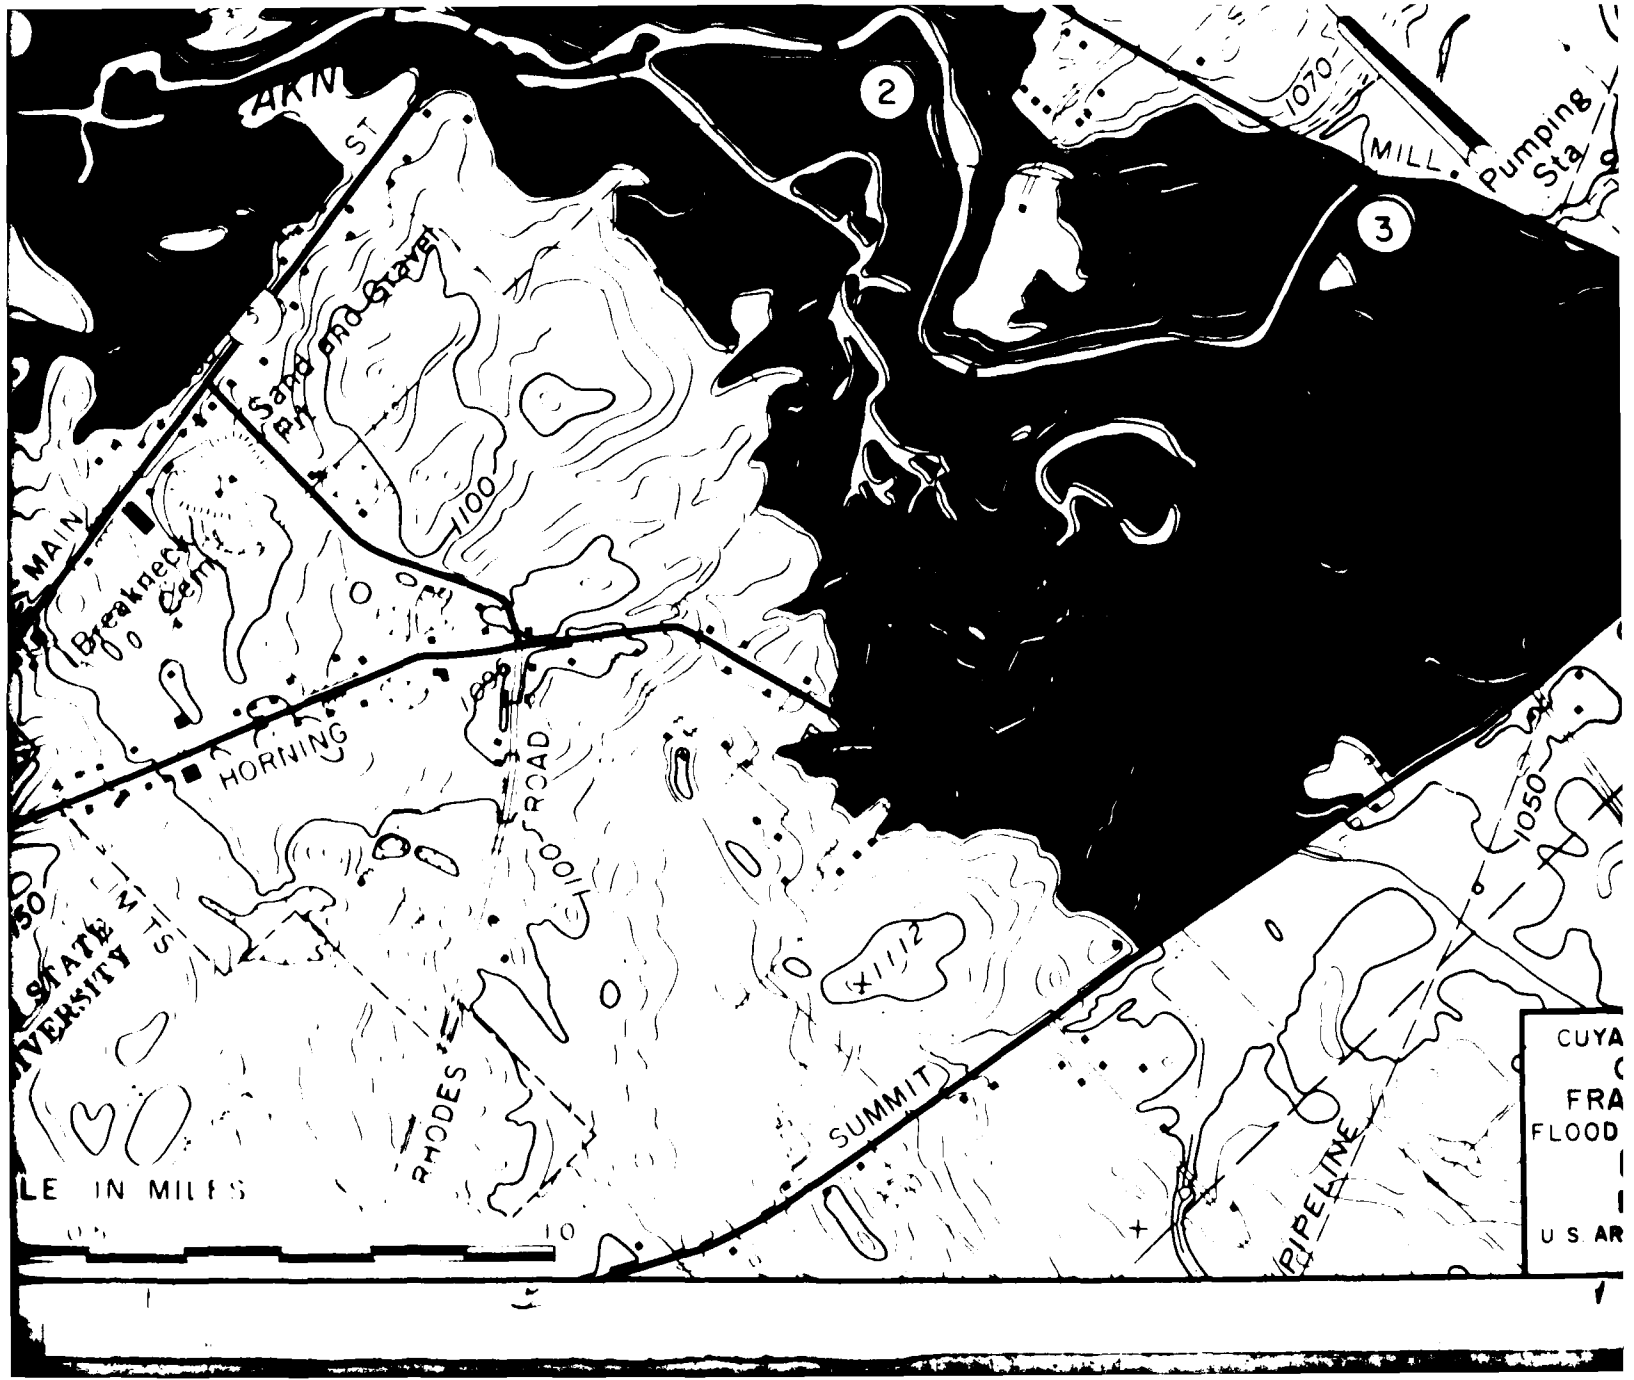
SA RIVER  
KENT AND  
TOWNSHIP, OHIO  
FORMATION REPORT  
D AREAS  
55 TO 58.10  
R DISTRICT, BUFFALO  
1972

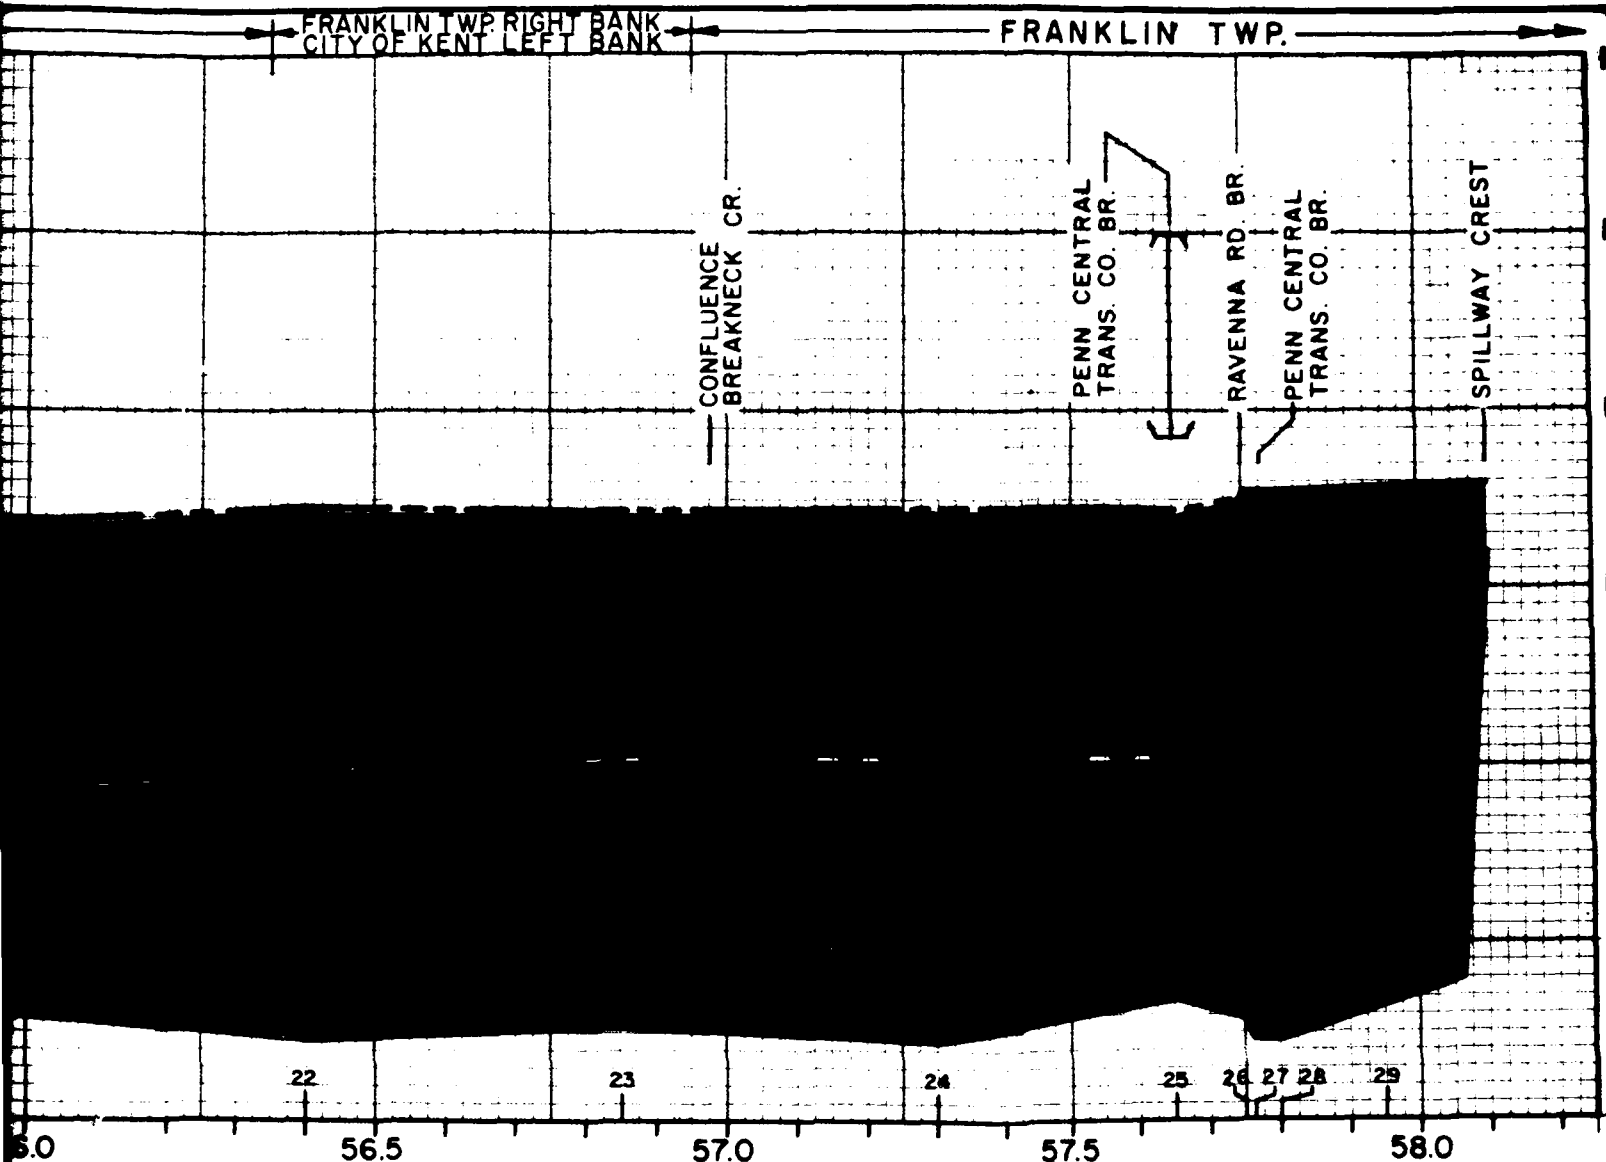
CREST PROFILES ARE BASED ON THE FOLLOWING:

1. EXISTING CHANNEL CONDITIONS
2. EXISTING STRUCTURES
3. EXISTING CONDITIONS OF DEVELOPMENT

**CUYAHOGA RIVER**  
**CITY OF KENT AND**  
**FRANKLIN TOWNSHIP,**  
**FLOOD PLAIN INFORMATION**  
**PROFILES**  
**MILE 52.65 TO 58.0**  
 U. S. ARMY ENGINEER DISTRICT,  
 MAY 1972

FLOODED AREAS, FLOOD PROFILES AND CROSS SECTIONS - Plates 7 and 8 show the approximate areas along the Cuyahoga River that would be inundated by the Intermediate Regional and the Standard Project Floods. The approximate elevations of these floods are shown on plates 9 and 10. Typical valley cross sections in the study area are shown on plate 11.

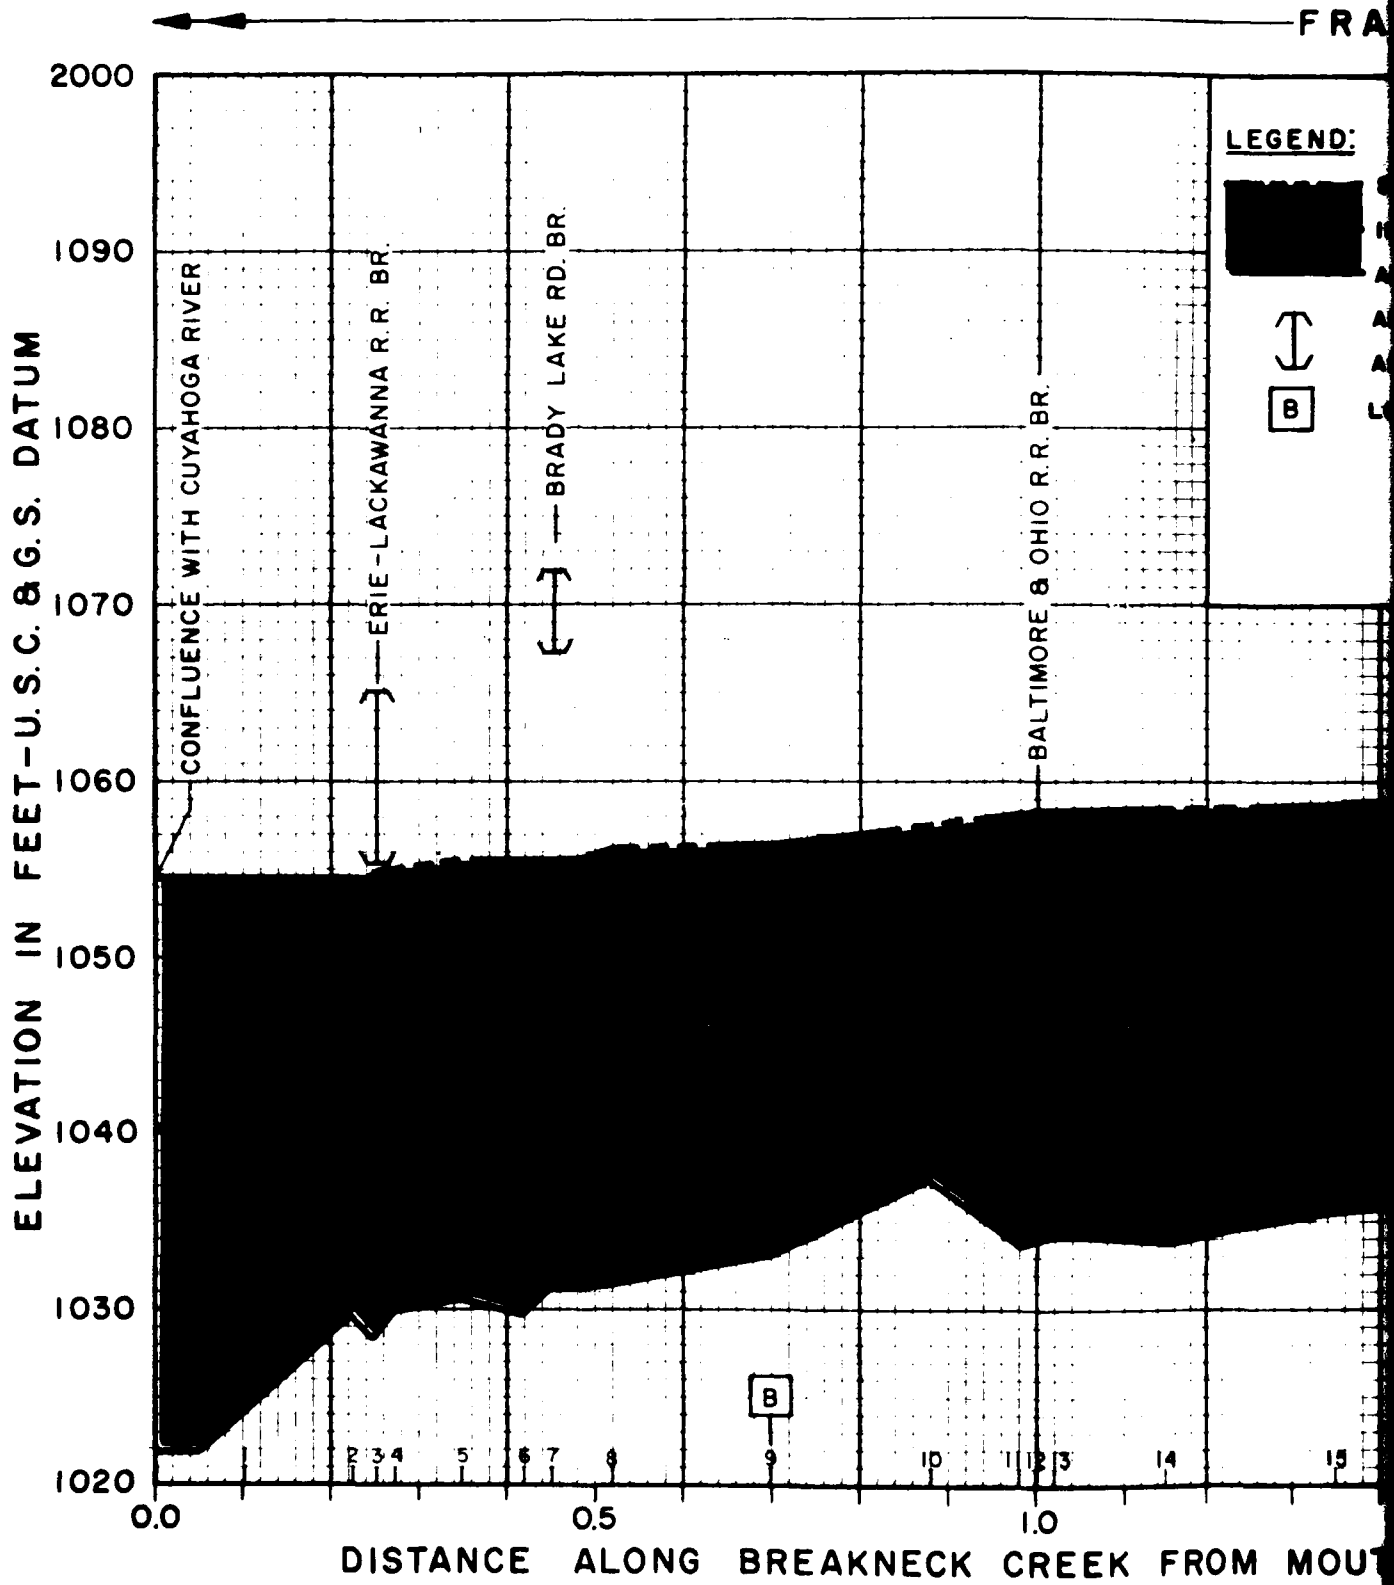
DISTANCE ALONG BREAKNECK CREEK FROM MOUTH

- 1. EXISTING CHANNEL CONDITIONS
- 2. EXISTING STRUCTURES
- 3. EXISTING CONDITIONS OF DEVELOPMENT

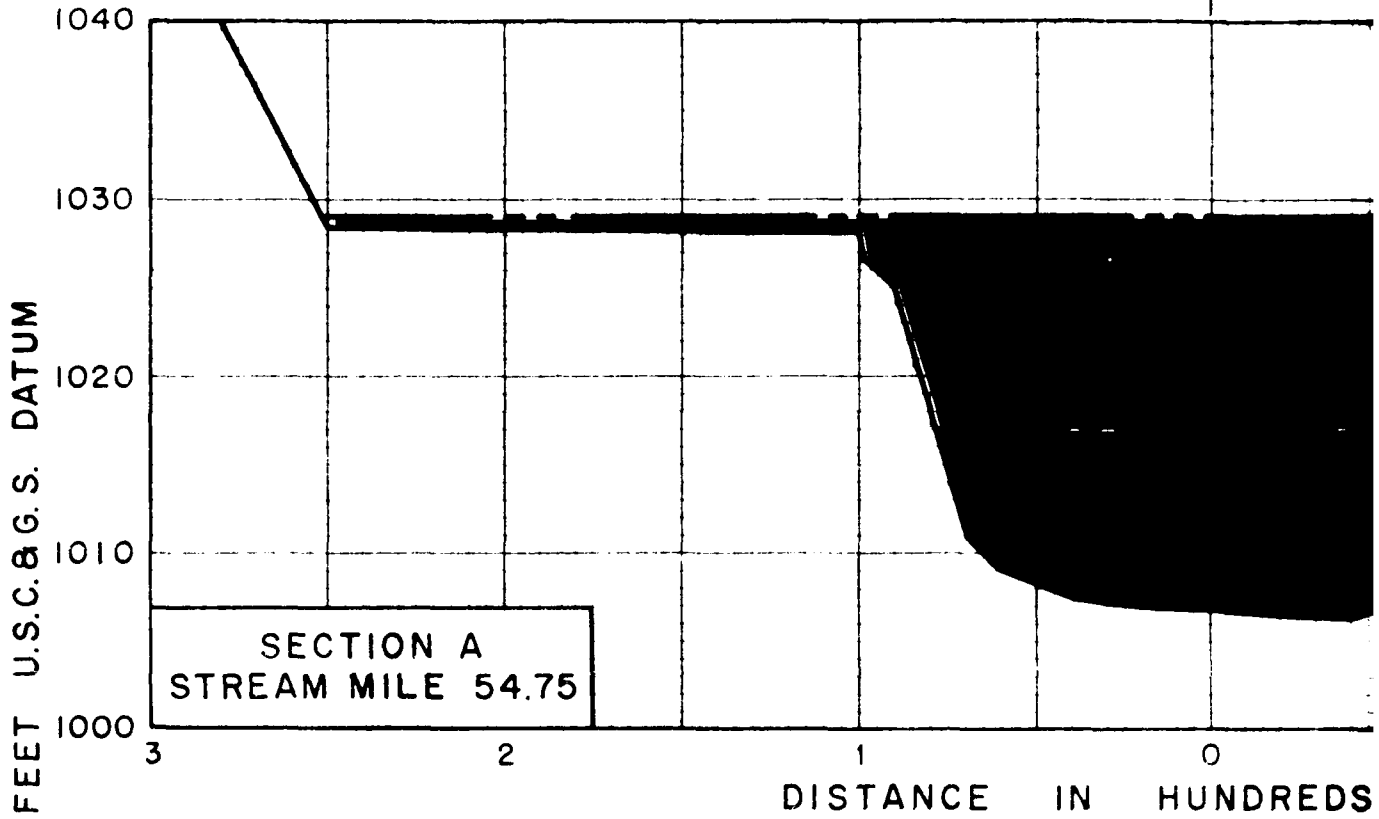
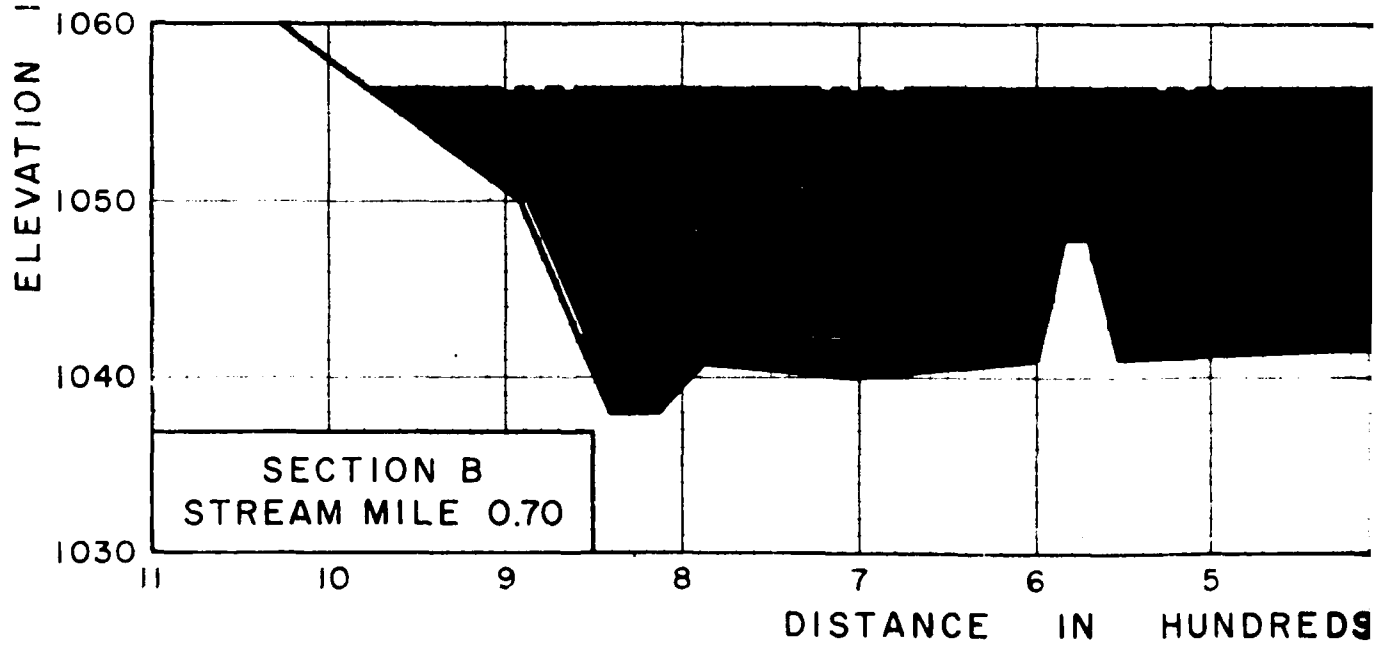
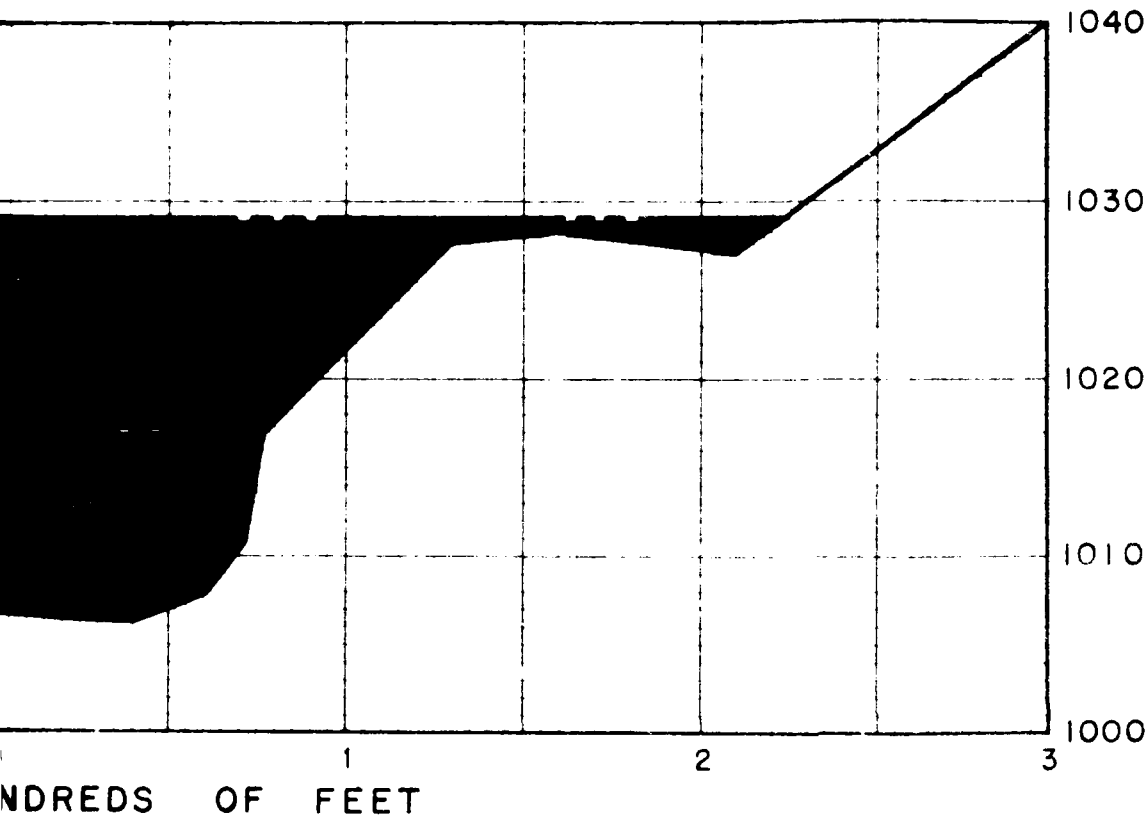
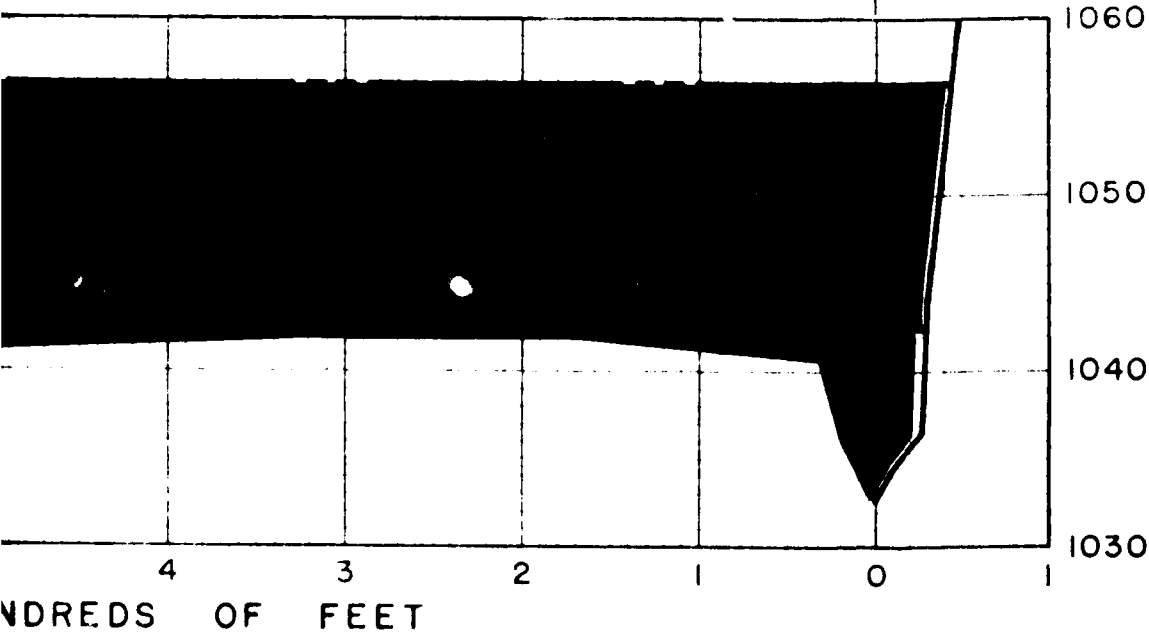
PLATE II

VALLEY CROSS SECTIONS A AND B ARE LOCATED DOWNSTREAM AND ARE LOCATED ON MAPS 7 AND 8.

CUYAHOGA RIVER  
 CITY OF KENT AND  
 FRANKLIN TOWNSHIP  
 FLOOD PLAIN INFORMATION  
 VALLEY CROSS SECTIONS  
 A AND B  
 U. S. ARMY ENGINEER DISTRICT  
 MAY 1972
