4. TITLE (and Subtitle) Flood Plain Information Oatka Creek and Genesee River, Town of Wheatland, Monroe County, New York		5. TYPE OF REPORT & PERIOD COVERED Final

6. PERFORMING ORG. REPORT NUMBER
7. AUTHOR(s)		8. CONTRACT OR GRANT NUMBER(s)
9. PERFORMING ORGANIZATION NAME AND ADDRESS U.S. Army Engineer District, Buffalo 1776 Niagara Street Buffalo, New York 14207		10. PROGRAM ELEMENT, PROJECT, TASK AREA & WORK UNIT NUMBERS

11. CONTROLLING OFFICE NAME AND ADDRESS U.S. Army Engineer District, Buffalo 1776 Niagara Street Buffalo, New York 14207		12. REPORT DATE <i>27</i> APRIL 1973

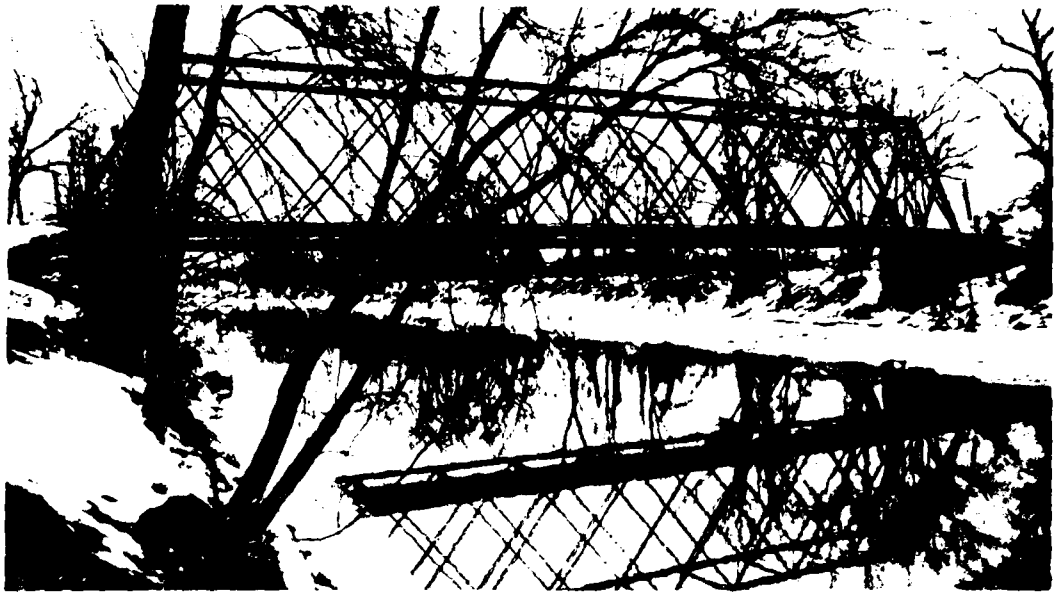
Figure 1 – View of upstream side of Scottsville - Henrietta Road bridge, river mile point 21.70. Photo taken February 1973.

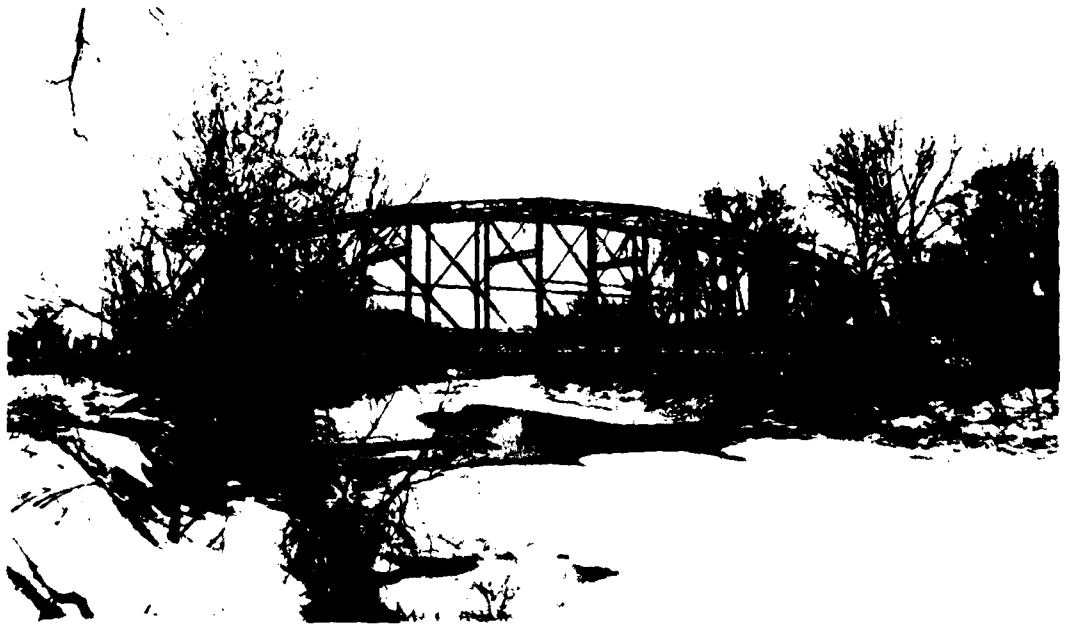
Figure 2 – View of upstream side of Rush Road bridge, river mile point 23.90. Photo taken February 1973.

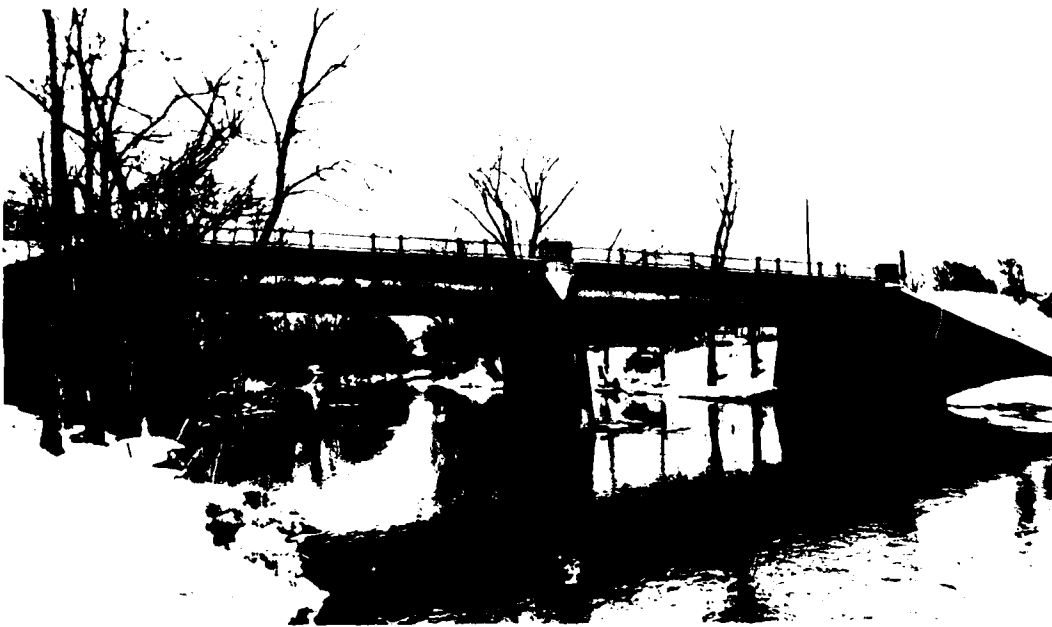
Figure 4 – View of upstream side of Canawaugus Road bridge, creek mile point 1.35. Photo taken February 1973.

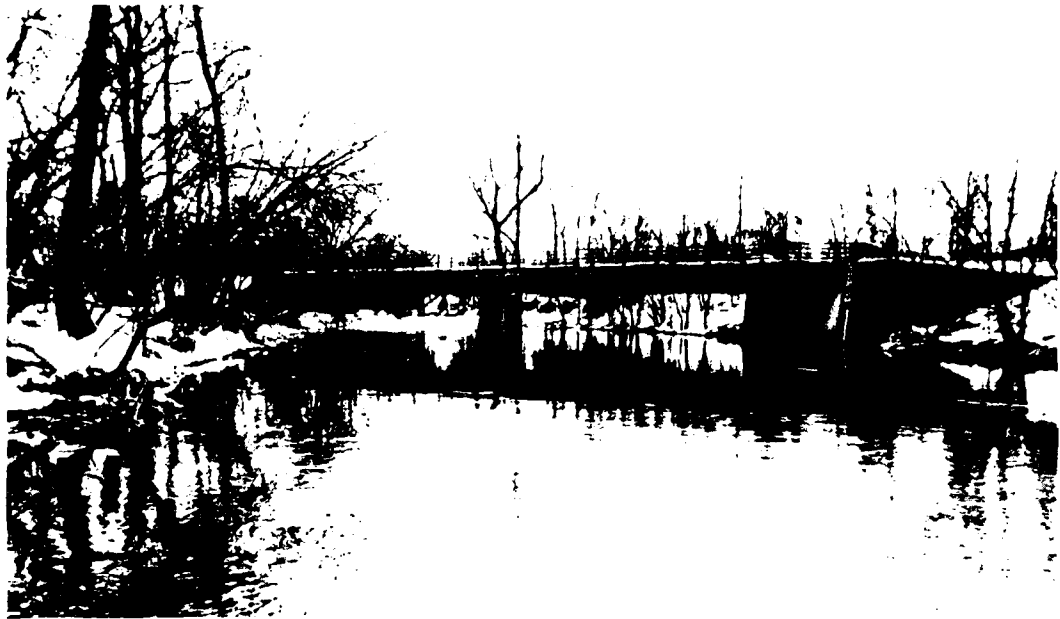
Figure 5 – View of upstream side of Bowerman Road bridge, creek mile point 2.60. Photo taken February 1973.

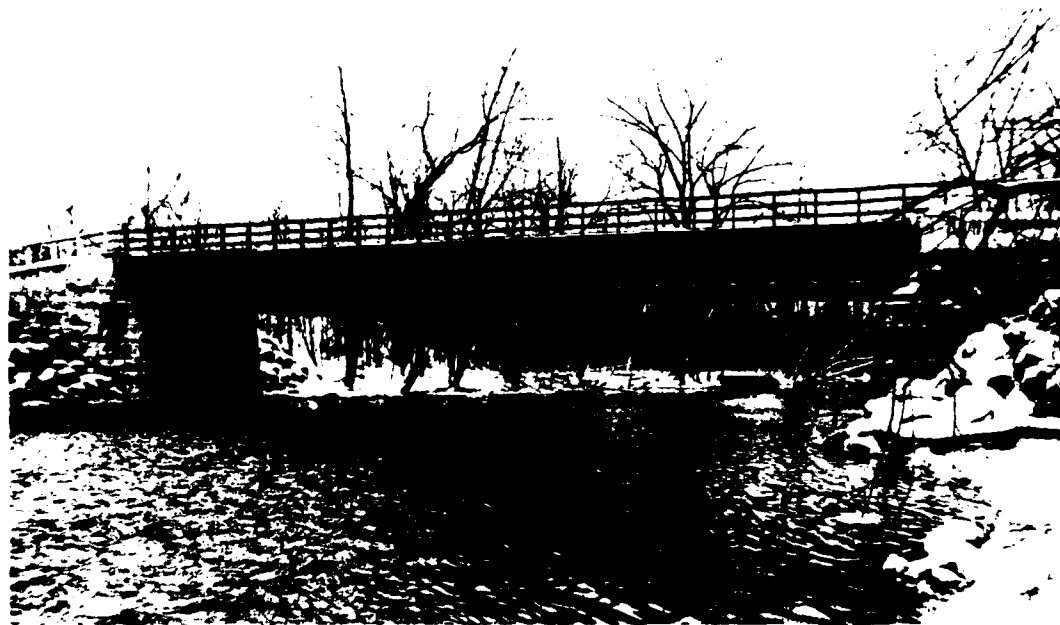
Figure 6 – View of upstream side of Union Street bridge, creek mile point 4.08. Photo taken February 1973.

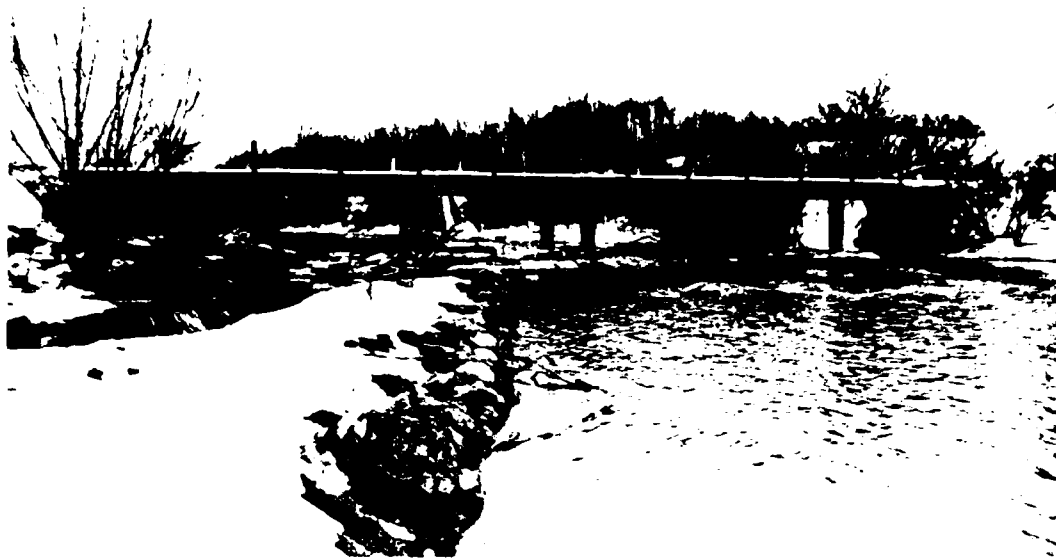
Figure 7 – View of upstream side of private access bridge, creek mile point 4.70. Photo taken February 1973.

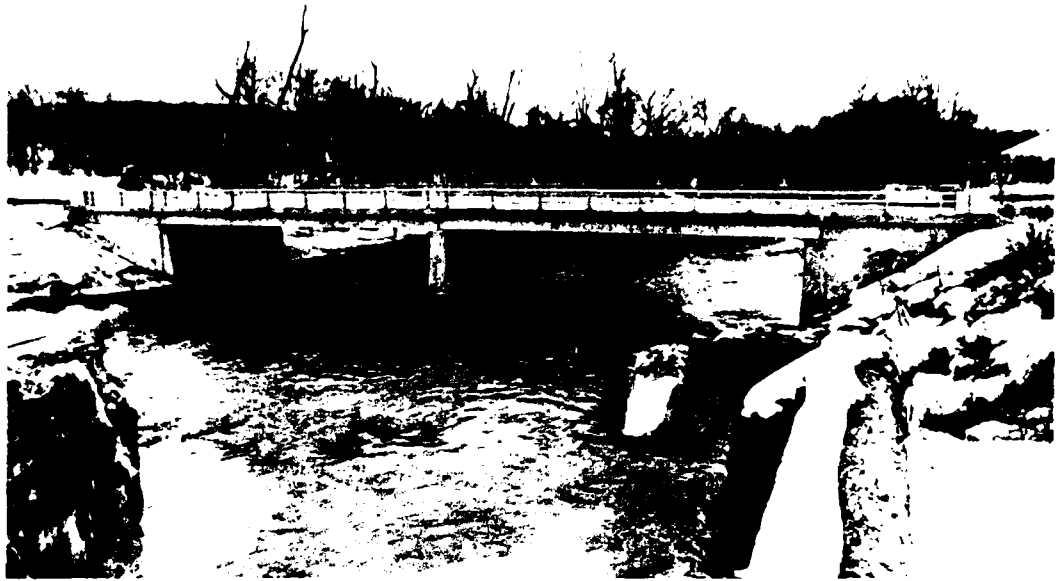
Figure 9 — View of downstream side of Wheatland Center Road bridge, creek mile point 5.75. Photo taken February 1973.

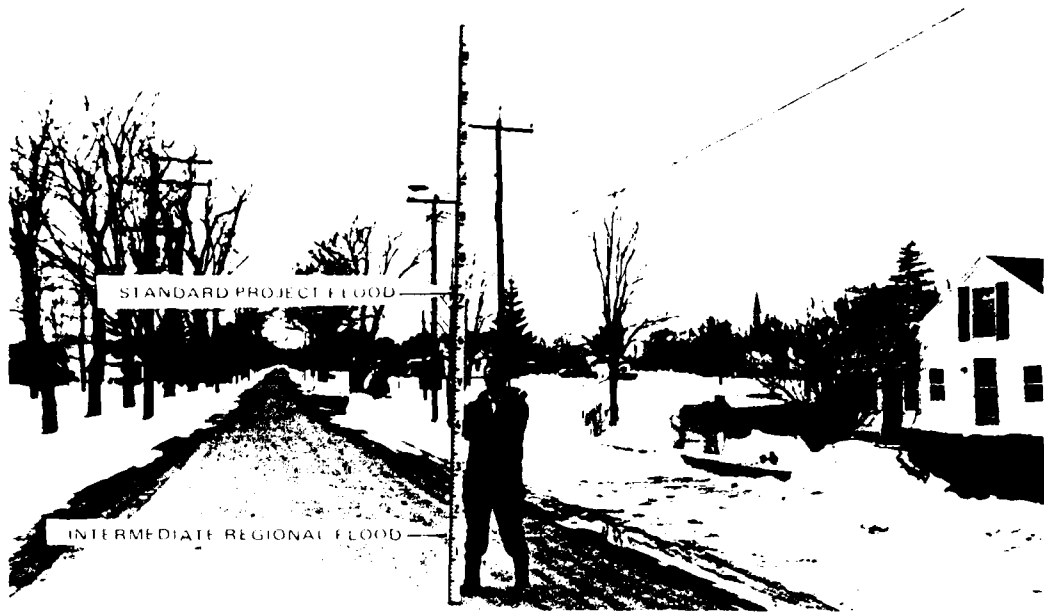
Figure 13 - Future flood heights at Scott Crescent in Scottsville.  
Photo taken February 1973.

**Photographs, future flood heights** -- The levels that the Intermediate Regional and Standard Project Floods are expected to reach at various locations in the Town of Wheatland are indicated on the following photographs.

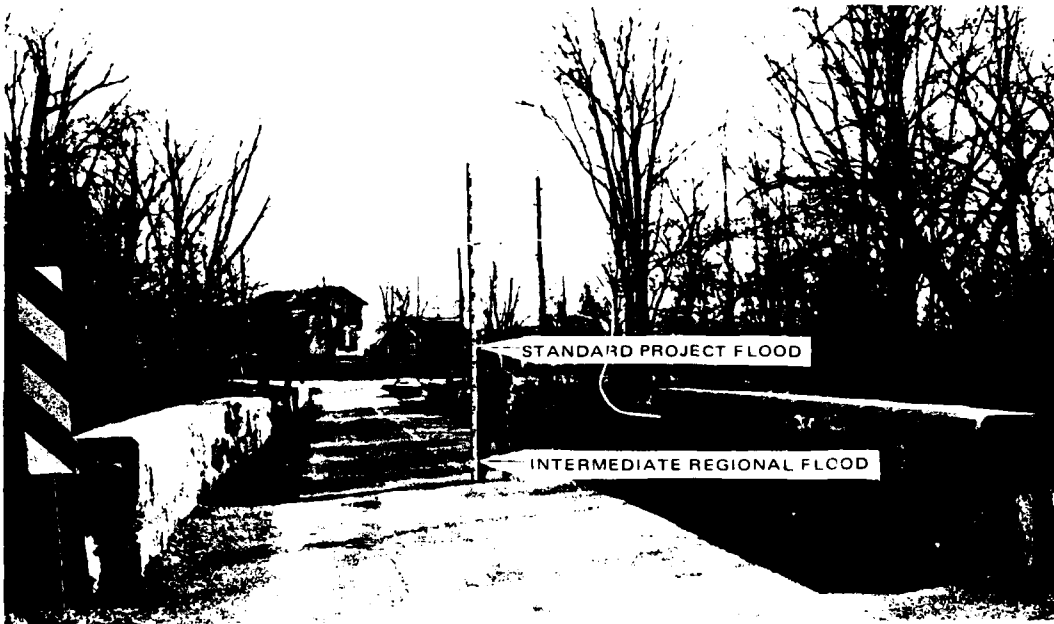
Figure 15 - Future flood heights at State Street bridge near Mumford.  
Photo taken January 1973.
