# FLOOD PLAIN INFORMATION

## PLUM CREEK

### CUYAHOGA AND LORAIN

BY  
CORPS OF ENGINEERS U.S. ARMY  
BUFFALO DISTRICT  
JUNE 1973

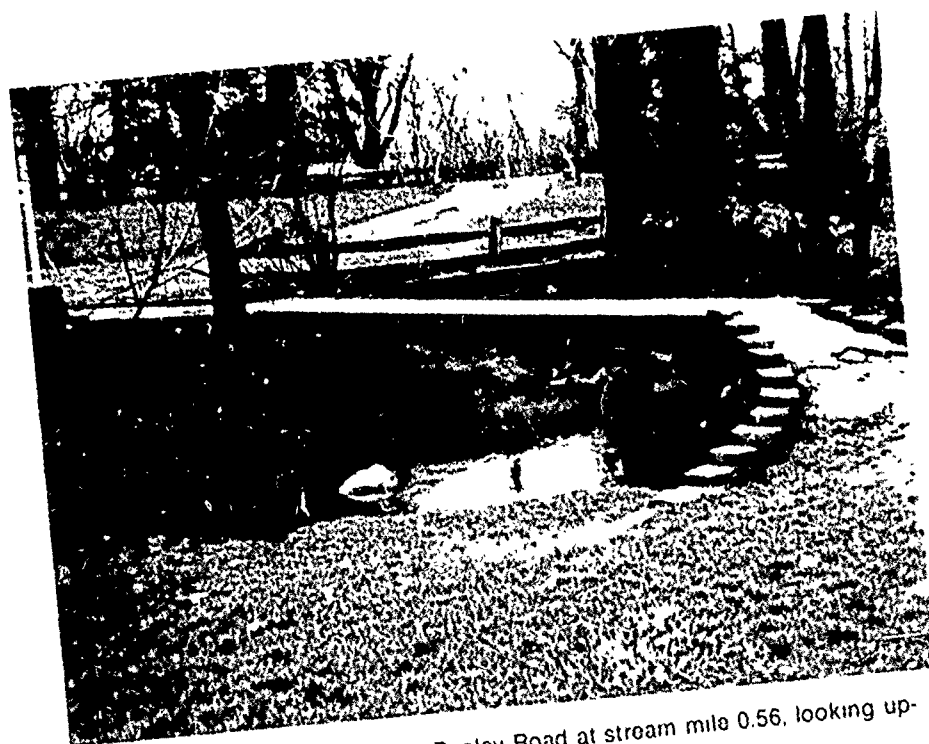
**FIGURE 18 —** Footbridge above Bagloy Road at stream mile 0.56, looking up-stream

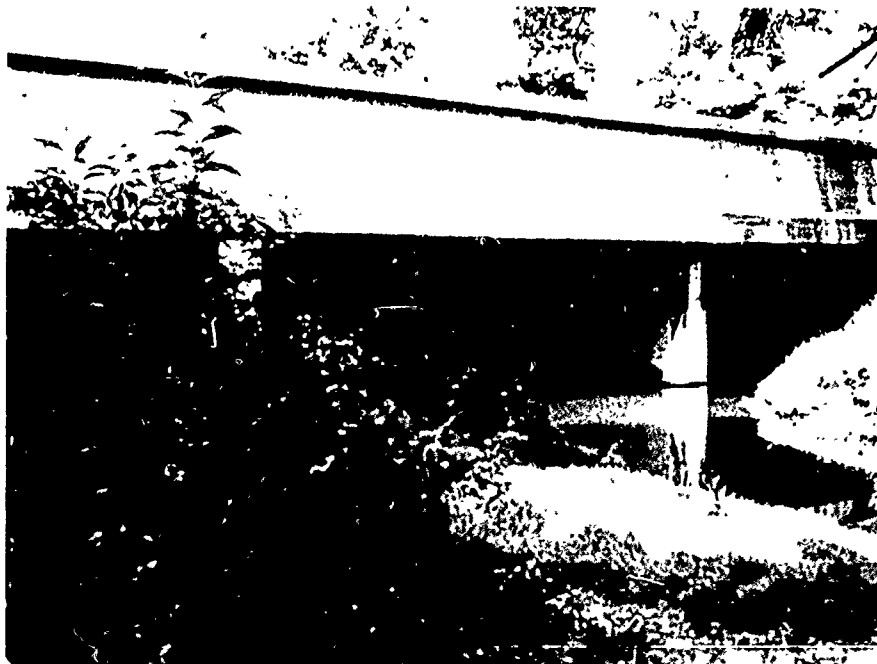
FIGURE 20 — Sprague Road bridge at stream mile 3.43, looking downstream at upstream face

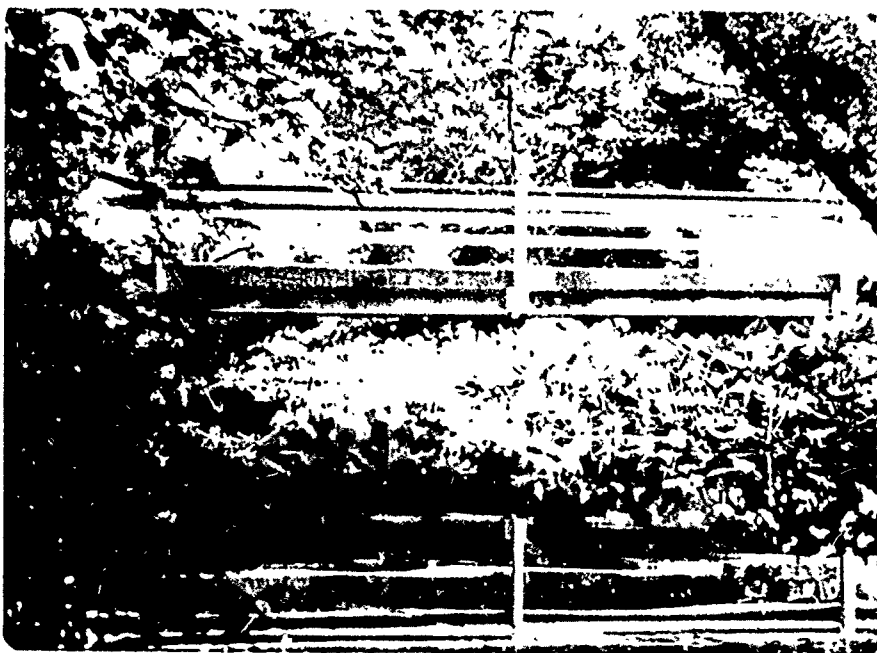
FIGURE 21 — Jaquay Road bridge at stream mile 4.91 looking downstream at upstream face

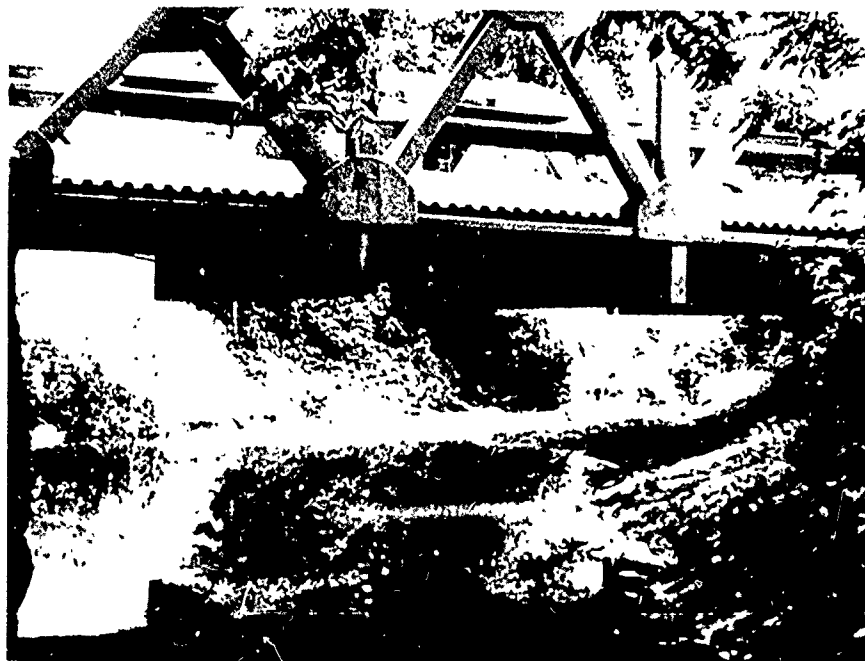
**FIGURE 22** — Folley Road bridge at stream mile 6 26, looking upstream at downstream face

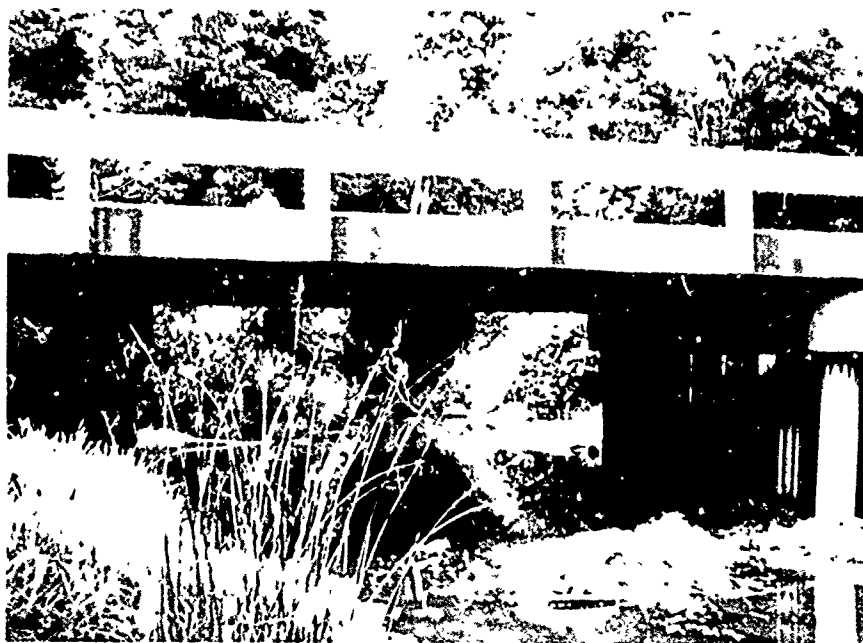
**FIGURE 23** — Royalton Road bridge at stream mile 6 79 looking downstream at upstream face
