FLOOD PLAIN INFORMATION

FLOOD HAZARD REPORT

4-7 JULY 1969 FLOOD

PREPARED BY
U. S. ARMY ENGINEER DISTRICT, BUFFALO
MAY 1970

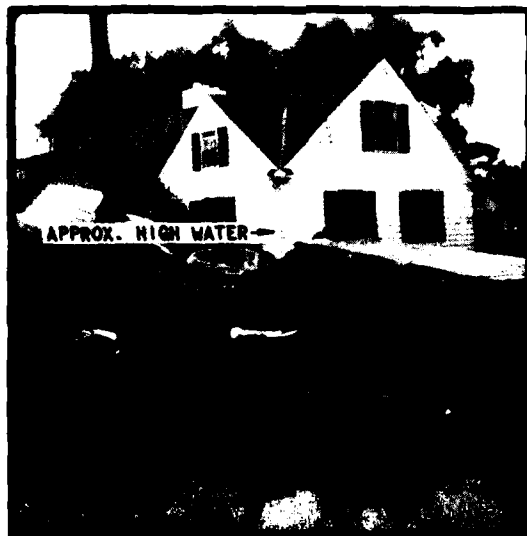
Figure 4 - Typical damage in lagoon area.

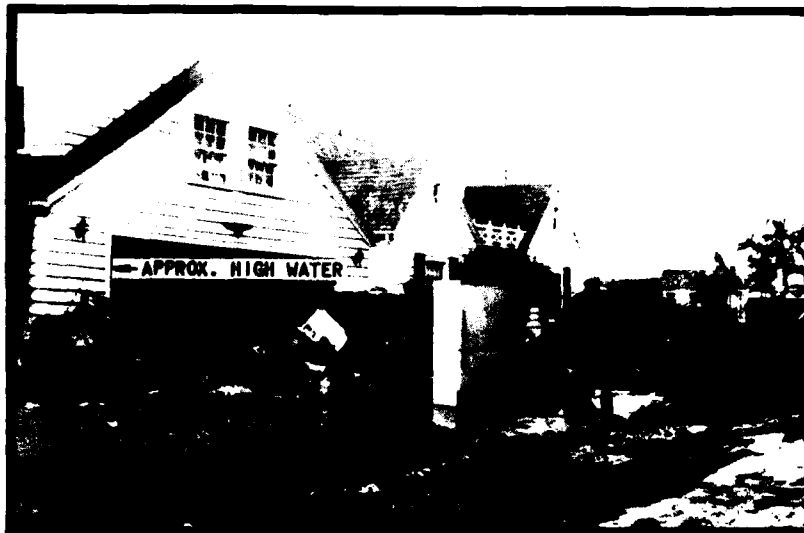
Figure 6 - Typical damage in lagoon area.

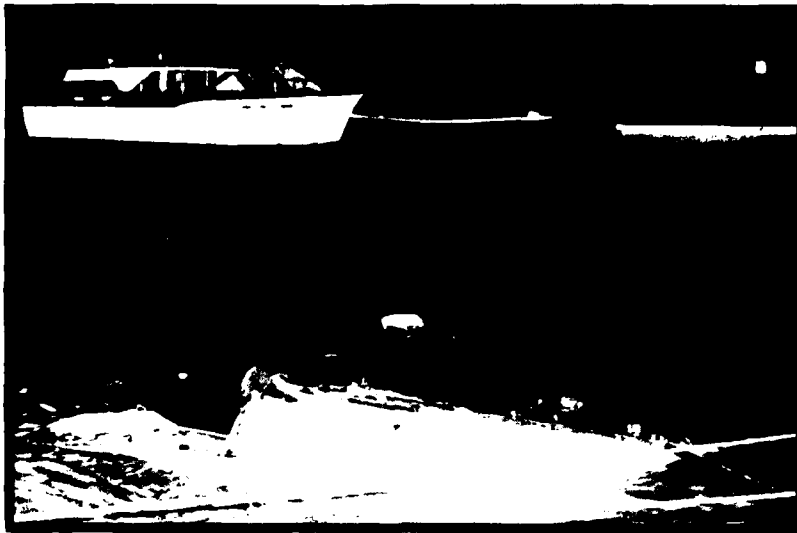
Figure 7 - Looking at flood approximately at peak.
Note roof of McGarvey's Restaurant at right side
of photo.

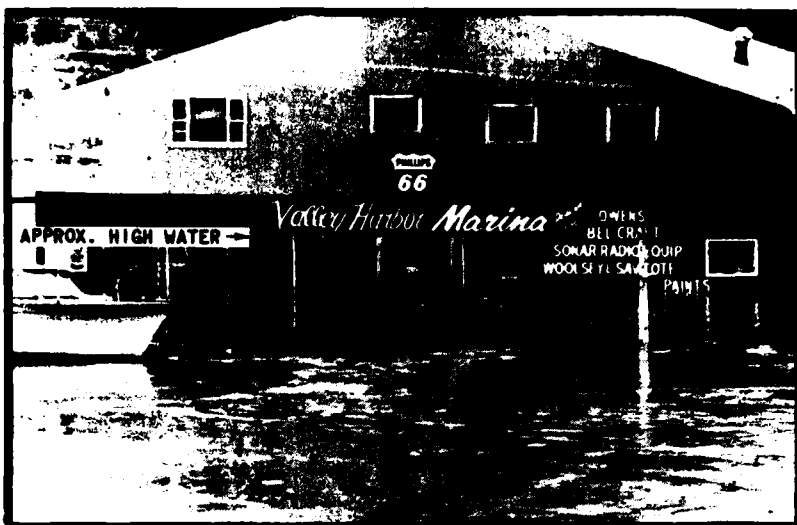
Figure 9 - Looking at Valley Harbor Marina. Water was approximately even with top of showroom windows at the peak.

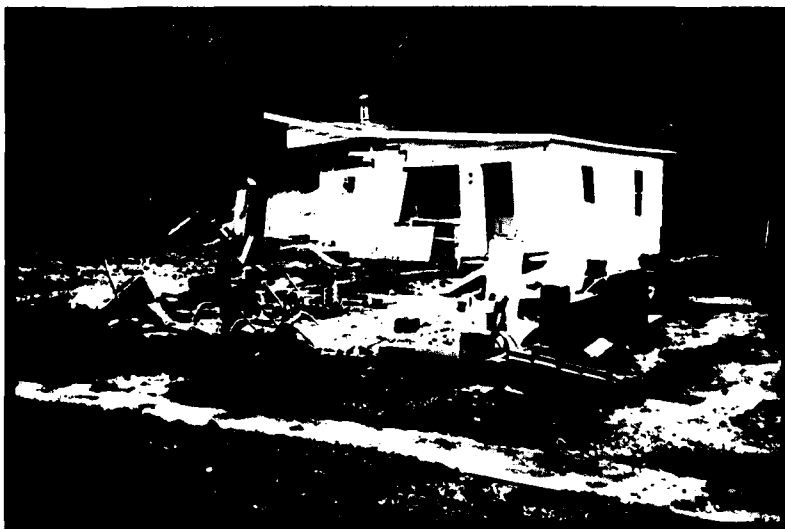
Figure 10 - Looking at typical damage in Olympic Outing Club area. Approximately 1.7 miles upstream from the mouth.

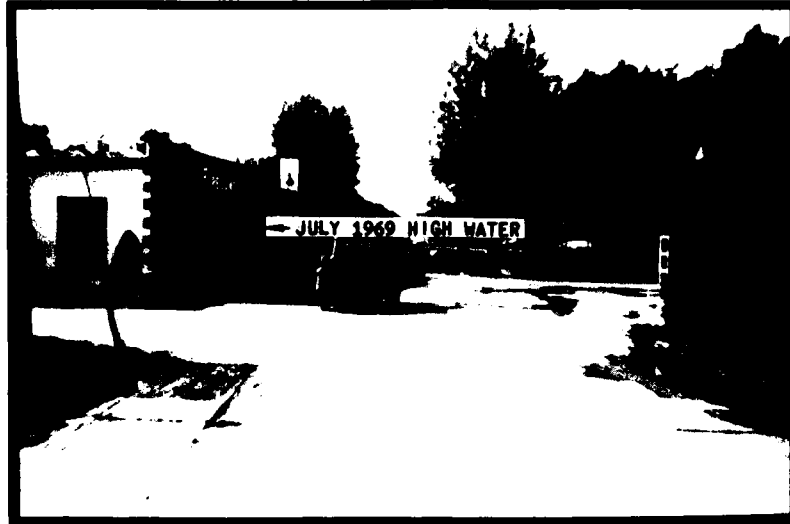
Shown in figure 15 is the Firelands Electric Corporation Inc. Company. The water surface was 4.9 feet above the first floor elevation. Figure 16 is a view of a demolished spillway of a private reservoir just upstream of Chenango Road.

Figure 15 - Skellenger Creek: Water was 4.9 feet above the threshold at the front door. Just upstream of the Penn Central Co. Railroad.

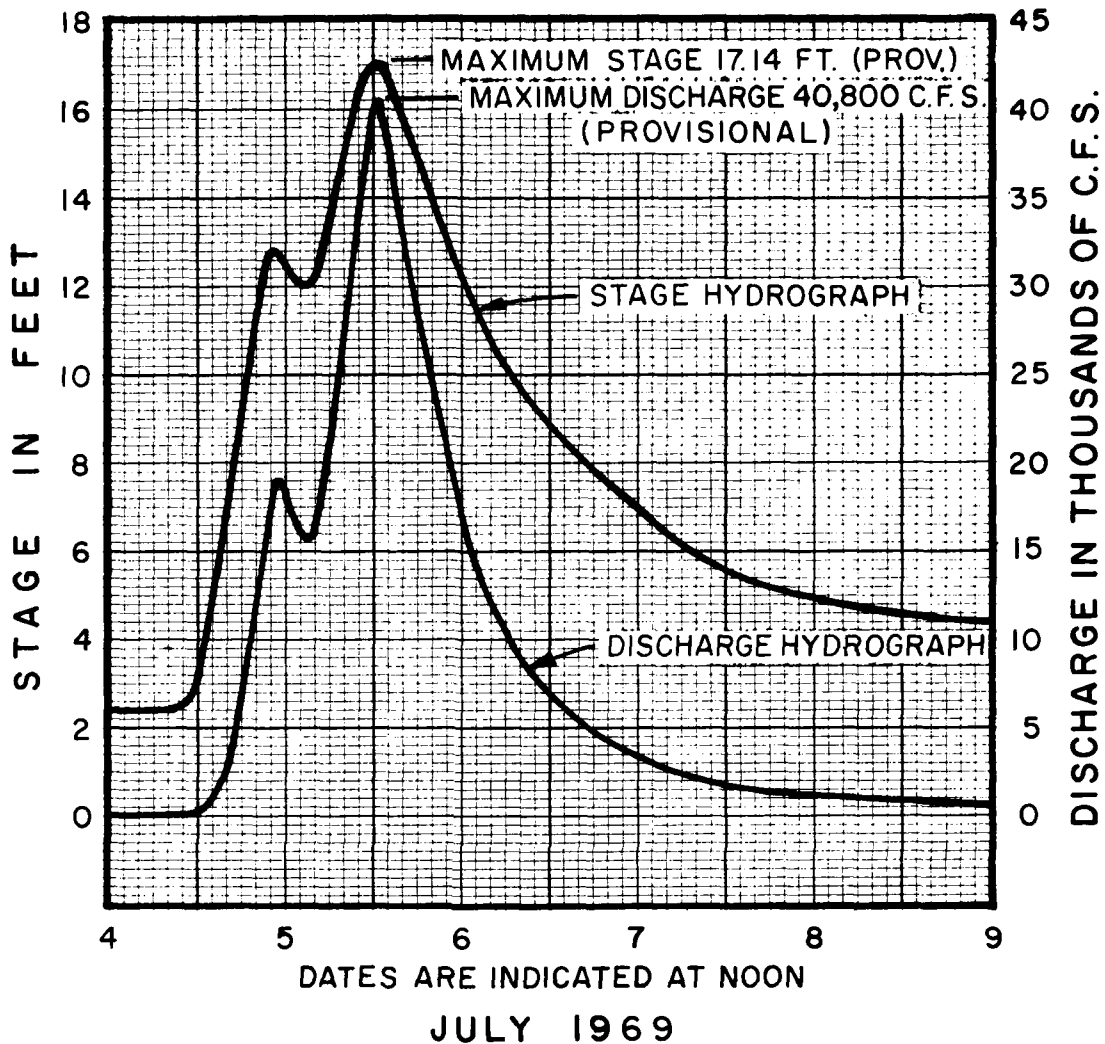
ZERO OF GAGE = 594.91
 U.S.C. & G.S. DATUM
 DRAINAGE AREA = 262
 SQUARE MILES.

REPORT OF FLOOD 4-7 JULY 1969
 VERMILION RIVER
STAGE & DISCHARGE HYDROGRAPHS
 U.S.G.S. GAGE DOWNSTREAM
 OF NORTH RIDGE ROAD
 U.S. ARMY ENGINEER DISTRICT, BUFFALO
 MARCH 1970

There is one water stage recorder operated by the U.S. Geological Survey on the Vermilion River. It is located on the right bank, 40 feet downstream of the North Ridge Road bridge in Lorain County, 3.5 miles southwest of the city of Vermilion, Erie County, and 4.5 miles upstream from the mouth. The gaging station was established in March 1950 and records the stages resulting from the runoff from 262 square miles of watershed upstream of that point. The total drainage area at the mouth is 272 square miles so that the gage site measures almost the total river flow. Shown on plate 2 are the stage and discharge hydrographs for the July 1969 flood occurrence. The data for the peak of the stage-hydrograph were established by indirect survey methods by the U.S.G.S. because the gage chart was damaged during the flood.
