FLOOD PLAIN INFORMATION

BUFFALO CREEK, NEW YORK

TOWNS OF ELMA AND WEST SENECA

MAIN REPORT

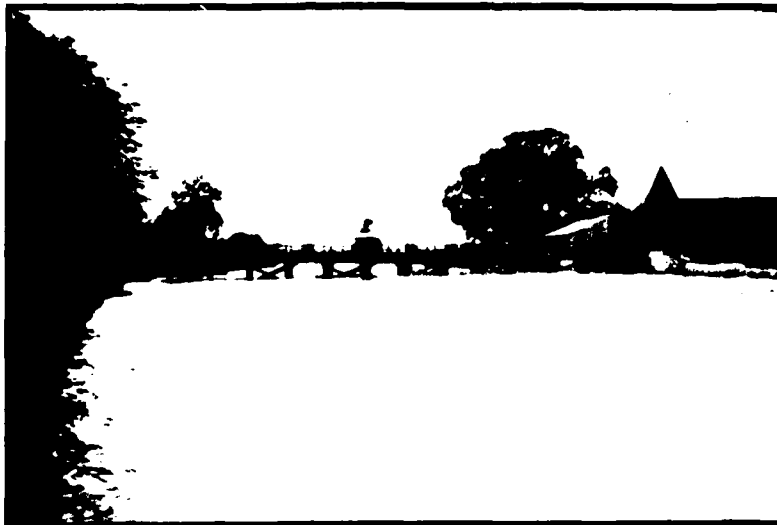
Photo No. 1. Looking downstream at temporary bridge used during construction of Union Road bridge during the flood of the summer of 1928.

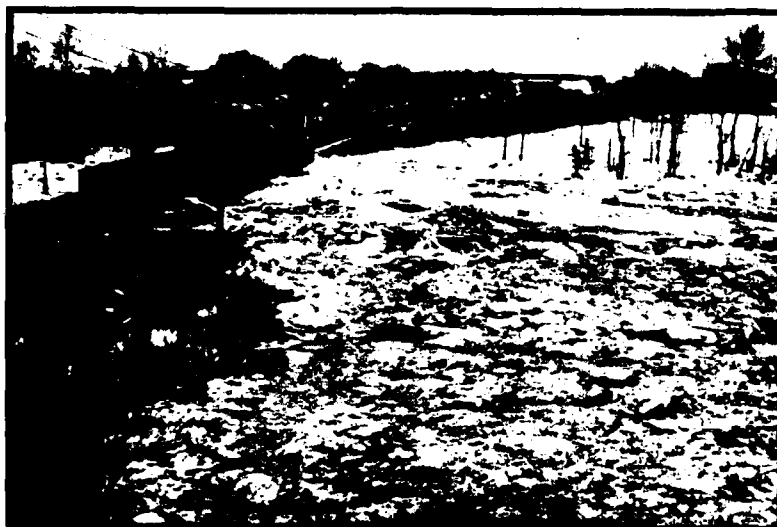
Photo No. 2. Looking north across creek from Indian Church Road toward the N.Y.C. R.R. bridge during the March 1942 flood.

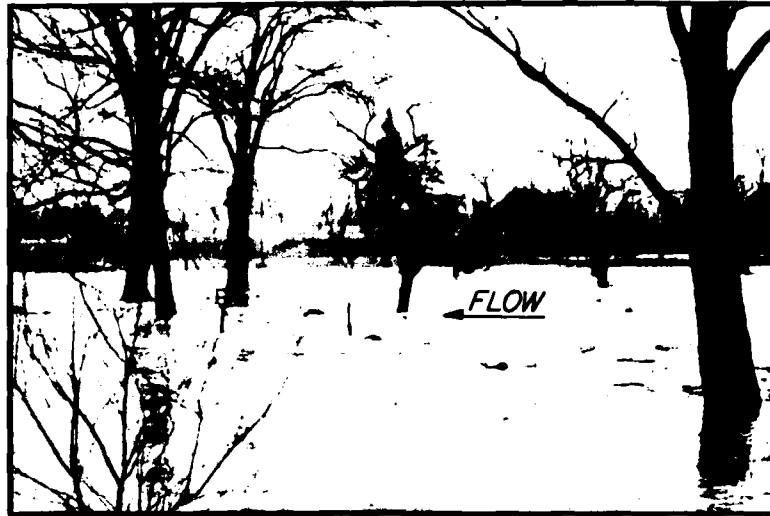
Photo No. 3. Looking north toward Clinton Street from Island Park at Gardenville, during the March 1942 flood.

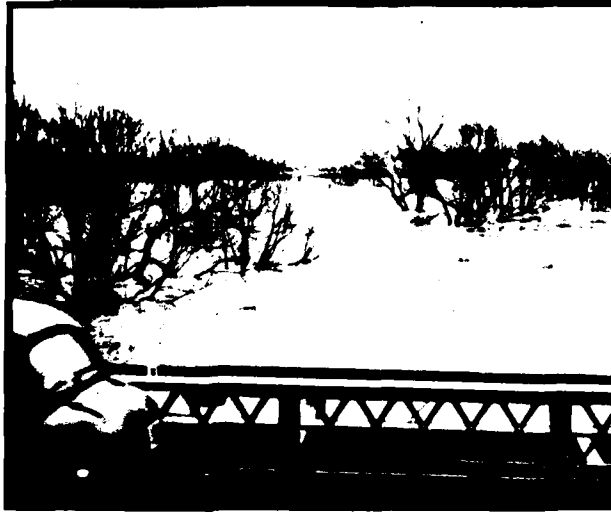
Photo No. 5. Looking upstream from Harlem Road Bridge at the flooded flats at the confluence of Buffalo and Cayuga Creeks during the March 1955 flood. Clinton Street is in the left background.

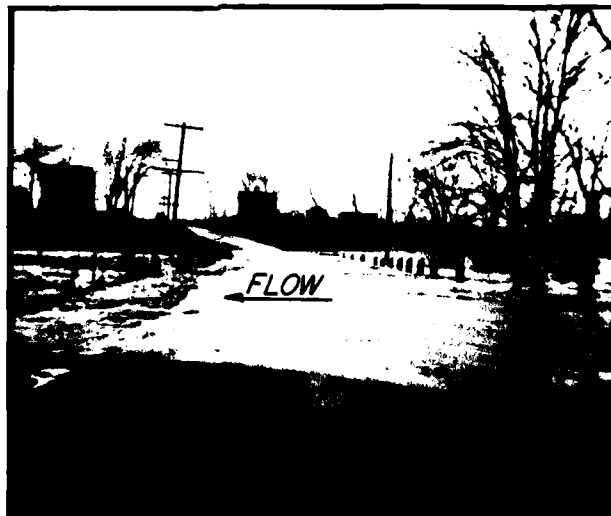
Photo No. 6. Looking north along Borden Road during the March 1955 flood. Although water is over the road the bridge, shown in the background, is not full. This is looking in the opposite direction from photos 4 and 5.

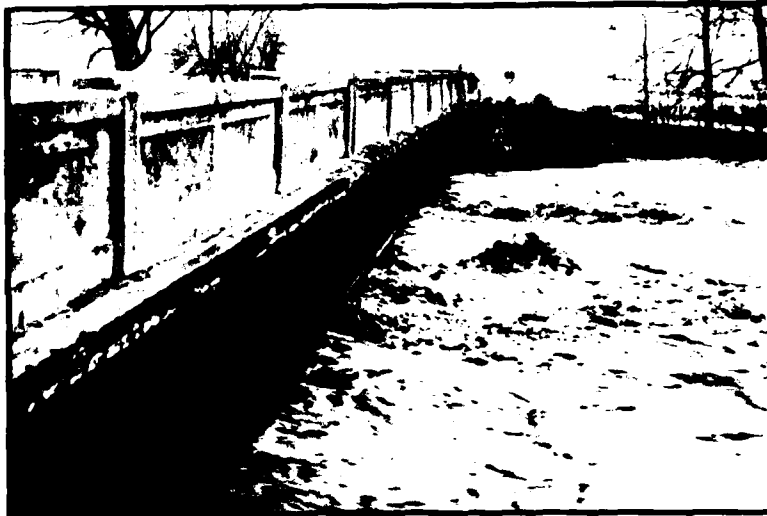
Photo No. 7. Looking south from the north abutment at the downstream side of the Transit Road bridge during the March 1955 flood.

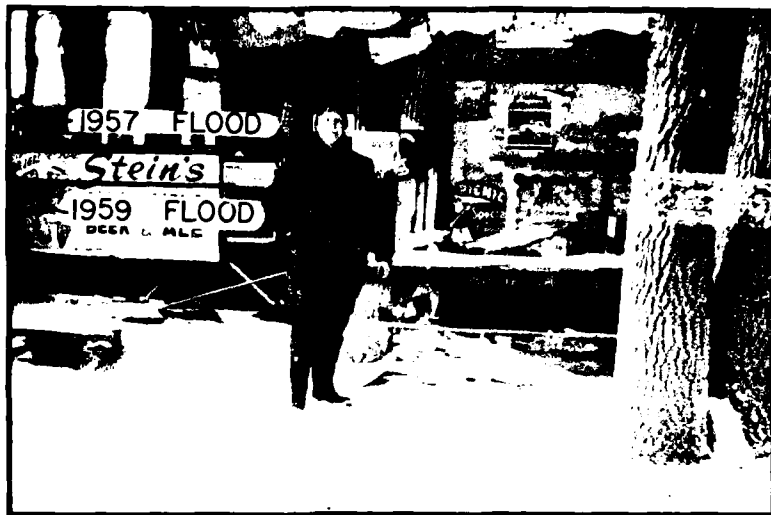
Photo No. 9. Ice lines indicate January 1959 flood elevation at Huppertz Grove, Collins Avenue. Near mile 0.15.

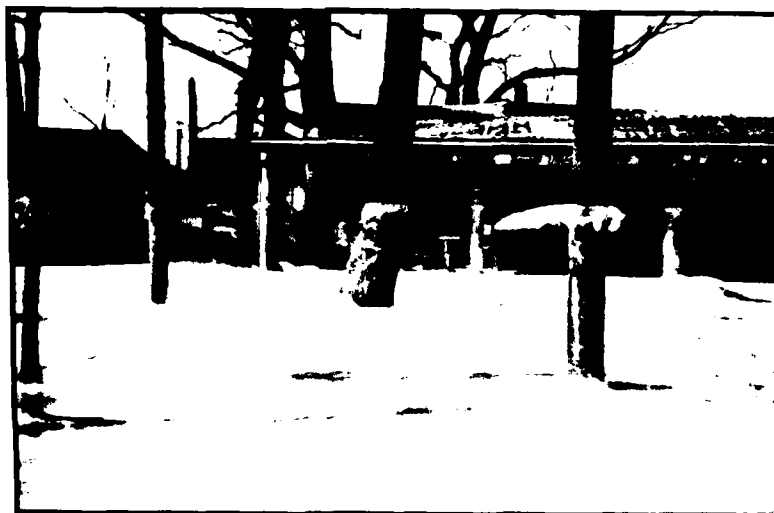
Photo No. 10. Same as photo no. 9. The January 1957 flood was 1.3' higher than the 1959 flood at this location.

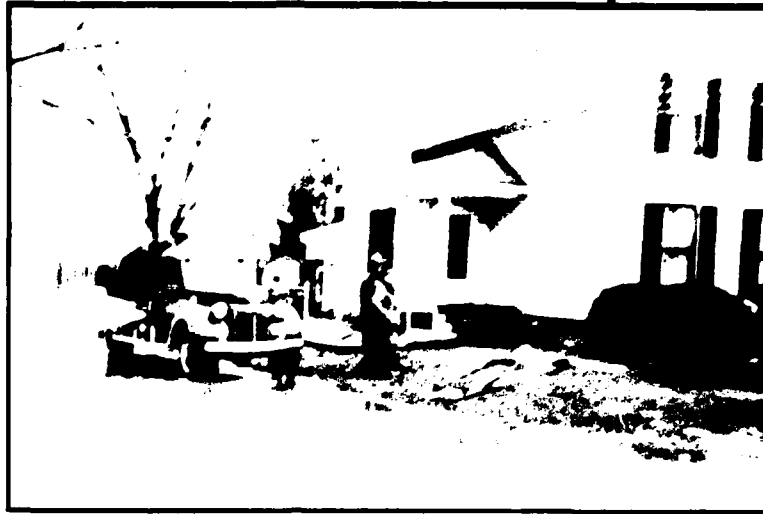
Photo No. 11. Firemen shown pumping overland flood water out of basement at residence on Borden Road after water receded, during the March 1962 flood.

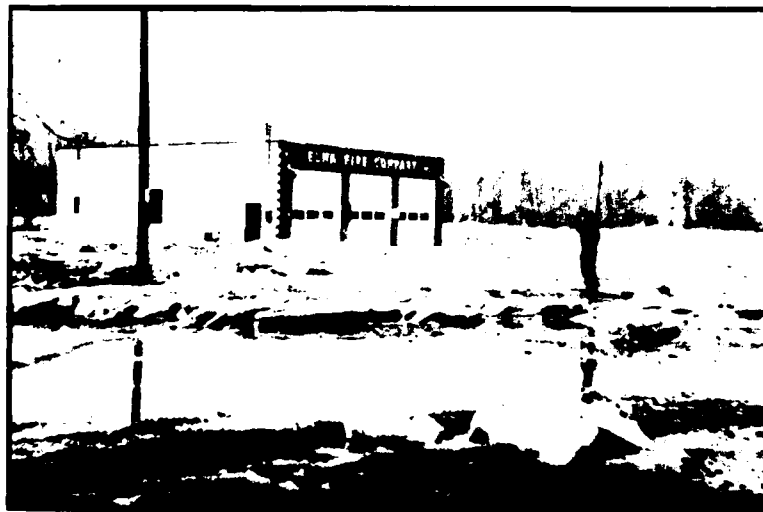
Photo No. 12. The new Elma Fire Hall during the March 1962 flood. The floor was covered by 8 inches of water.

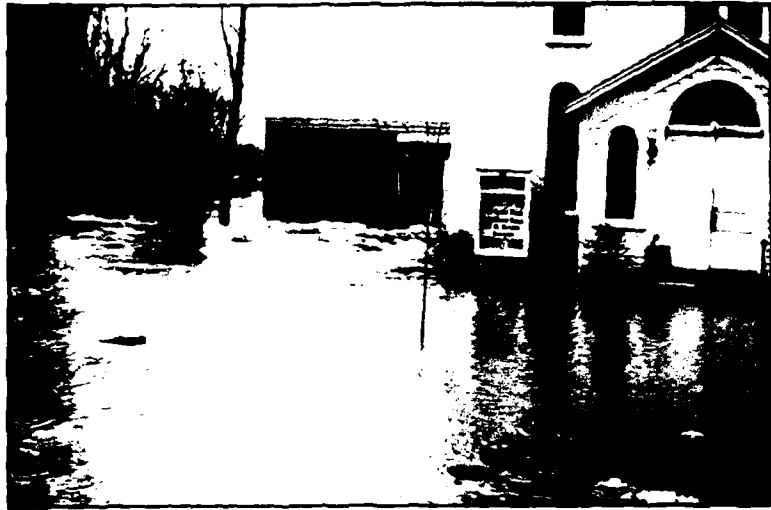
Photo No. 13. Elma Methodist Church and Sunday School addition on Bowen Road, during the March 1962 flood.

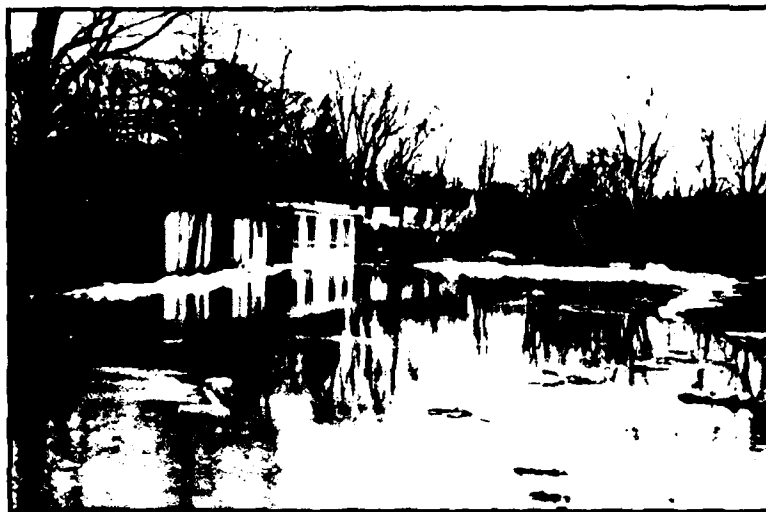
Photo No. 14. Rear of Sunday School addition during the March 1962 flood. Addition now being used for regular school classes. The addition had 4 inches of water on the first floor.

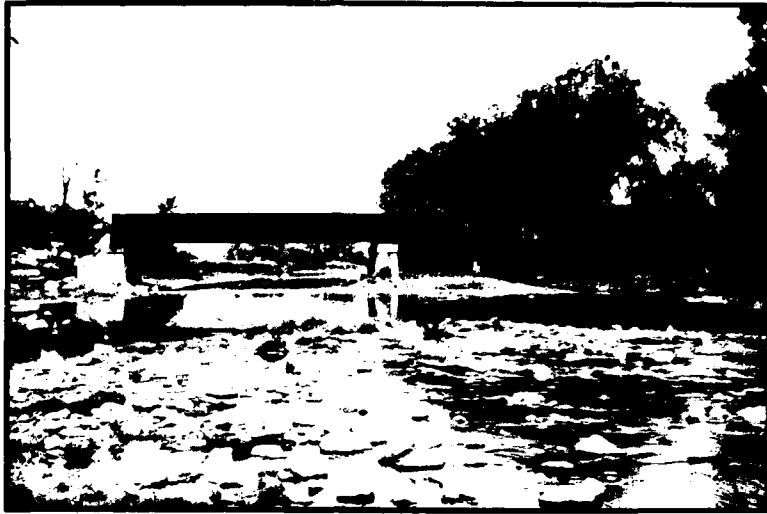
Photo No. 17. Looking downstream at the New York Central R. R. bridge. Note the shoal upstream of the center pier.

42. There are several natural and man-made sections along Buffalo Creek which have an effect on water surface elevations during high discharge periods. Consideration should be given to modifying the condition whenever possible, removing the restrictive structure when it has outlived its usefulness, or replacing with a less restrictive structure when replacement becomes necessary.

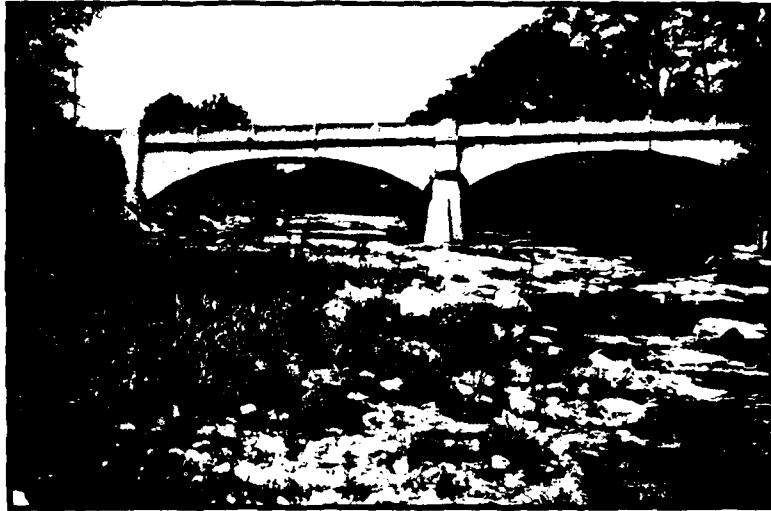
Photo No. 19. Looking downstream at Borden Road bridge showing rock channel bottom and shoals.

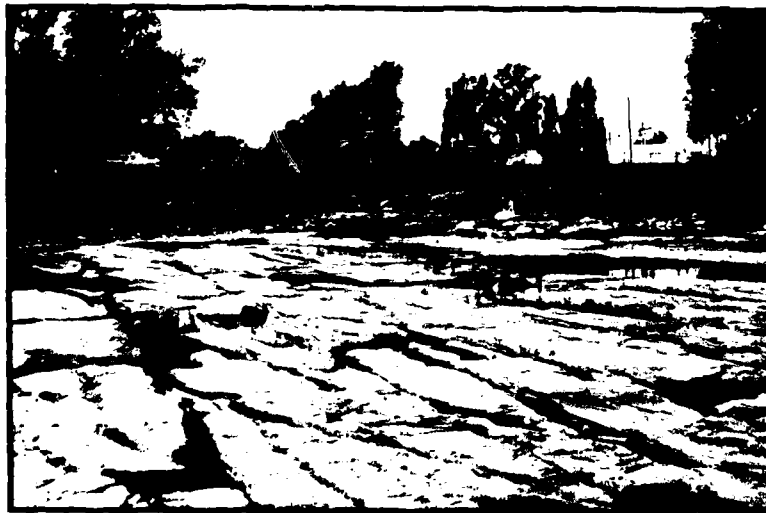
Photo No. 20. Looking downstream at Transit Road bridge showing the rock channel bottom.

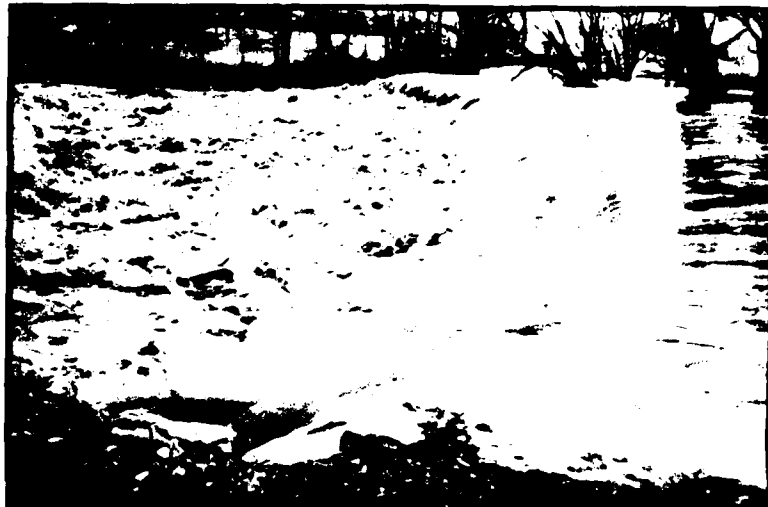
Photo No. 21. Blossom Dam near mile 5.95. Photo shows increase in water surface at the dam during the moderate runoff of April 1959.

44. At the present time there are dams at Blossom and Elma which are no longer in use and which project 3 to 4 feet above the natural creek bottom. Shoal areas have formed at the upstream end of the pools and ice floes and debris are easily grounded. If these dams are not serving any useful purpose removing them would reduce high water elevations in the immediate area. Pictures of the Blossom and Elma dams are shown on exhibits 11 and 12. Picture 21 shows the increase in water surface at the Blossom dam during a moderate runoff. Picture 22 shows that equipment has been engaged in removing shoal material from upstream of the Blossom dam.

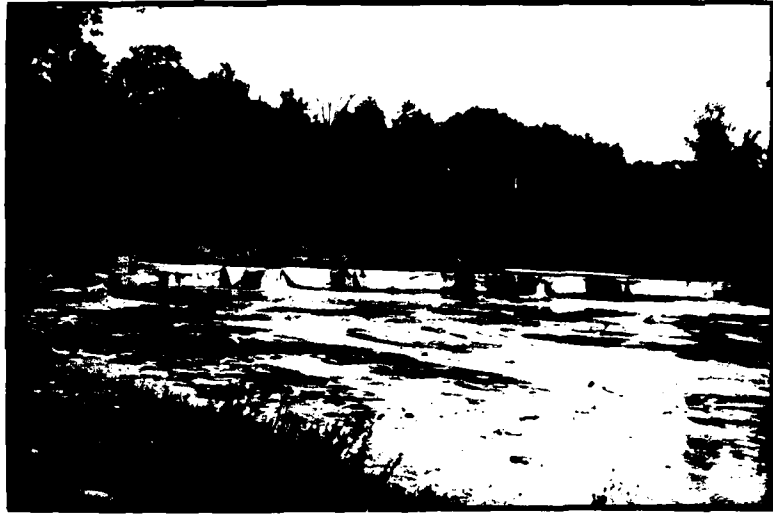
Photo No. 23. Elma Dam upstream of Bowen Road near mile 10.2. Note shale on right bank upstream of the dam.

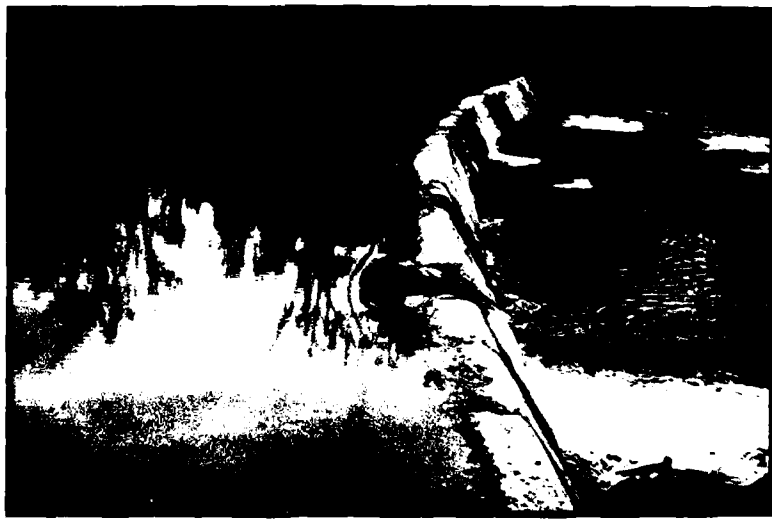
Photo No. 24. Looking along crest of Elma Dam.

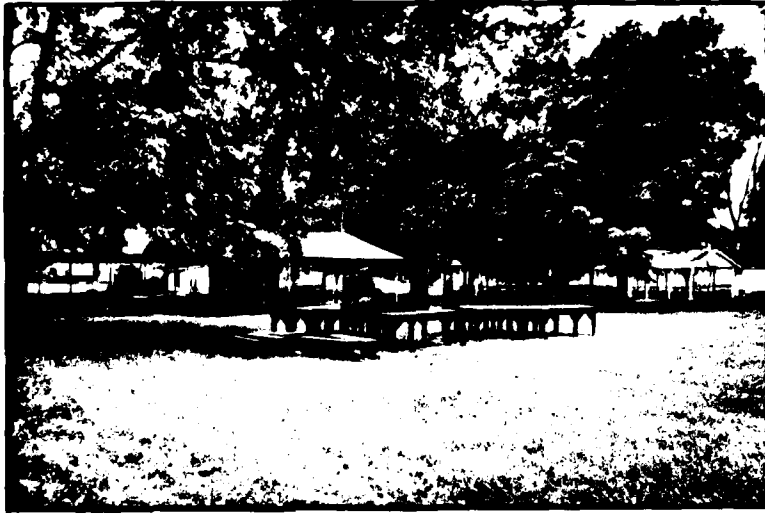
Photo No. 31. Island Park at Gardenville near mile 2.3. This area was flooded by about 2 feet of water in the 1955 and 1956 floods.

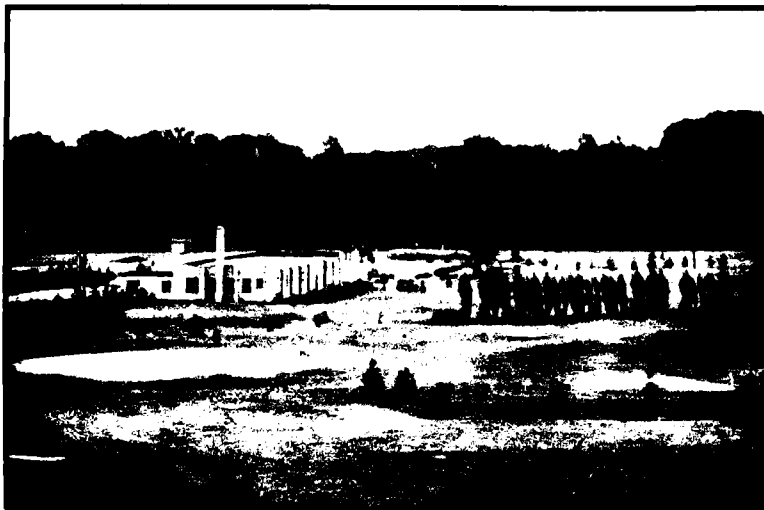
Photo No. 33. Elma Meadows County Park near mile 14.3. The building is above flood levels but lower portions of the golf course are flooded.
