# FLOOD PLAIN INFORMATION REPORT

BLACK RIVER  
NEW YORK, LEVEL #

DEFERIET DAM TO CONFLUENCE  
DEER RIVER.

NOVEMBER 1977

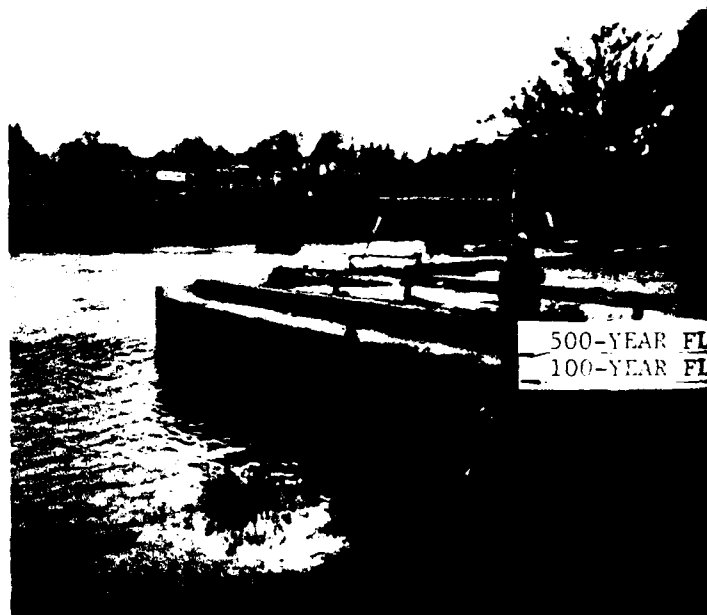
Possible future flood heights at  
a parking lot in Carthage at stream mile 32.2.

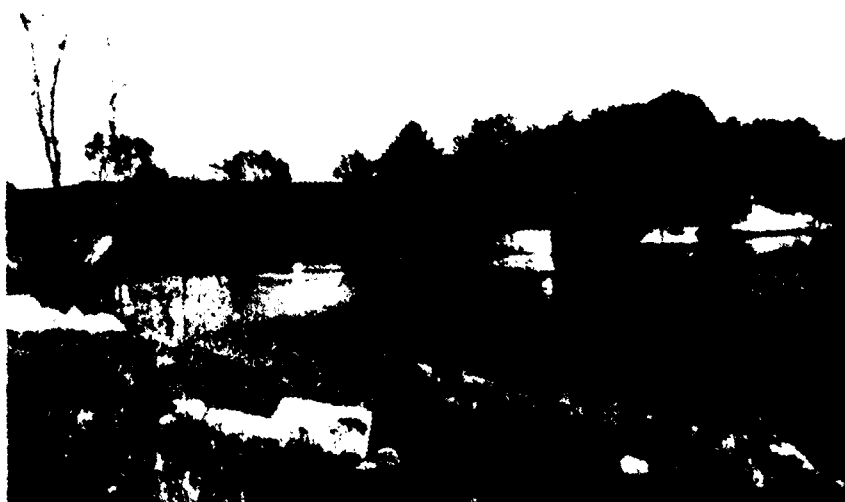
Figure 3 - Upstream face of abandoned railroad bridge,  
stream mile 30.06.

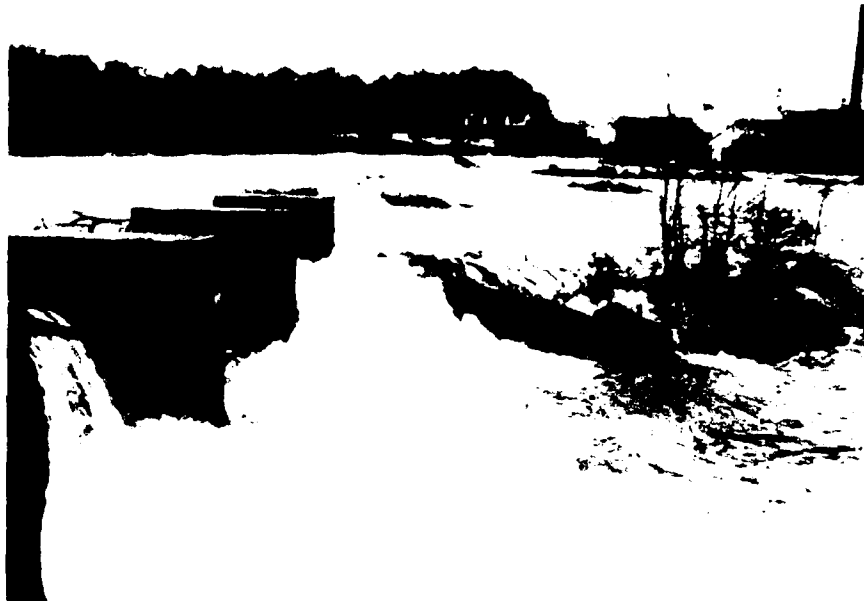
Figure 5 - Crest of Carthage State Dam at stream mile 31.92.

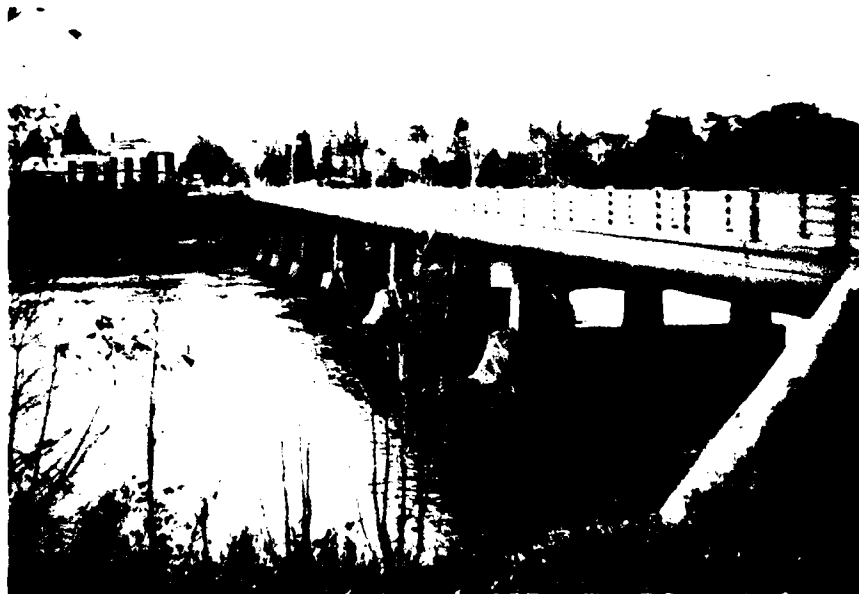
Figure 6 - Upstream face of State Route 26 bridge at stream mile 32.14.

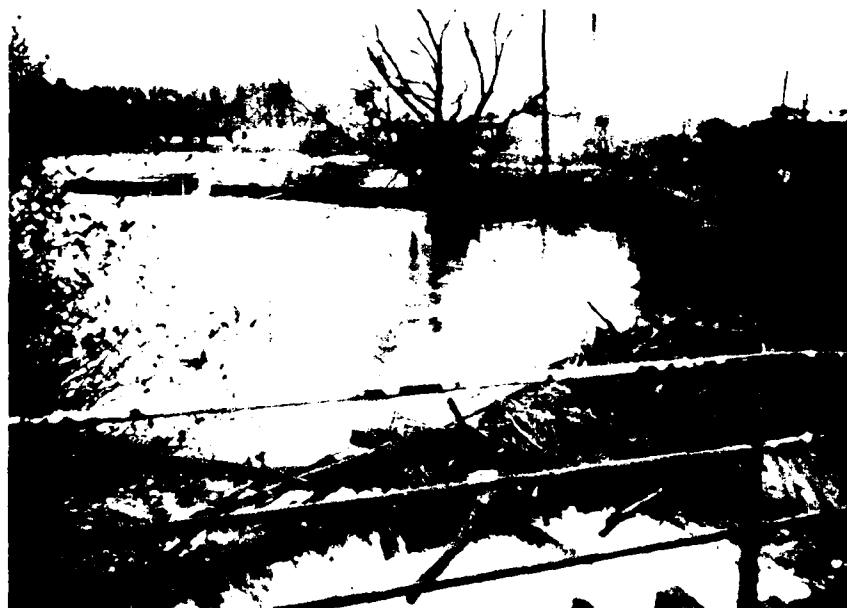
Figure 10 - Debris near bridge at mill race, stream mile 31.82.

Generally, obstructions at bridges and culverts restrict flows, raise water surface elevations in overbank areas and result in unpredictable areas of flooding, destruction, and damage. Since it is impossible to predict the degree or location of the accumulation of debris, therefore, for the purposes of this report, it was assumed that there would be no accumulation of debris at any of the bridges or culverts. Photographs of typical bridges, dams and other stream characteristics are shown on Figures 1 through 8. Examples of obstructions to flow are shown on Figures 9 and 10.

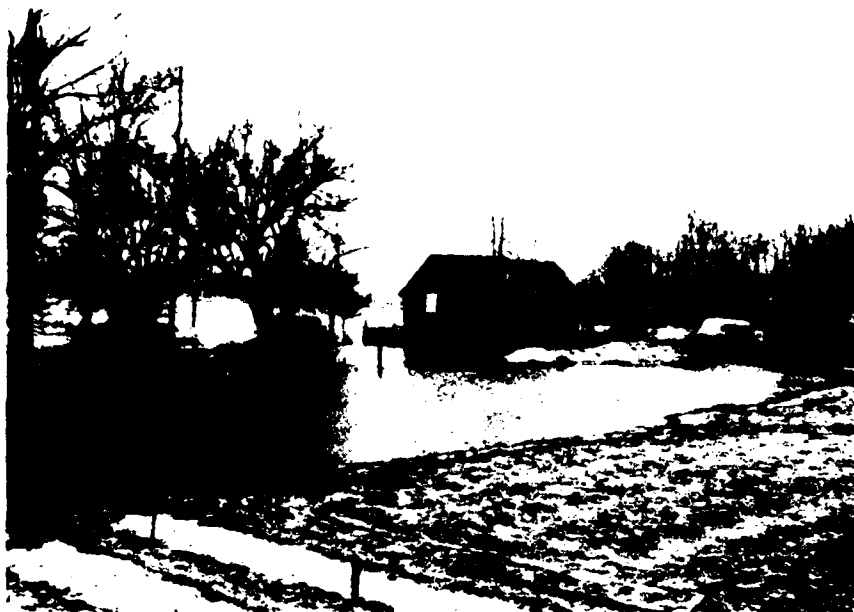
Figure 11 - Flooding conditions in March 1977 at barn on west side of State Route 3 in town of Wilna at stream mile 28.26.

Agricultural damage consisted of: losses to farm lands, farm equipment and buildings and loss of milk production and shipment. In the fields there were widespread standing flood waters that were from 1/2 to two miles wide and six feet deep. Flooding conditions in March 1977 are shown on Figures 11 through 14.

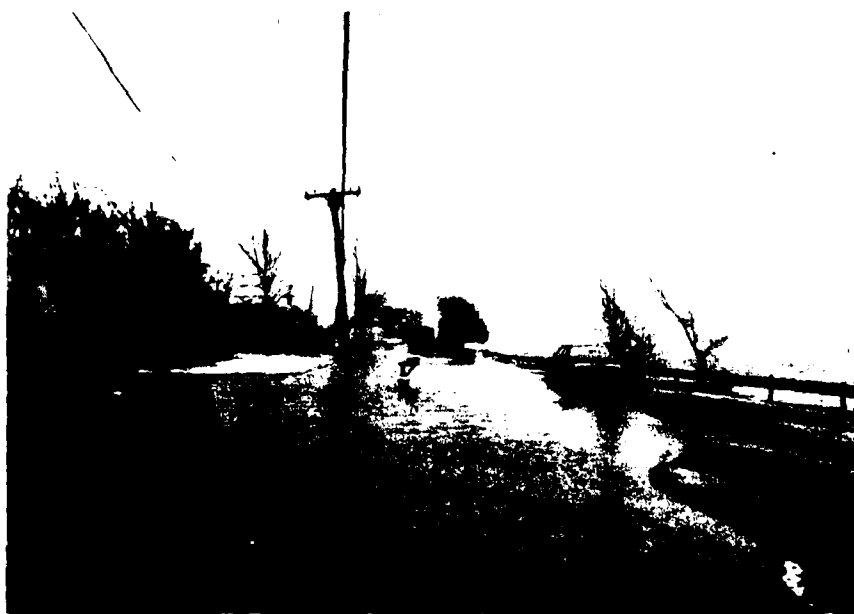
Figure 12 - Flooding conditions in March 1977 along State Route 3 in town of Wilna at stream mile 28.66.

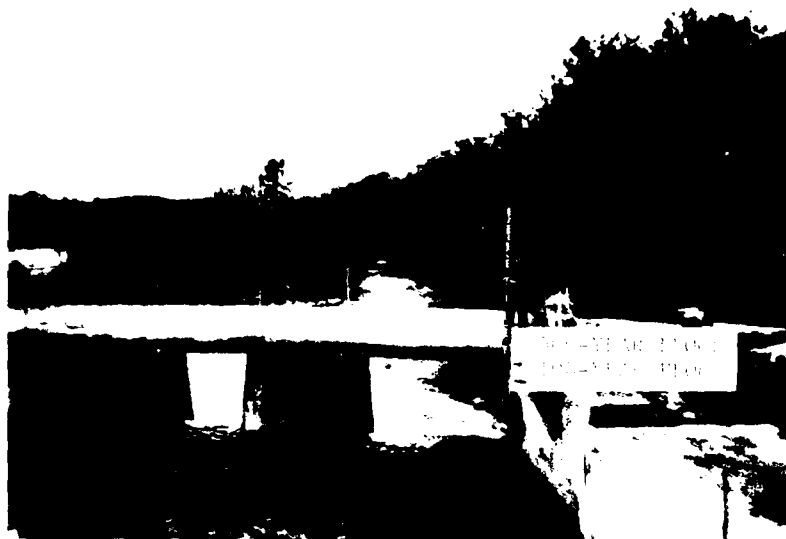
Figure 15 - The 100- and 500-year flood heights at the Deferiet Dam at stream mile 26.53 are shown.

The expected levels of the 100-year and 500-year floods at various locations in the study area are indicated on Figures 15 through 20.
