FLOOD PLAIN INFORMATION  
 WEST AND NORTH BRANCHES  
 ROCKY RIVER  
 MEDINA COUNTY

PREPARED FOR  
 OHIO DEPARTMENT OF NATURAL RESOURCES  
 DIVISION OF WATER  
 AND  
 TRI-COUNTY REGIONAL PLANNING COMMISSION

BY  
 OF ENGINEERS, U.S. ARMY  
 BUFFALO DISTRICT  
 OCTOBER 1971

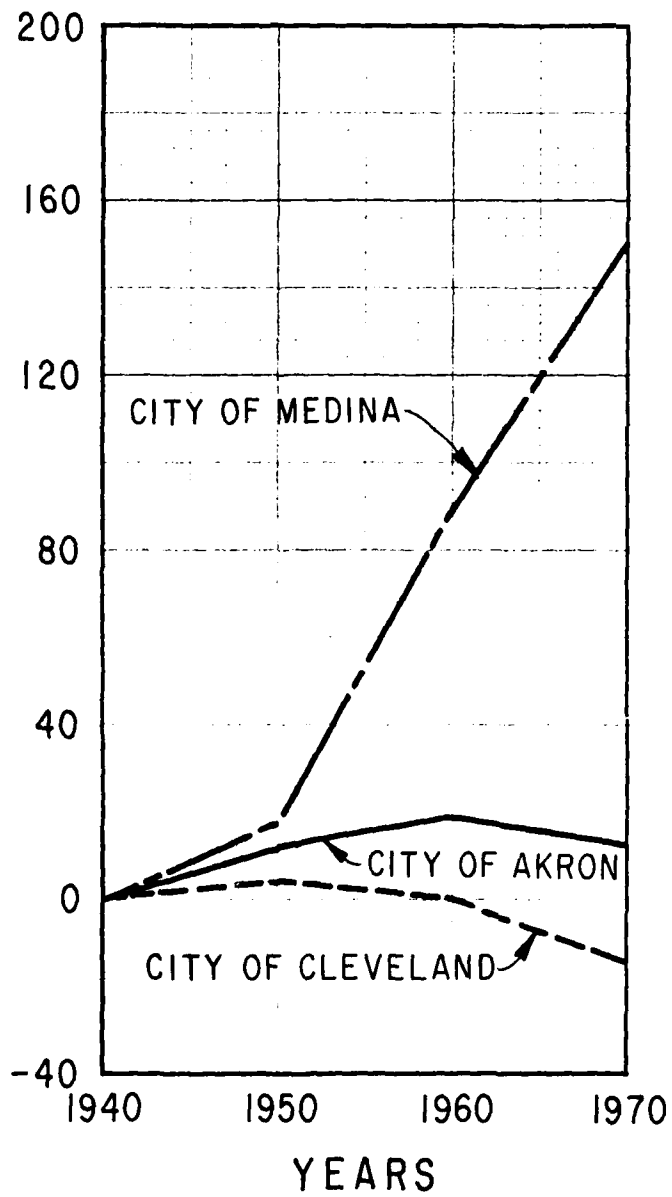
POPULATION TRENDS

POPULATION CHANGE IN PERCENT SINCE 1940

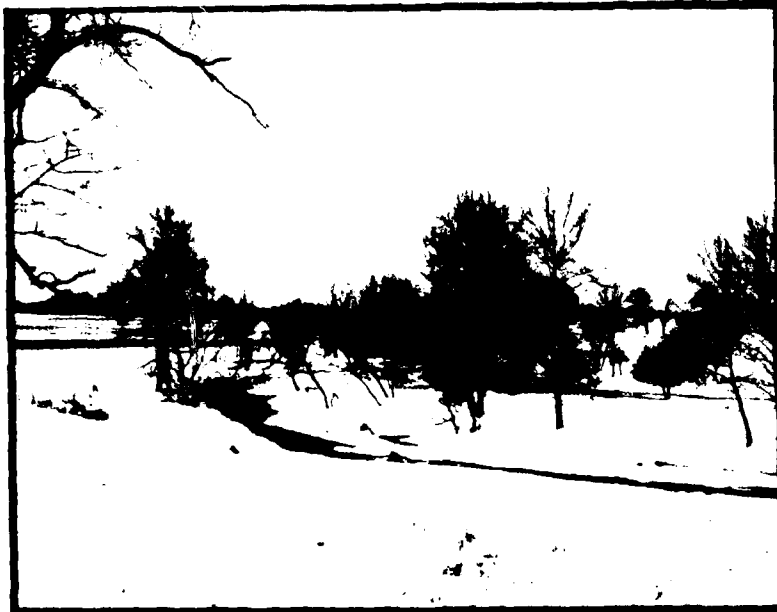
Figure 3 - Looking southeast from Hamilton Road, near Gayer Road, at Oxbow, stream mile 35.1.

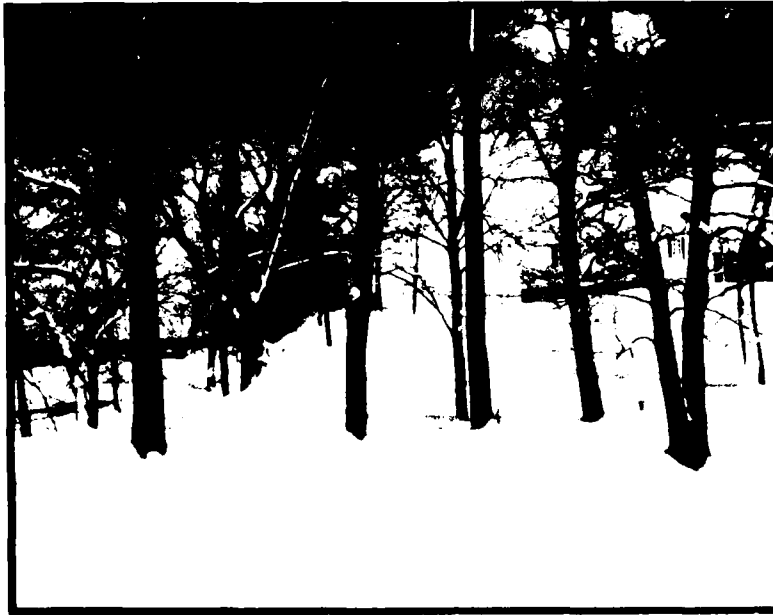
Figure 5 - Looking unstream from Wolff Road at elevated house on left bank. Note west branch of Rocky River at much lower elevation to left of house, stream mile 34.9.

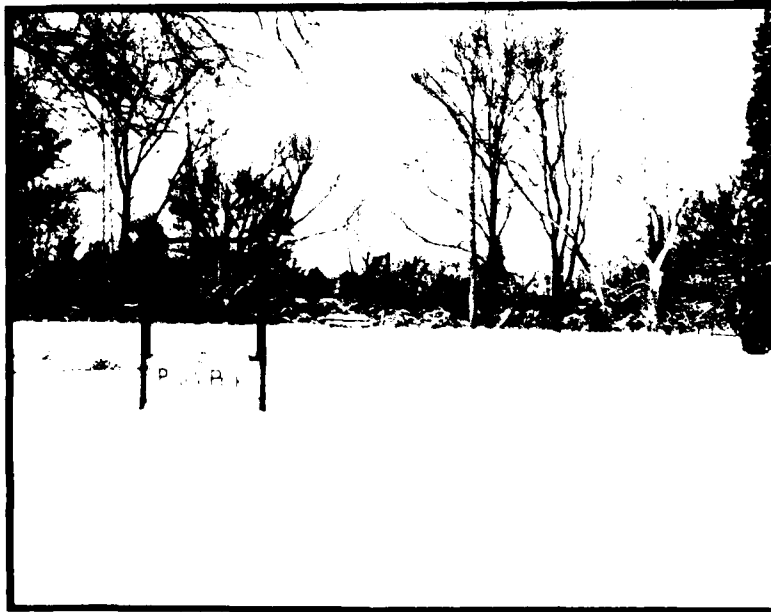
Figure 6 - Looking toward Rocky River at Private Park from downstream right bank of Pearl Road, near stream mile 36.0.

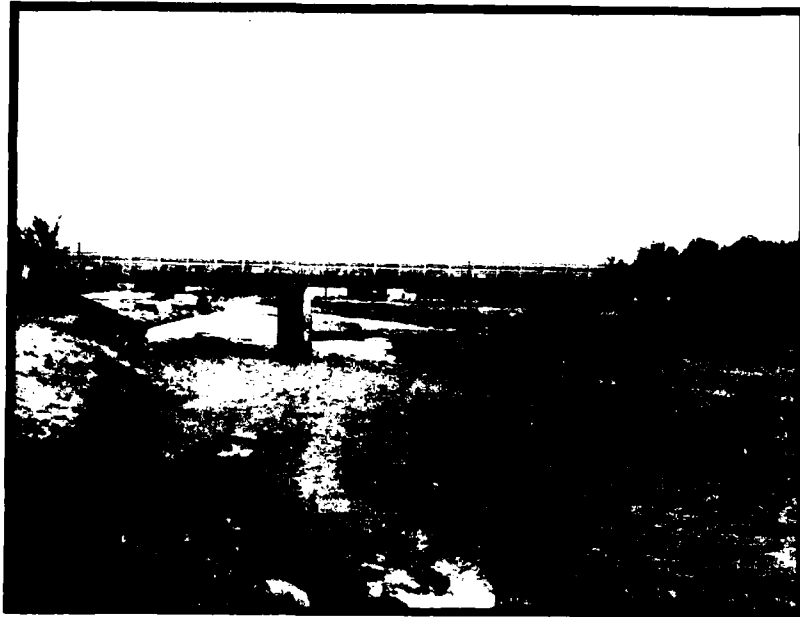
Figure 8 - Looking downstream at Ohio State Route 303 bridge, stream mile 30.29.

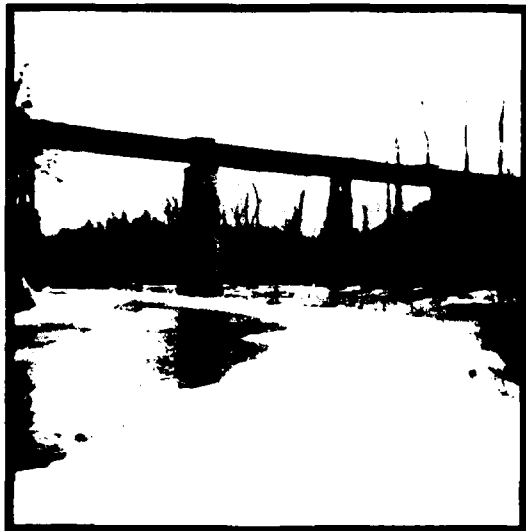
Figure 9 - Looking downstream at Baltimore & Ohio Railroad bridge, stream mile 32.75.

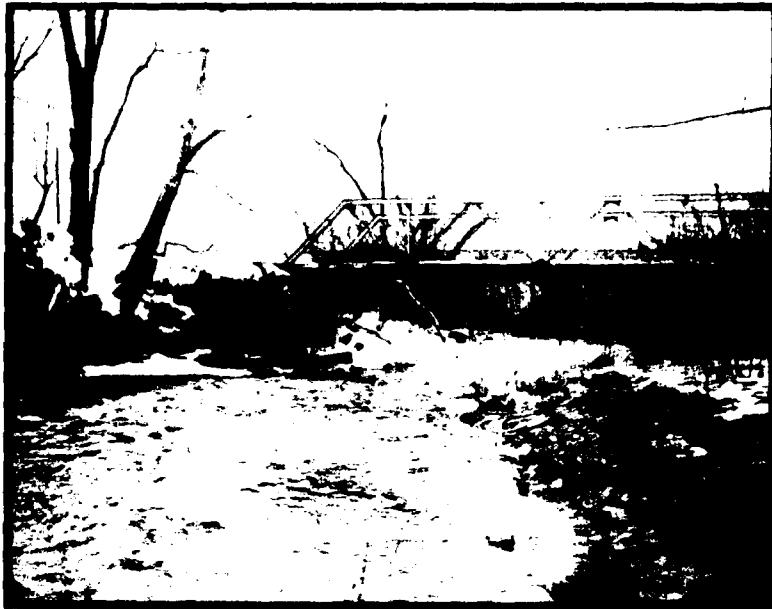
Figure 11 - Looking downstream at Bagdad Road bridge,  
stream mile 43.10.

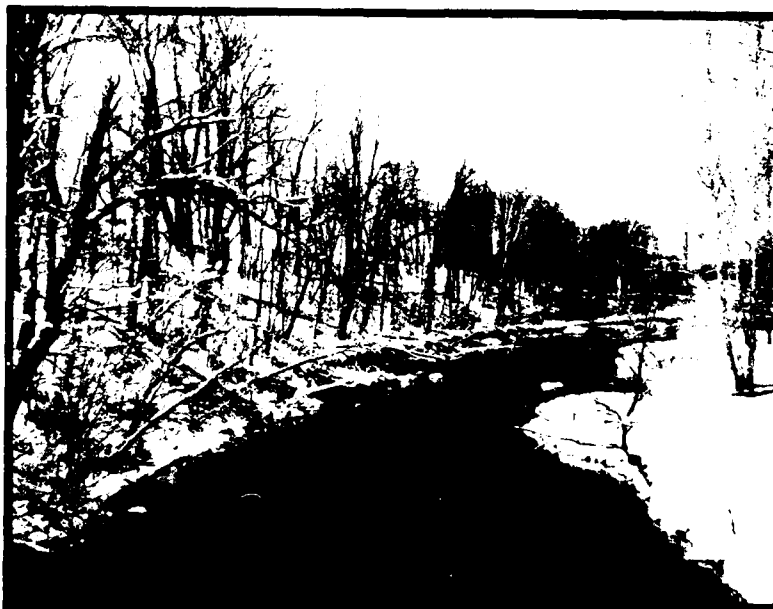
Figure 14 - Looking downstream from Marks Road toward debris on left bank, stream mile 35.5. These dead and fallen trees are not presently a hazard although, they could be a potential threat if, during high water they floated downstream and collected in restricted areas.

Rates of rise are dependent on the size, shape, and slope of the basin, intensity of the storm; development within the basin; and infiltration of rainfall. The condition of and amount of debris in the channel can have a large effect on the depth of flooding. Figures 13 through 16 show examples of debris that may increase

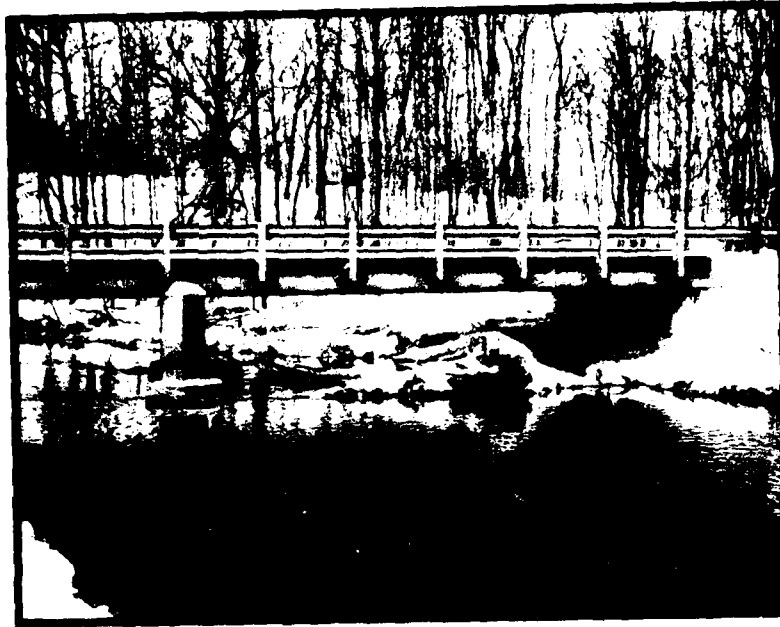
Figure 15 - Looking downstream toward debris at Nichols Road bridge, stream mile 45.9.

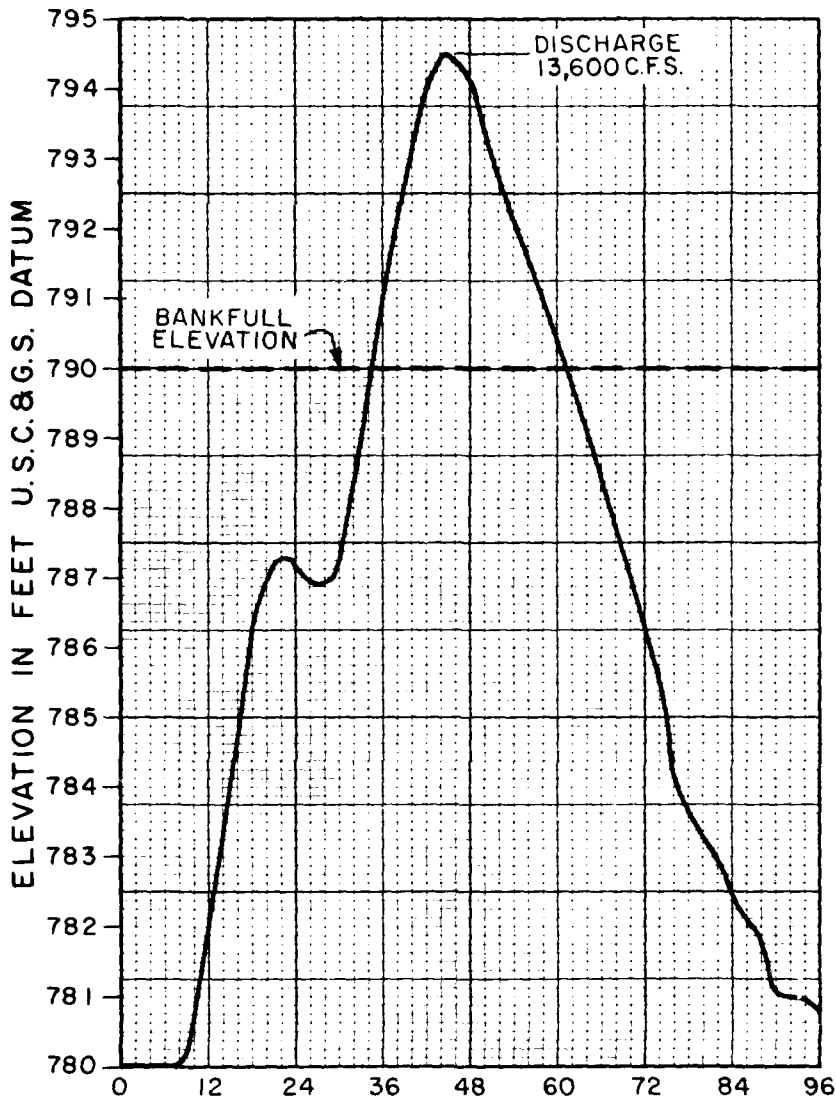
WEST BRANCH ROCKY RIVER  
RIVER MILE 28.09

WEST BRANCH  
ROCKY RIVER  
MEDINA COUNTY, OHIO  
FLOOD PLAIN INFORMATION REPORT  
STAGE HYDROGRAPH OF  
INTERMEDIATE REGIONAL FLOOD  
U.S. ARMY ENGINEER DISTRICT, BUFFALO  
OCTOBER 1971

DURATION AND RATE OF RISE - Shown on plate 2 is the estimated stage hydrograph of the Intermediate Regional Flood (IRF) just upstream of Grafton Road. During the IRF the river is expected to reach its peak in 36 hours at an average rate of 0.40 foot per hour and remain above bankfull stage for approximately 27 hours.

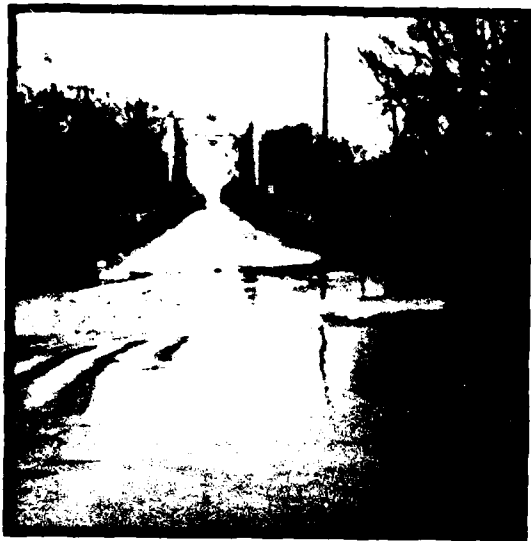
Figure 17 - Flooding conditions on 29 January 1970 at Grafton Road bridge, stream mile 28.02.

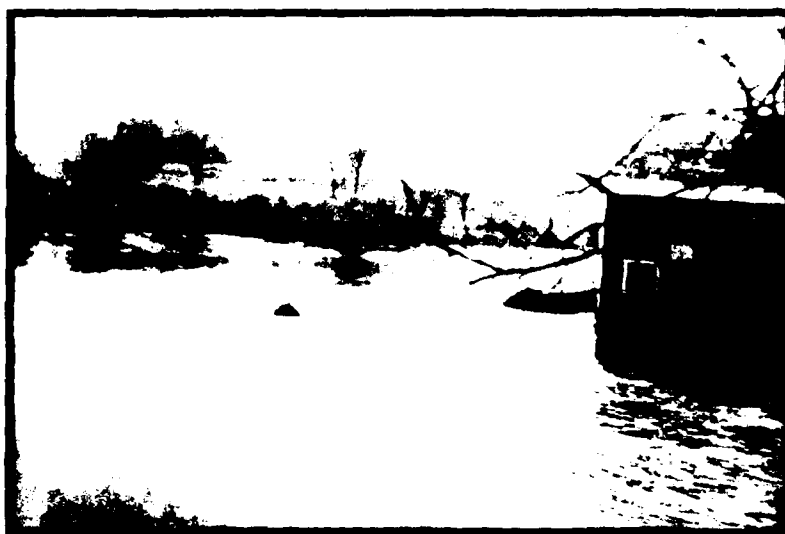
Figure 19 - 1938 high water conditions at Nichols Road, stream mile 45.87.

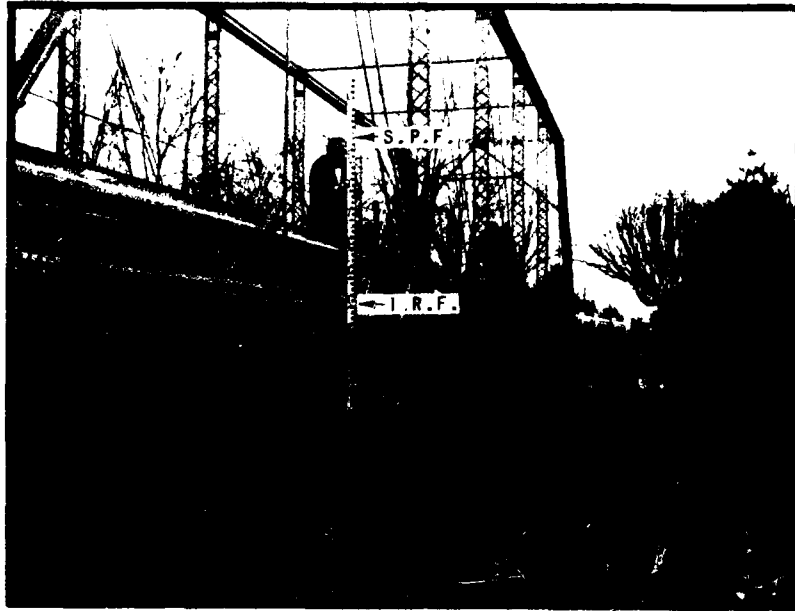
Figure 21 - Arrows indicate the heights of the Standard Project and Intermediate Regional Floods at Grafton Road bridge, stream mile 28.02. Photo taken March 1970.

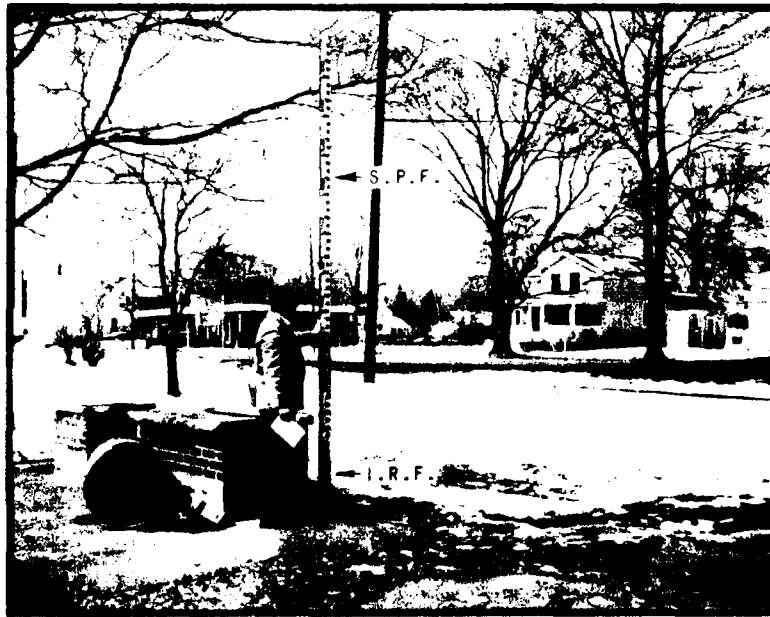
Figure 22 - Arrows indicate the heights of the Standard Project and Intermediate Regional Floods on Ohio State Route 305 in Valley City, Ohio, stream mile 30.29. Photo taken March 1971.

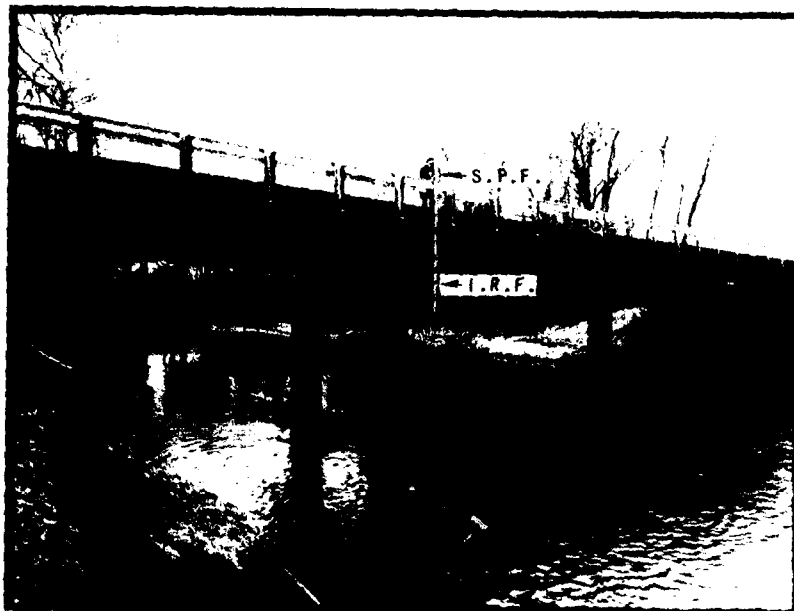
Figure 23 - Arrows indicate the heights of the Standard Project and Intermediate Regional Floods at Ohio State Route 252 bridge, stream mile 31.53. Photo taken March 1970.

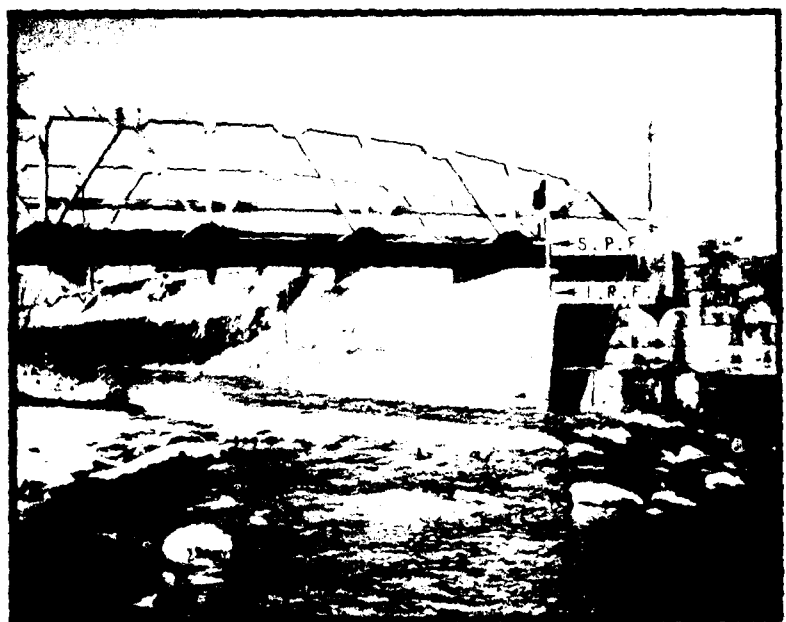
Figure 24 - Arrows indicate the heights of the Standard Project and Intermediate Regional Floods at Noff Road bridge, stream mile 33.42. Photo taken March 1971.

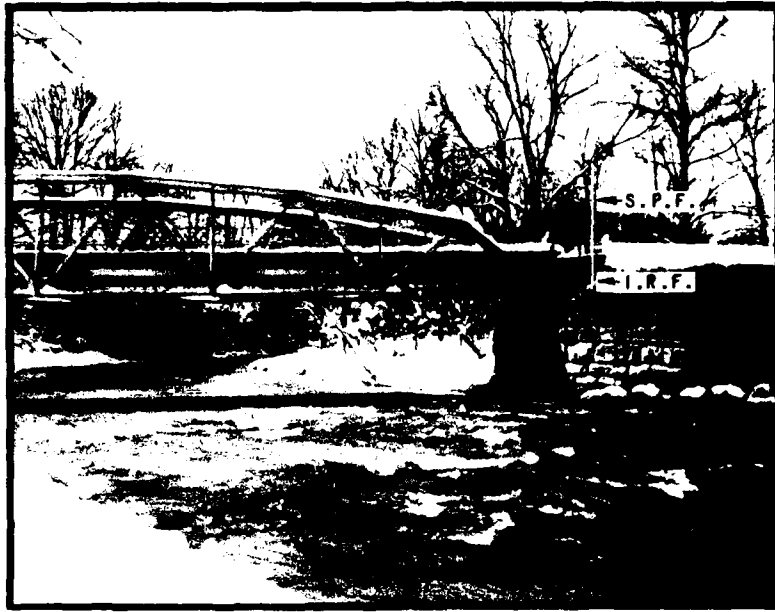
Figure 25 - Arrows indicate the heights of the Standard Project and Intermediate Regional Floods at Abbeyville Road bridge, stream mile 34.85.

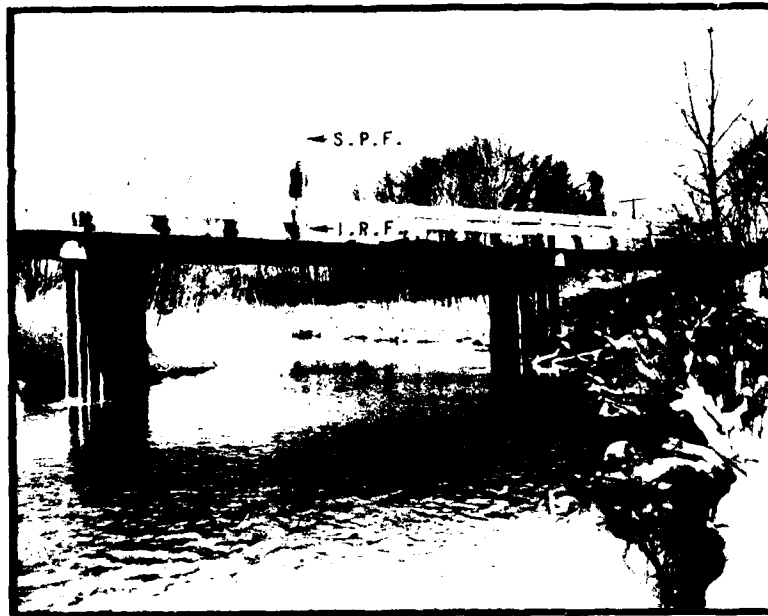
Figure 26 - Arrows indicate the heights of the Standard Project and Intermediate Regional Floods at Fenn Road bridge, stream mile 38.92.

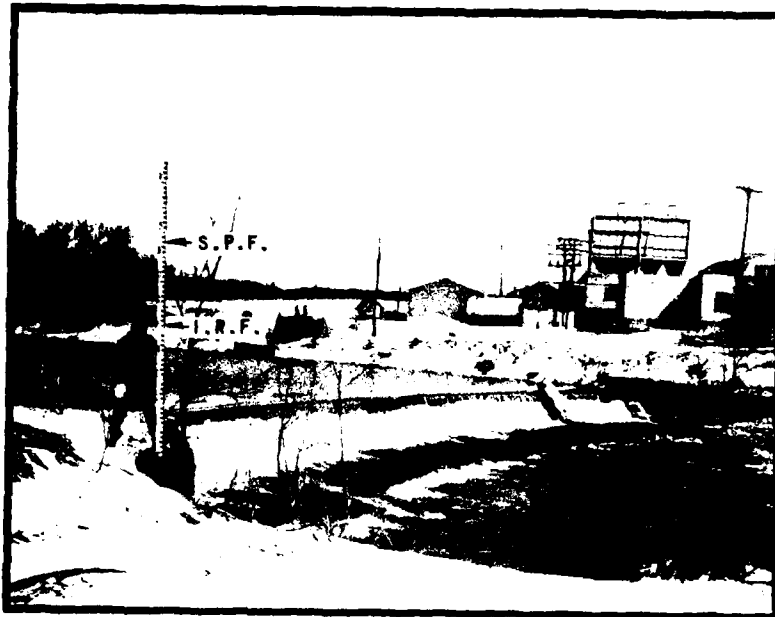
Figure 27 - Arrows indicate the heights of the Standard Project and Intermediate Regional Floods at the dam adjacent to the Medina City Waterworks, stream mile 42.0.

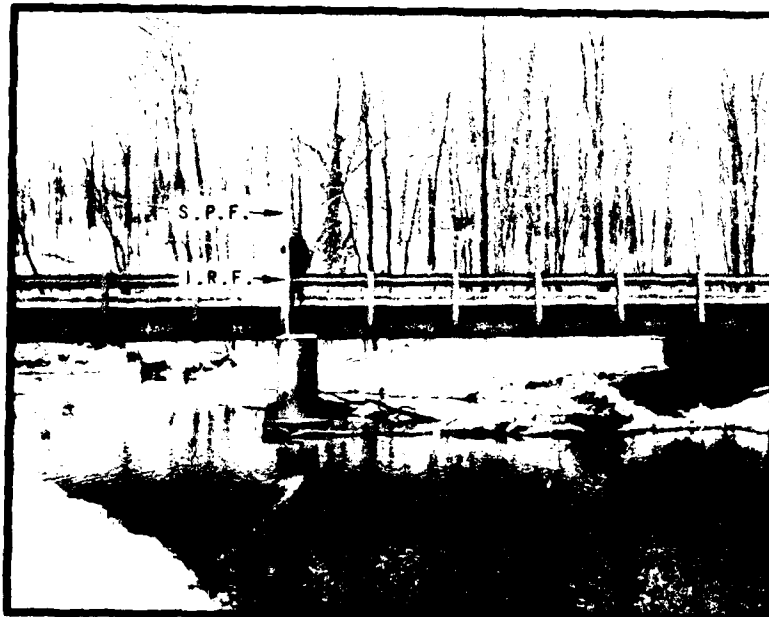
Figure 28 - Arrows indicate the heights of the Standard Project and Intermediate Regional Floods at Nichols flood bridge, stream mile 45.87.

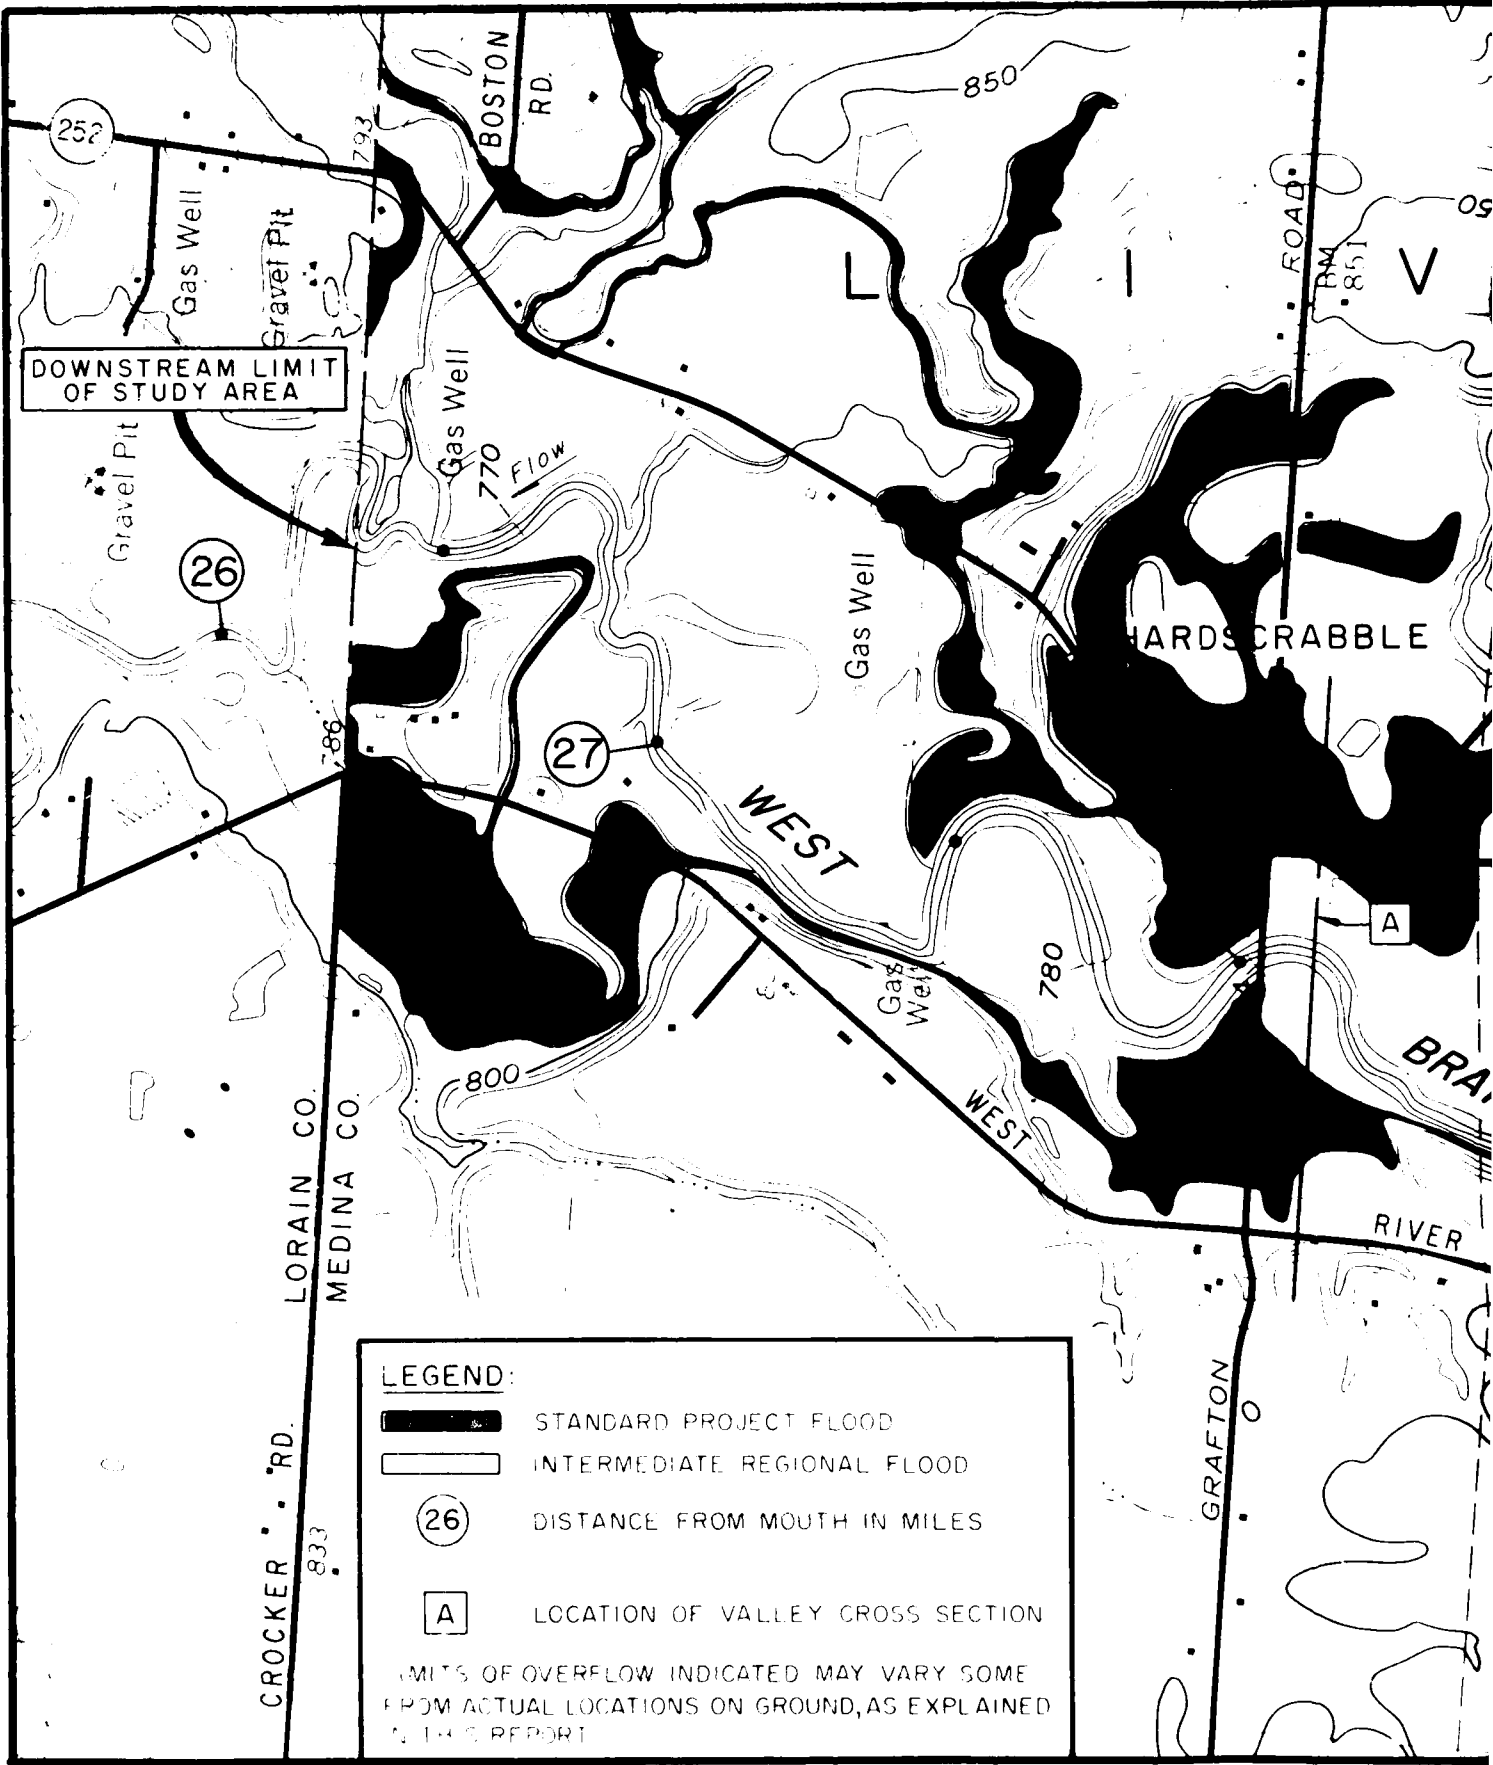
WEST BRANCH  
ROCKY RIVER  
MEDINA COUNTY, OHIO  
FLOOD PLAIN INFORMATION REPORT  
FLOODED AREAS  
MILE 26.4 TO 32.5  
U. S. ARMY ENGINEER DISTRICT, BUFFALO  
OCTOBER 1971

FLOODED AREAS, FLOOD PROFILES, AND CROSS SECTIONS - Plates 4 through 7 show the approximate areas along the West and North Branches of the Rocky River that would be inundated by the Intermediate Regional and Standard Project Floods. The actual limits of the overflow areas may vary somewhat from those shown on the map because the 10-foot contour interval and scale of the map do not permit precise plotting of the flood area boundaries. The purpose of the flood maps is to identify the approximate areas subject to flooding so that flood hazards can be considered before development occurs.

AREAS FLOODED AND HEIGHTS OF FLOODING - Areas in this study that would be flooded by the Standard Project and Intermediate Regional Floods are shown on plates 4 through 7. Depths of flow can be estimated from the crest profiles which are shown on plates 8 through 10.

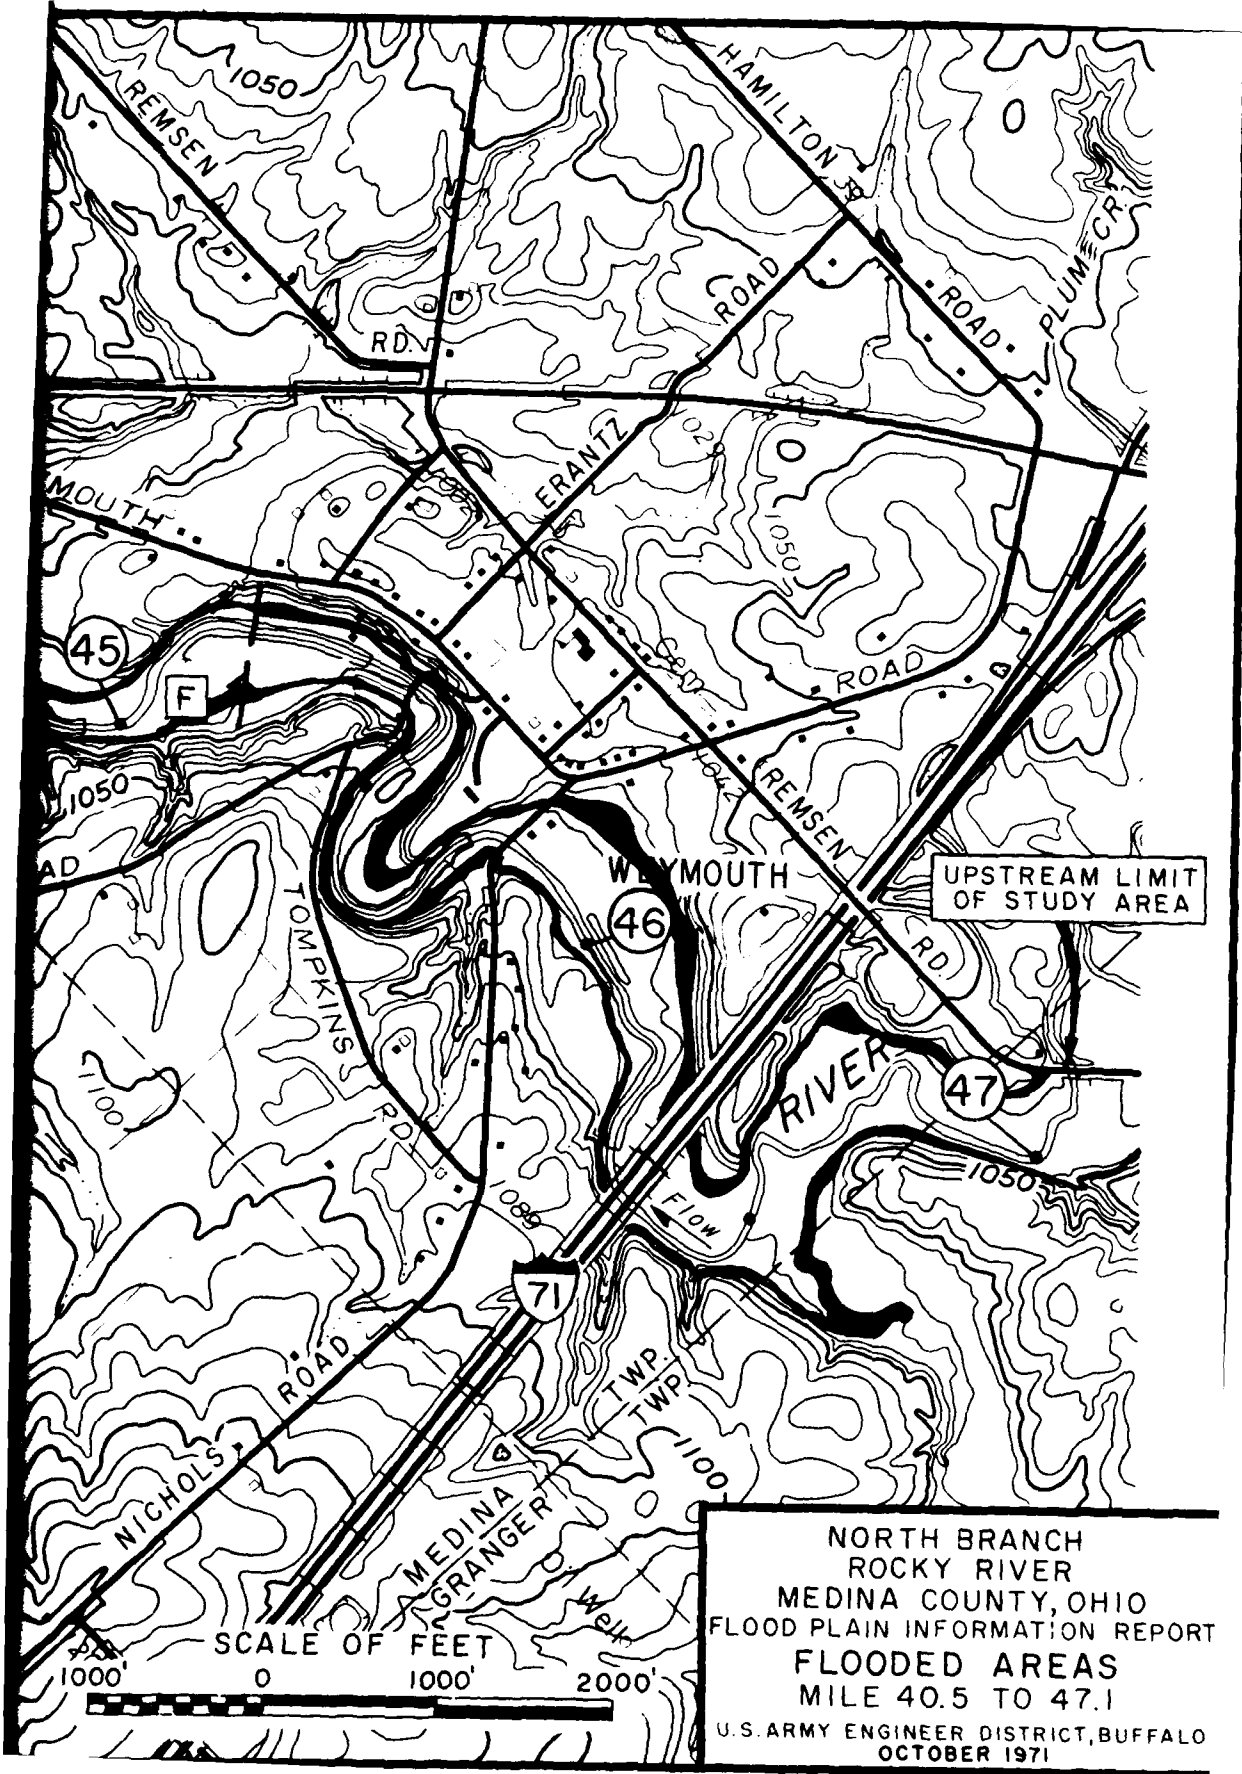
NORTH BRANCH  
 ROCKY RIVER  
 MEDINA COUNTY, OHIO  
 FLOOD PLAIN INFORMATION REPORT  
**FLOODED AREAS**  
 MILE 40.5 TO 47.1  
 U.S. ARMY ENGINEER DISTRICT, BUFFALO  
 OCTOBER 1971

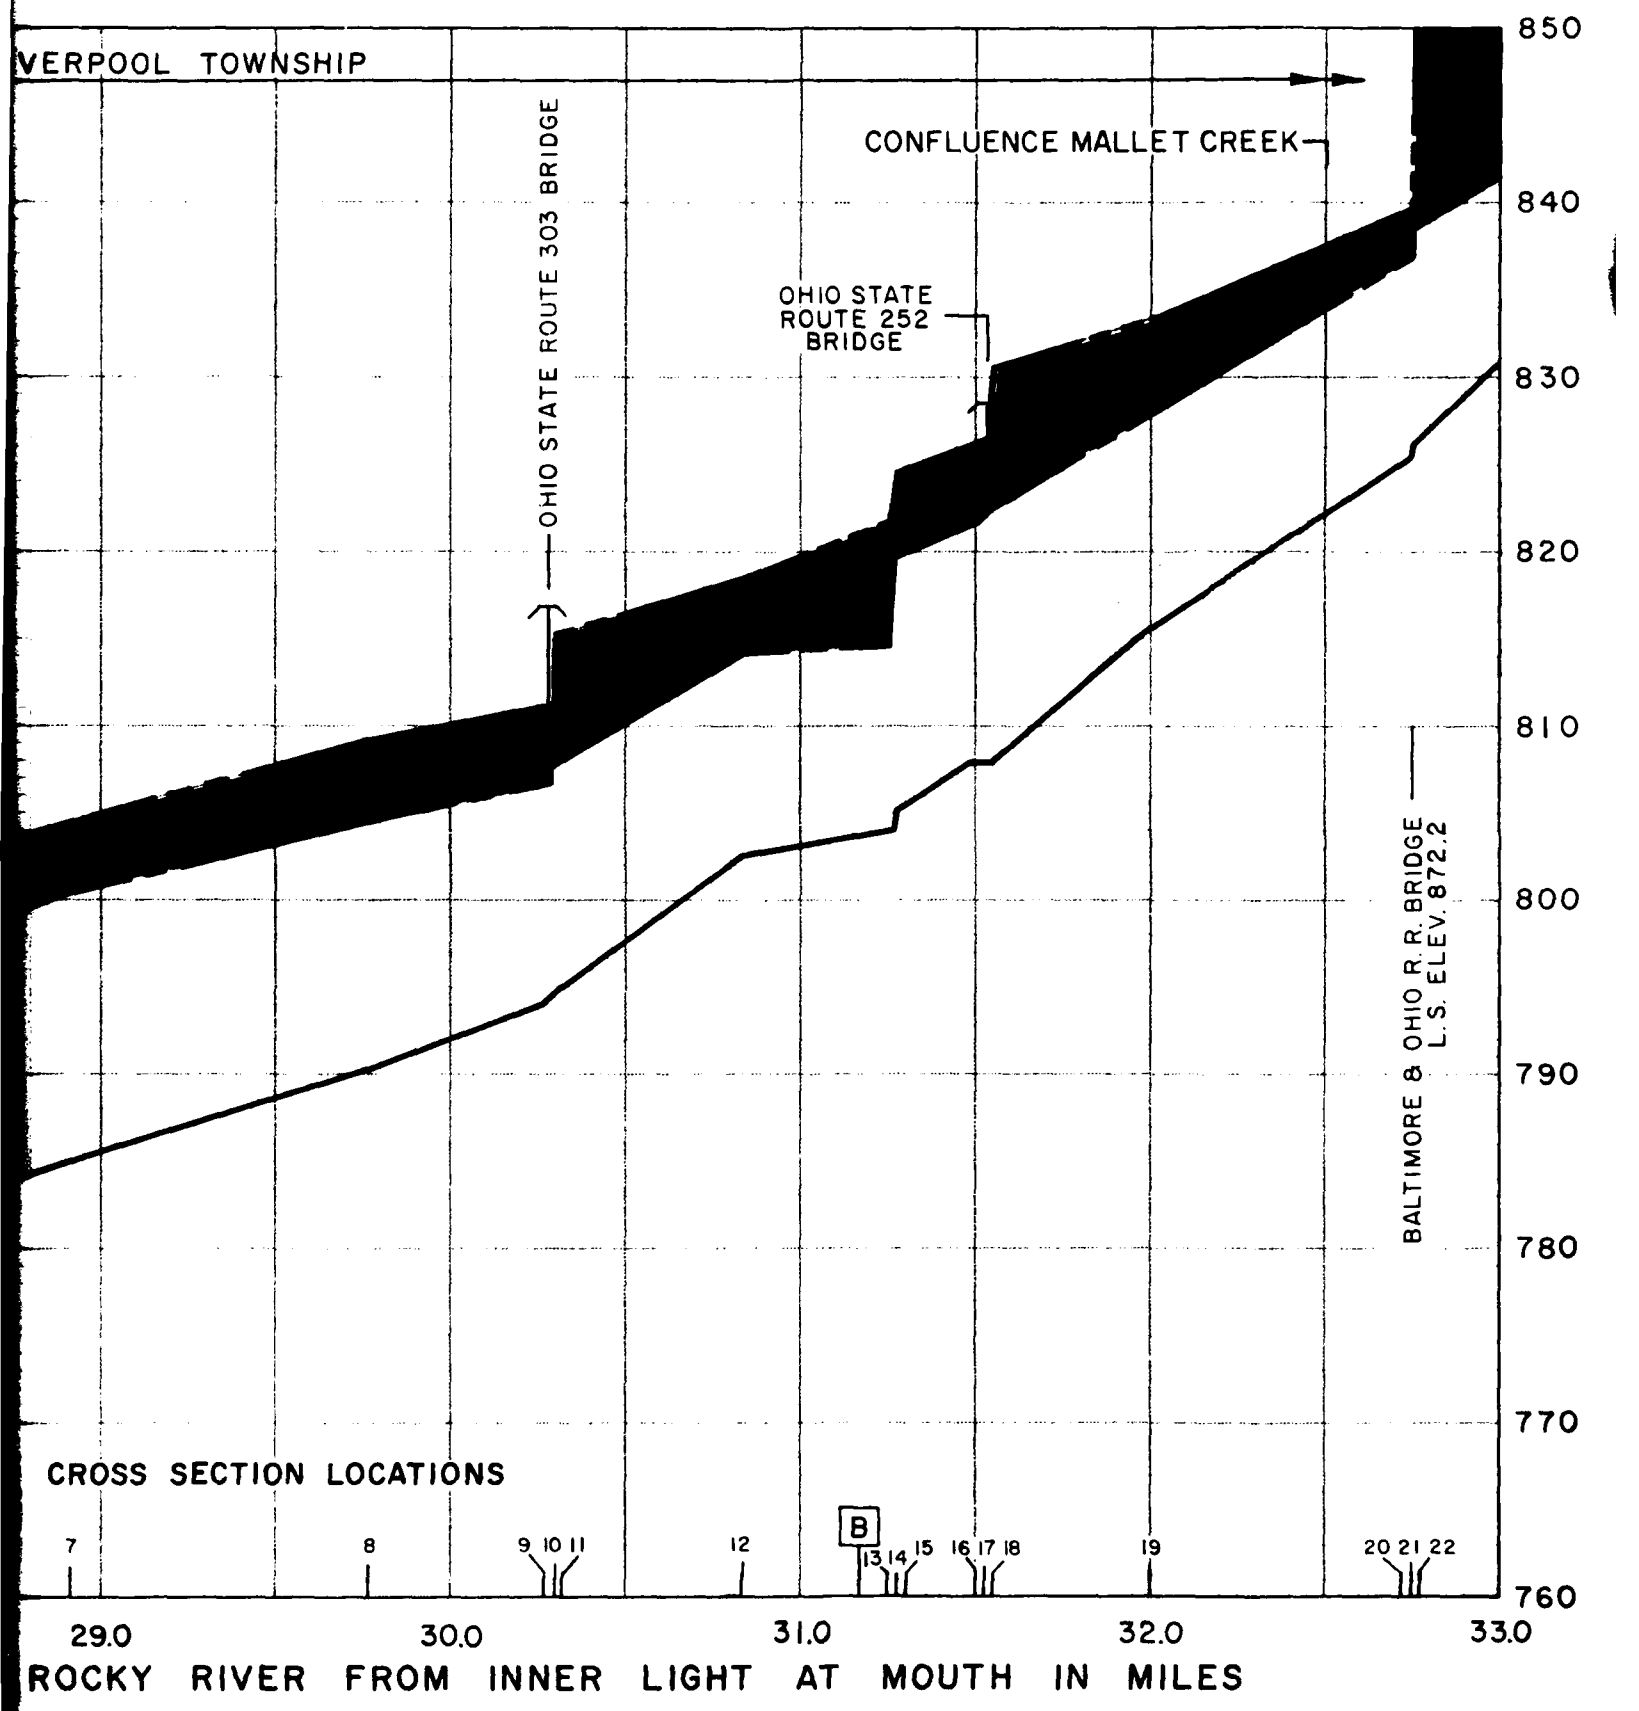
**WEST BRANCH  
 ROCKY RIVER  
 MEDINA COUNTY, OHIO  
 FLOOD PLAIN INFORMATION REPORT  
 PROFILES  
 MILE 26.4 TO 33.0  
 U.S. ARMY ENGINEER DISTRICT, BUFFALO  
 OCTOBER 1971**

Head losses (defined in the Glossary of this report) determined from hydraulic computations are shown on the water surface profiles of plates 8 through 10. The maximum head loss occurs at the Baltimore & Ohio Railroad bridge. The major causes of this abrupt loss is attributed to the steep stream slope upstream of the bridge and the high railroad embankment which limits any appreciable overbank flow around this bridge.

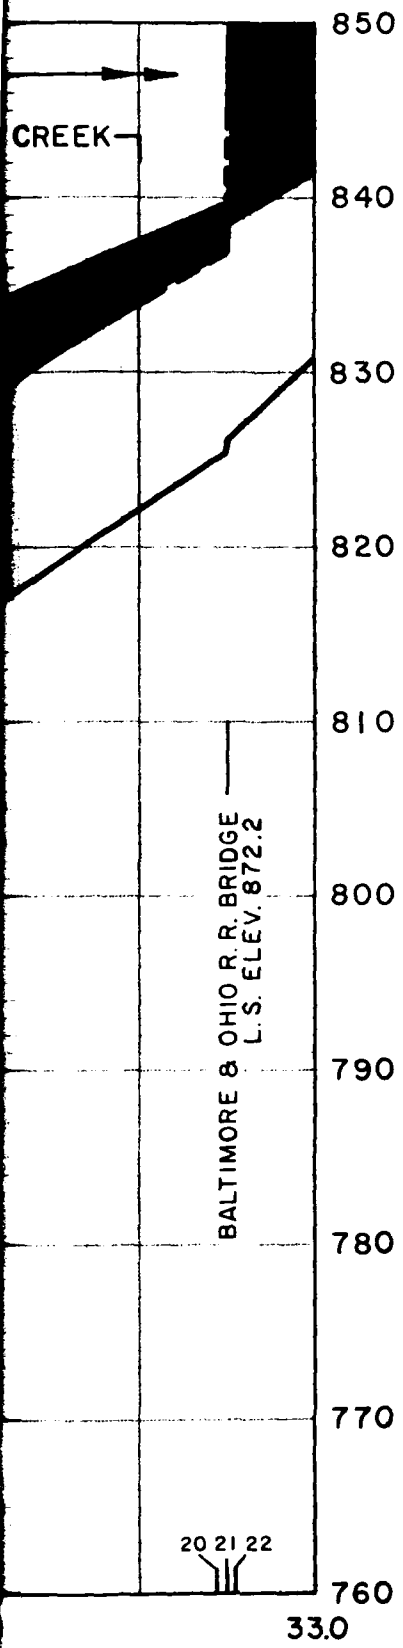
LARGE SCALE FILLING WILL RAISE PROFILES UNLESS SUFFICIENT FLOODWAY IS PROVIDED.

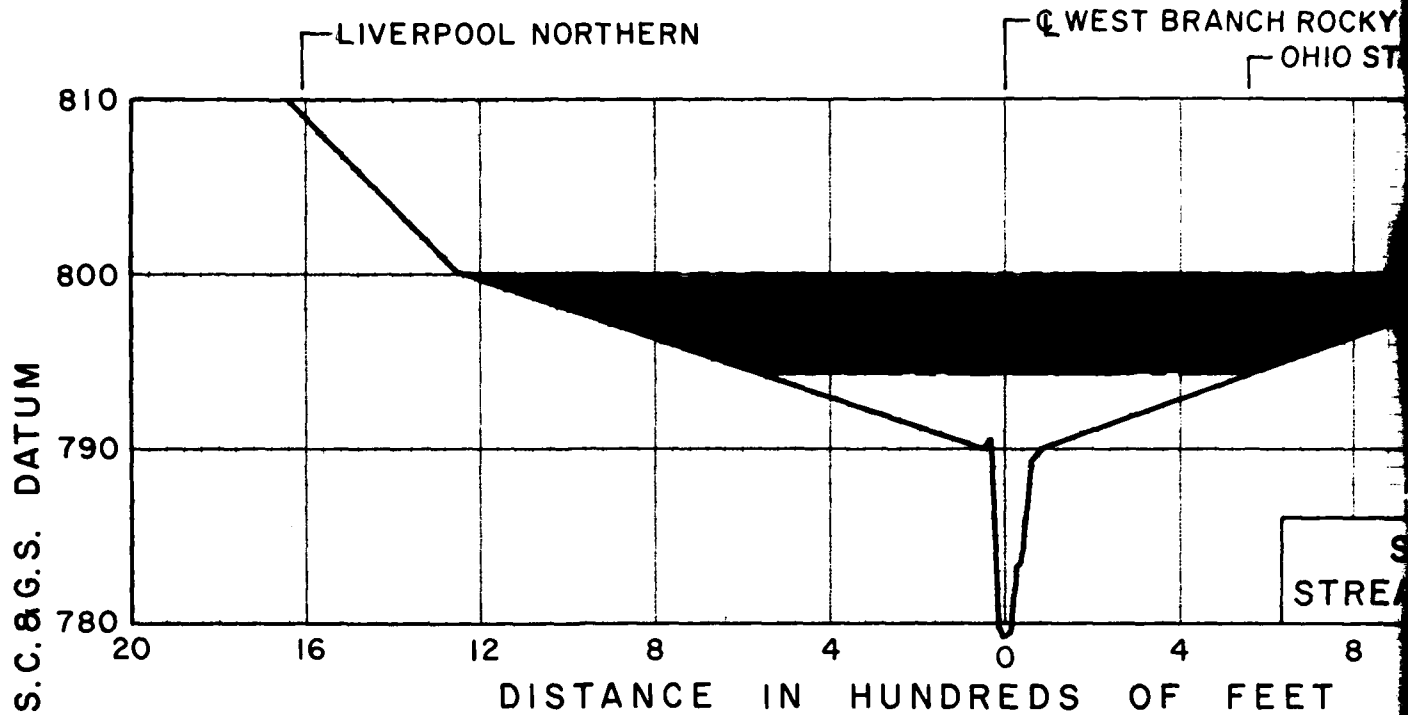
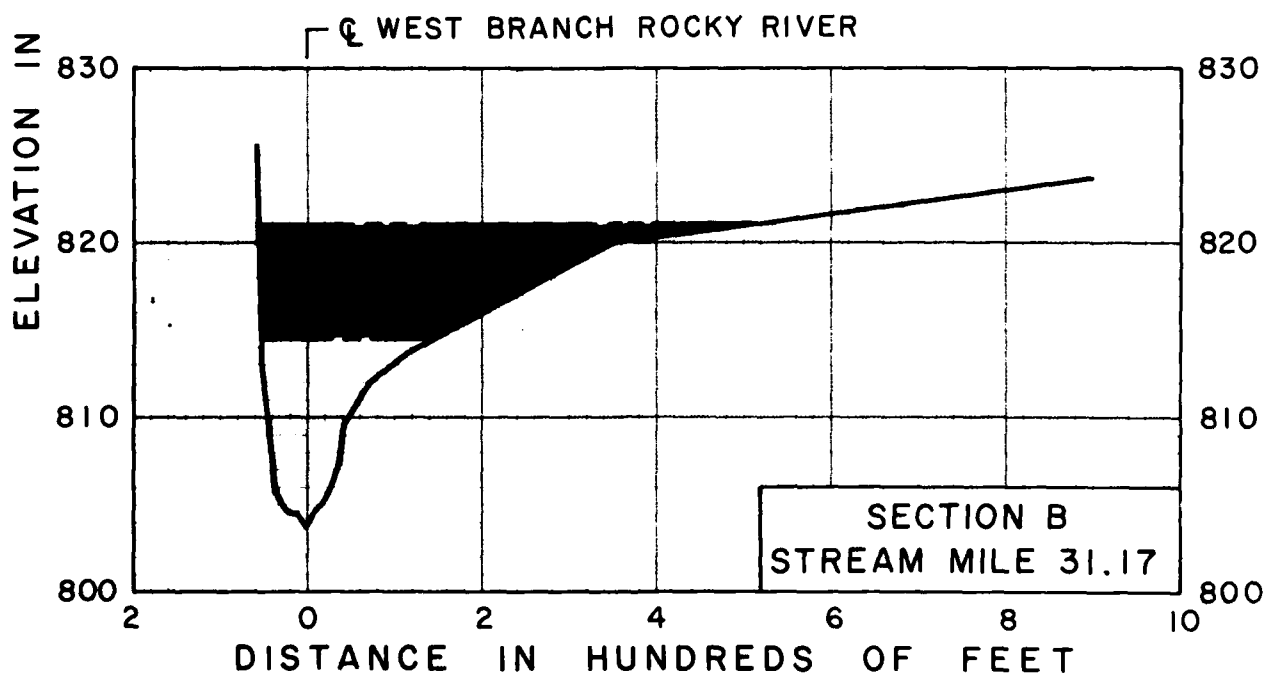
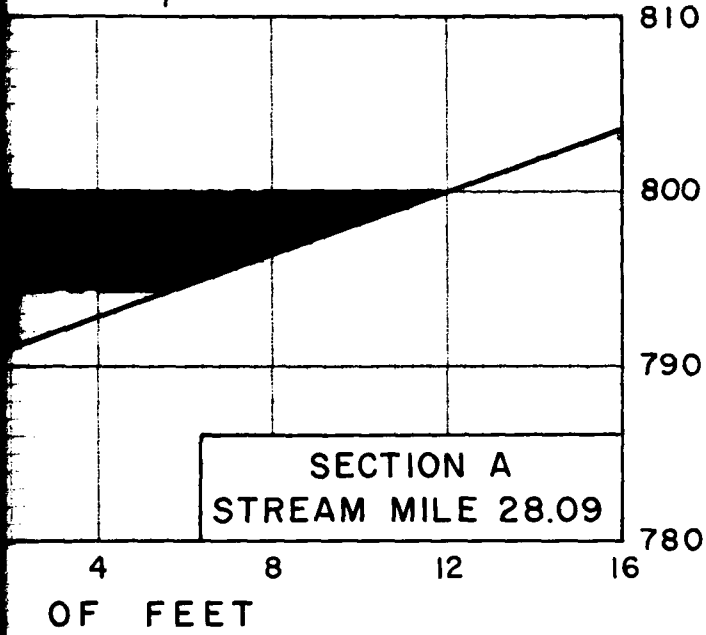
VALLEY CROSS SECTIONS ARE BASED ON ACTUAL FIELD SURVEYS, AND U. S. GEOLOGICAL QUADRANGLE MAPS.

VALLEY CROSS SECTIONS ARE LOOKING DOWNSTREAM AND ARE LOCATED ON PLATE 4.

**WEST BRANCH  
ROCKY RIVER  
MEDINA COUNTY, OHIO  
FLOOD PLAIN INFORMATION REPORT  
VALLEY CROSS SECTION  
A AND B**  
 U.S. ARMY ENGINEER DISTRICT, BUFFALO  
 OCTOBER 1971
