FLOOD PLAIN INFORMATION  
 WEST AND NORTH BRANCHES  
 ROCKY RIVER  
 MEDINA COUNTY

PREPARED FOR  
 OHIO DEPARTMENT OF NATURAL RESOURCES  
 DIVISION OF WATER  
 AND  
 TRI-COUNTY REGIONAL PLANNING COMMISSION

BY  
 OF ENGINEERS, U.S. ARMY  
 BUFFALO DISTRICT  
 OCTOBER 1971

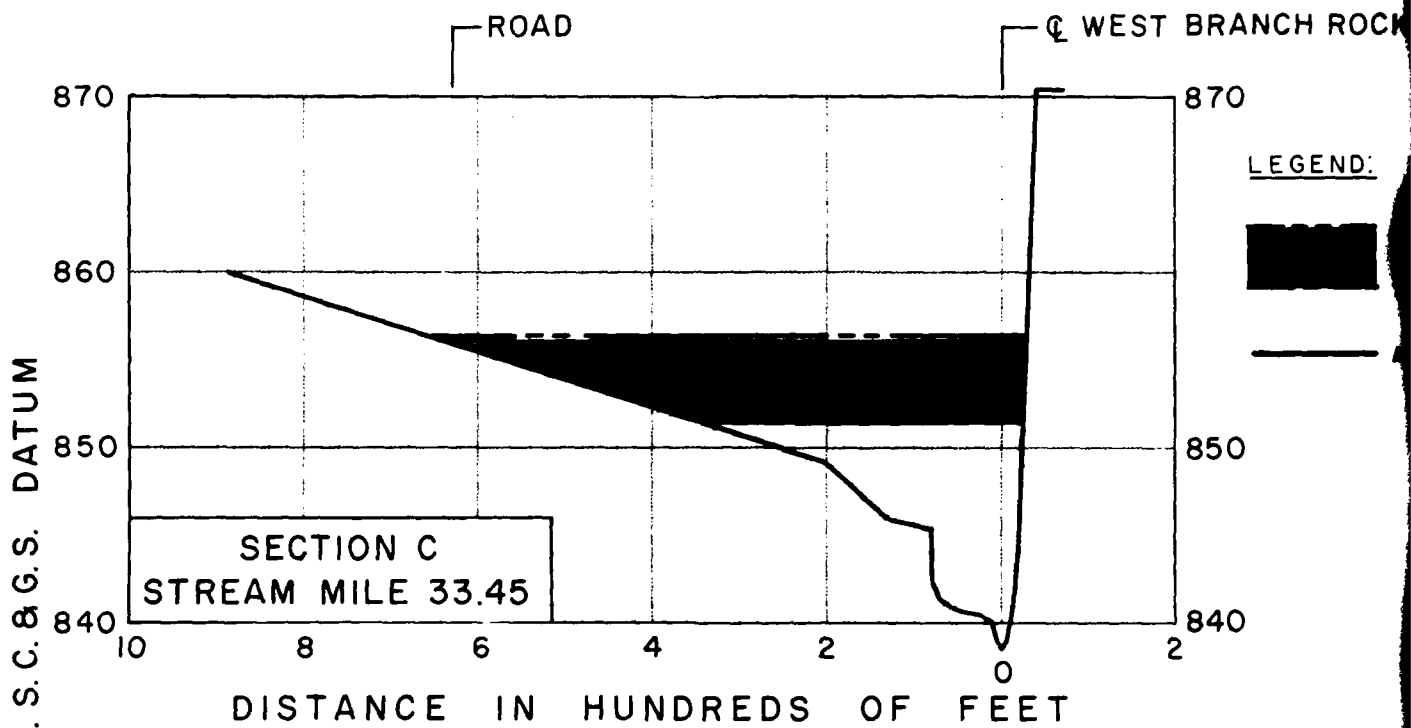
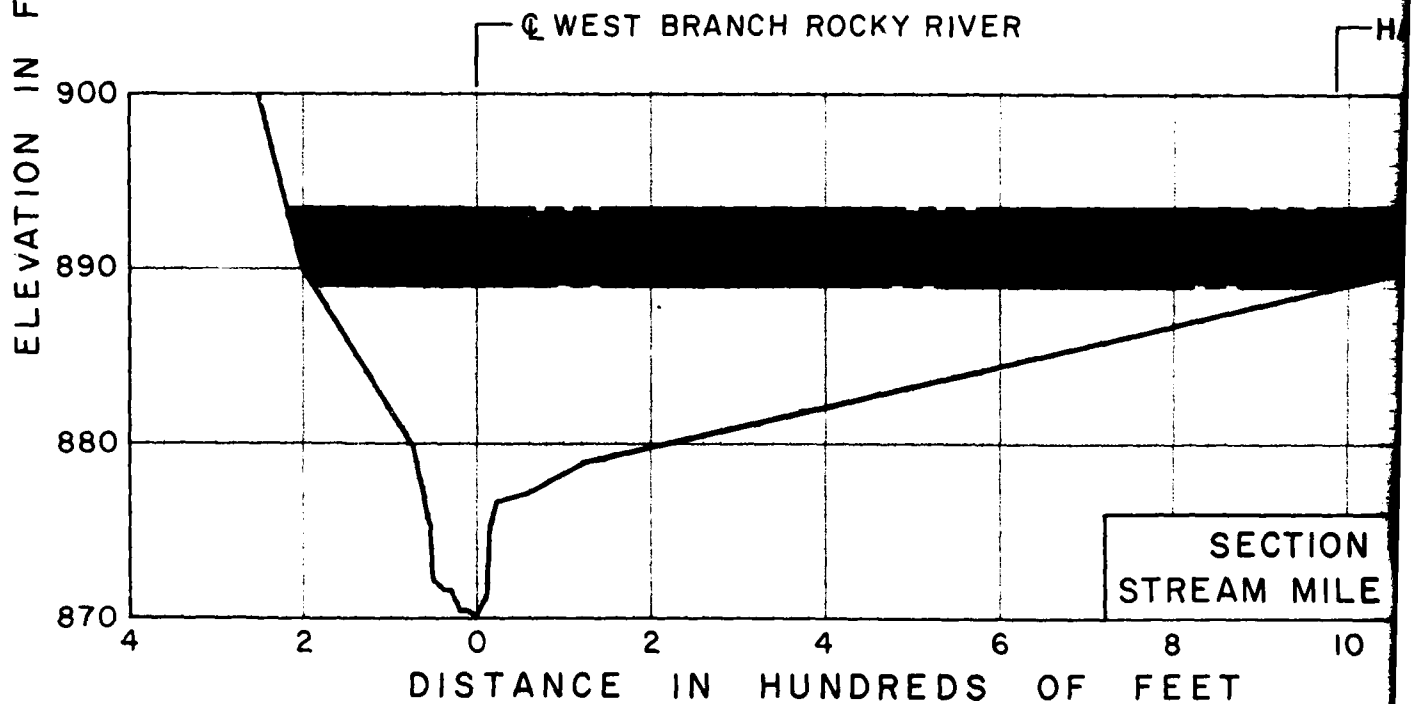
VALLEY CROSS SECTIONS ARE LOOKING DOWNSTREAM AND ARE LOCATED ON PLATE 5.

WEST BRANCH  
ROCKY RIVER  
MEDINA COUNTY, OHIO  
FLOOD PLAIN INFORMATION REPORT  
VALLEY CROSS SECTION  
C AND D  
U.S. ARMY ENGINEER DISTRICT, BUFFALO  
OCTOBER 1971

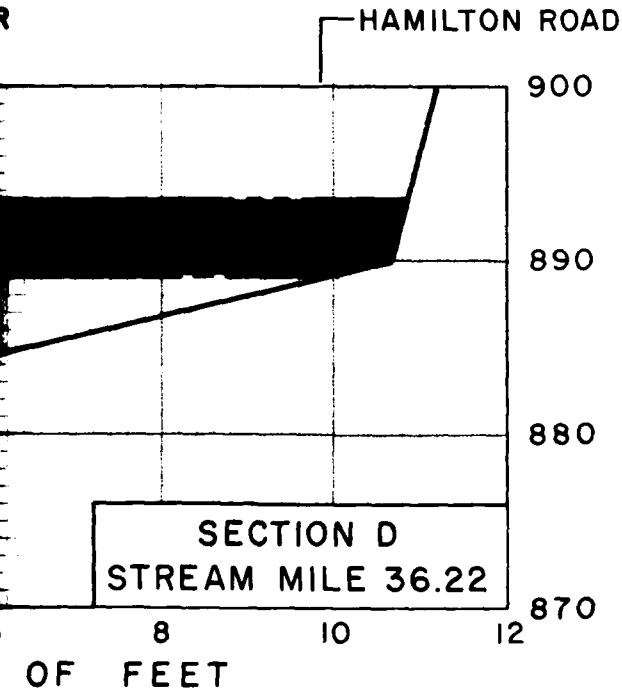
VALLEY CROSS SECTIONS ARE BASED ON ACTUAL FIELD SURVEYS, AND U.S. GEOLOGICAL QUADRANGLE MAPS.

Cross sections that are representative of the flood plain are shown on plates 11 through 13. The location of these cross sections are shown on plates 4 through 7. The depth and approximate limits of flooding for the Intermediate Regional and Standard Project Floods are indicated on these sections.

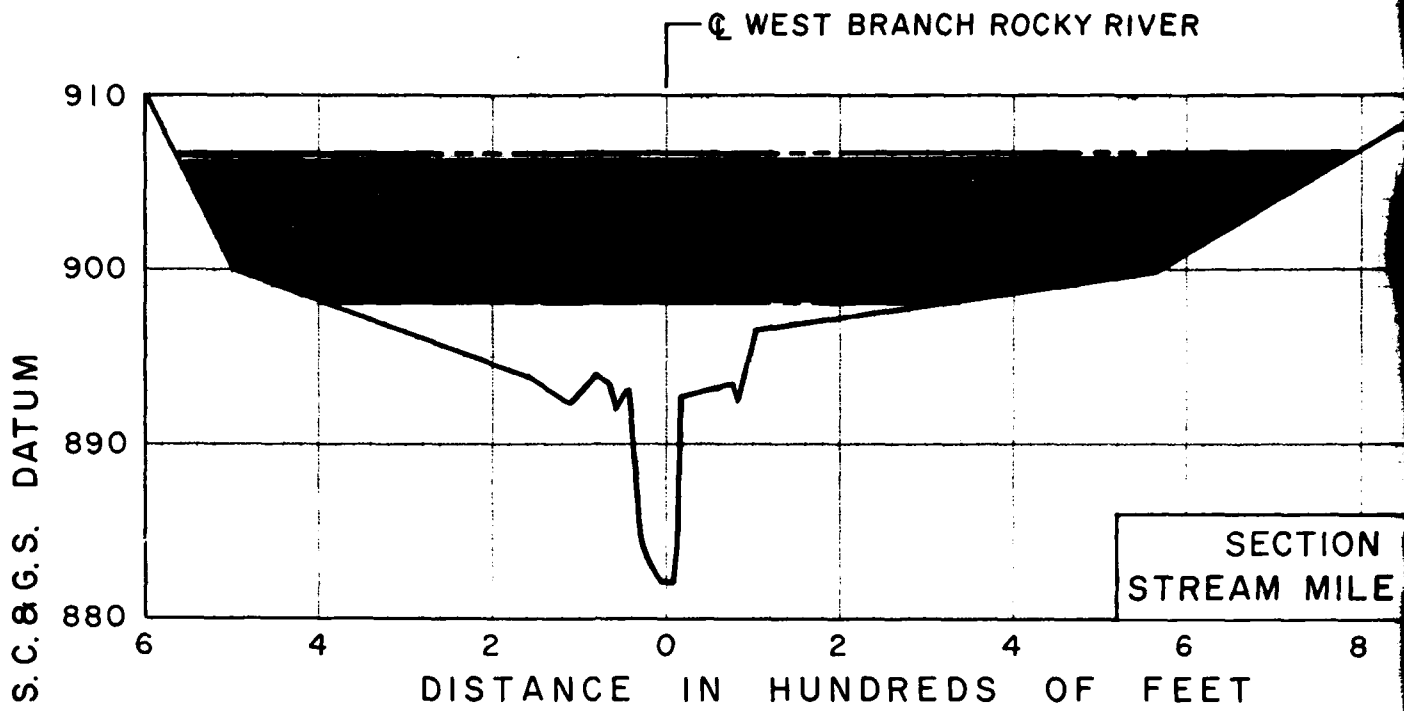
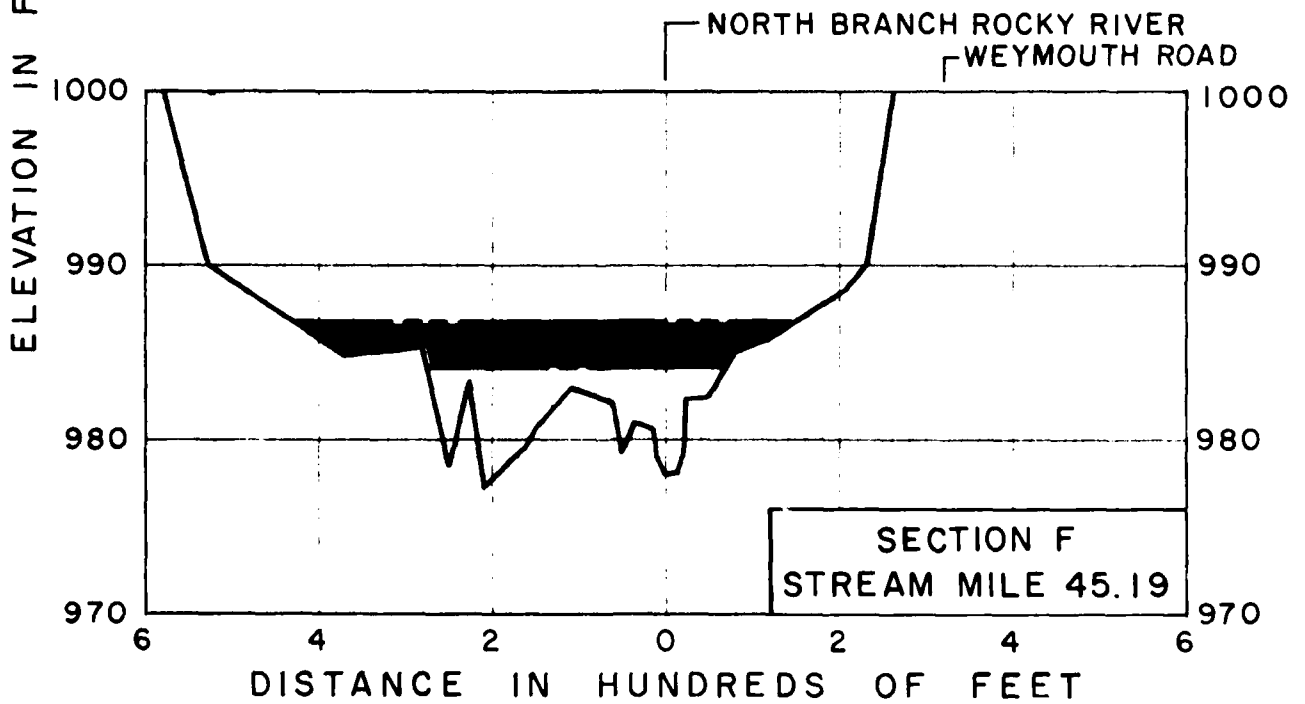
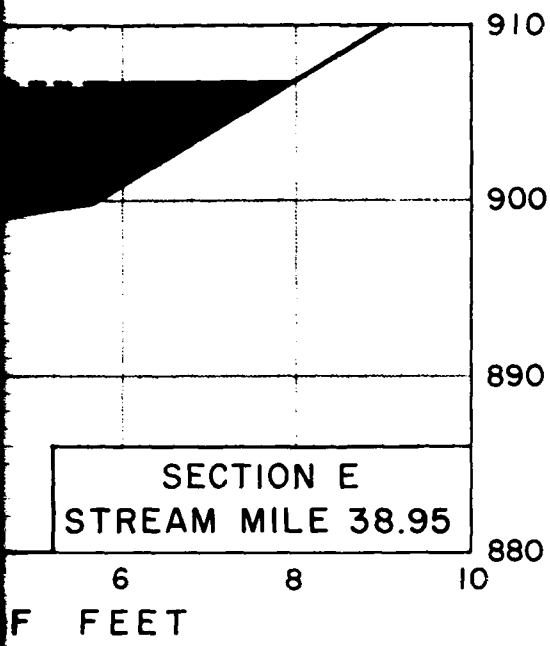
VALLEY CROSS SECTIONS ARE LOOKING DOWNSTREAM AND ARE LOCATED ON PLATES 6 AND 7

WEST AND NORTH BRANCH  
ROCKY RIVER  
MEDINA COUNTY, OHIO  
FLOOD PLAIN INFORMATION REPORT  
**VALLEY CROSS SECTION  
E AND F**  
U.S. ARMY ENGINEER DISTRICT, BUFFALO  
OCTOBER 1971
