# FLOOD PLAIN INFORMATION

## ONEIDA CREEK- NEW YORK

JULY 1973

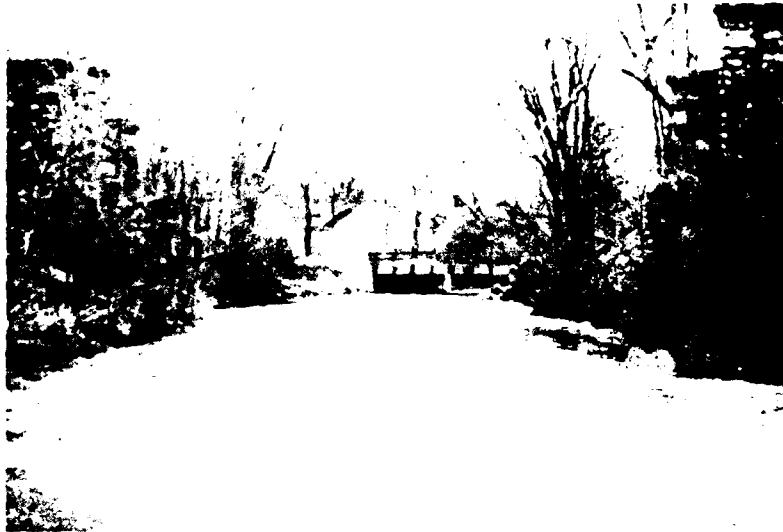
**FIGURE 1** - Railroad bridge abutments can cause stream to back up  
(Nov. 9, 1972)

Most of the 21 bridges which span Oneida Creek are obstructive to the flow. They tend to backup flood flows causing inundation of low lying areas upstream. The Erie Canal Crossing and the old New York Central Railroad Bridge near Sconodoa Street are two locations which are especially obstructive to even minor flood flows.

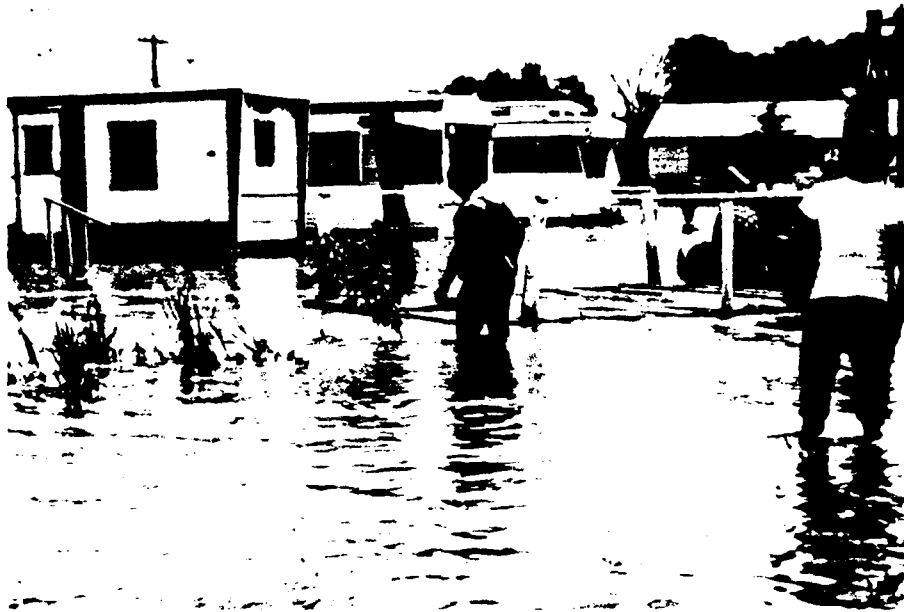
FIGURE 5 - Trailer park adjacent to Oneida Creek was flooded (June 23, 1972)

The Oneida Creek flood plain has been subjected to numerous instances when homes, streets and farm lands have been covered with flood water. Many times this flooding condition does no permanent damage but only creates temporary nuisance conditions. Minor floods such as this often go unrecorded and are accepted as a normal occurrence. Figures 5 to 8 show some of the flooding which has occurred in the past.

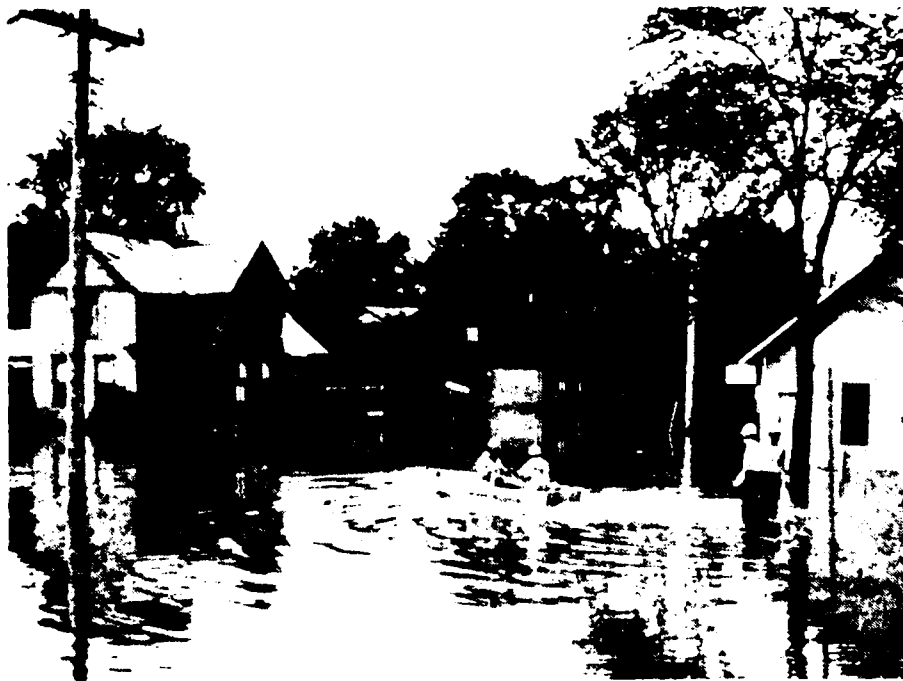
FIGURE 6 - Power crews used boats to shut off electrical power (June 23, 1972)

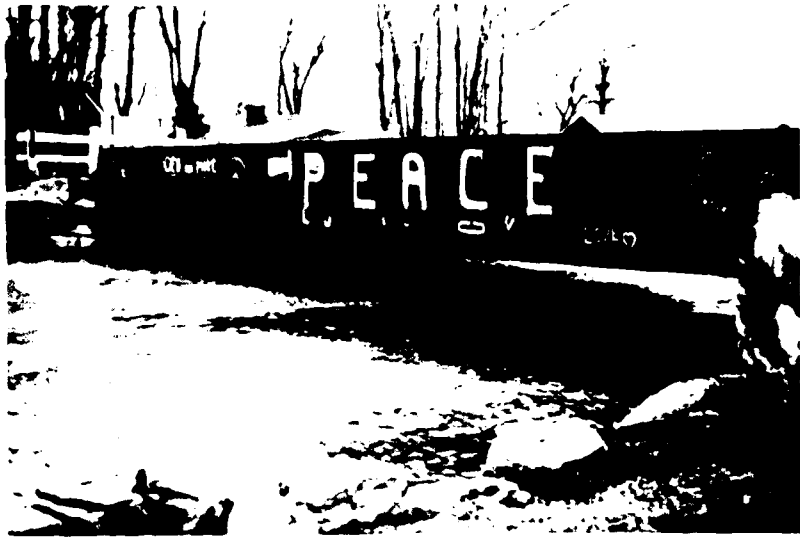
FIGURE 13 - Lake Road Bridge at mouth of Oneida Creek  
(Nov. 9, 1972)

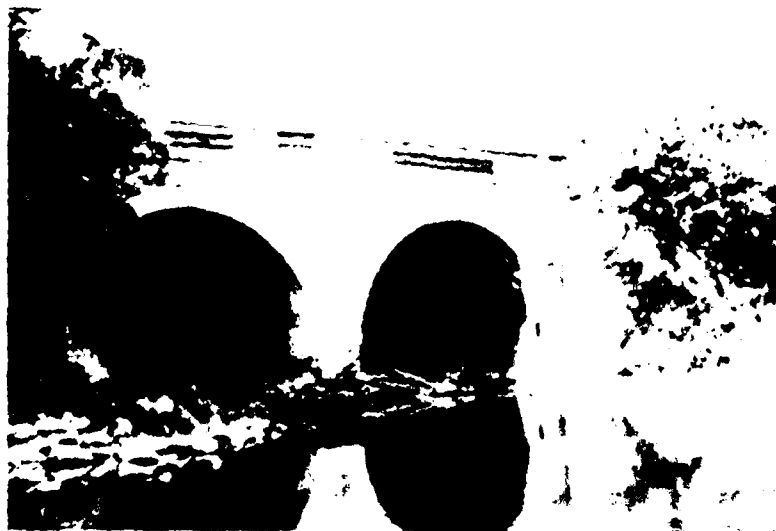
**FIGURE 16** Old New York Central Railroad Bridge. Arched openings would cause SFE flow to inundate much of the City of Oneida. (Sept. 27, 1973)
