FLOOD PLAIN ⁽²⁾ INFORMATION

EAST BRANCH CHAGRIN RIVER

LAKE AND GEAUGA COUNTIES, OHIO

PREPARED FOR
OHIO DEPARTMENT OF NATURAL RESOURCES
DIVISION OF WATER
BY
DEPARTMENT OF THE ARMY
CORPS OF ENGINEERS
BUFFALO DISTRICT
JULY 1976

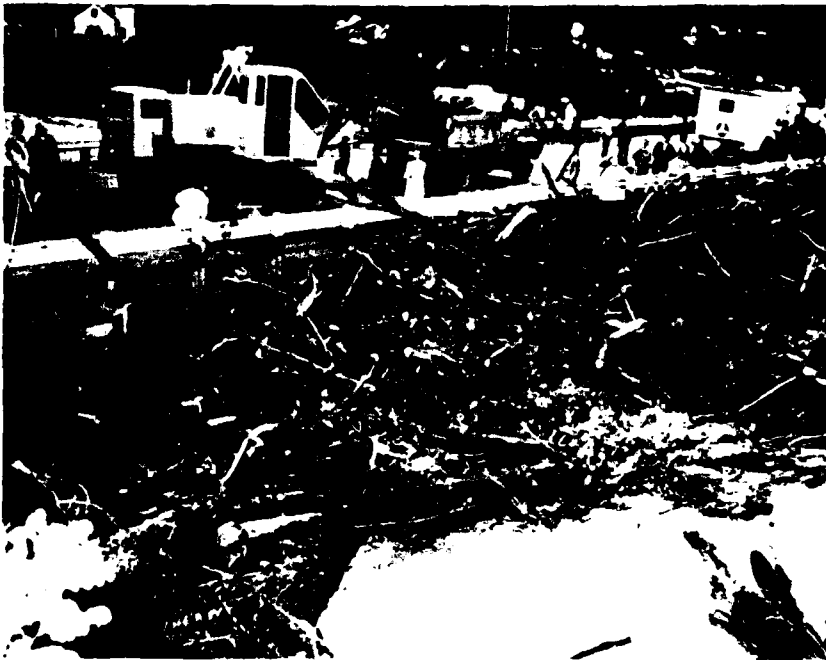
Cover Photo

Debris deposited by storm of June 1959, at the upstream face of the state route 306 bridge over the East Branch of the Chagrin River at Kirkland, Ohio. Photo courtesy Mrs. C. G. Simpson.

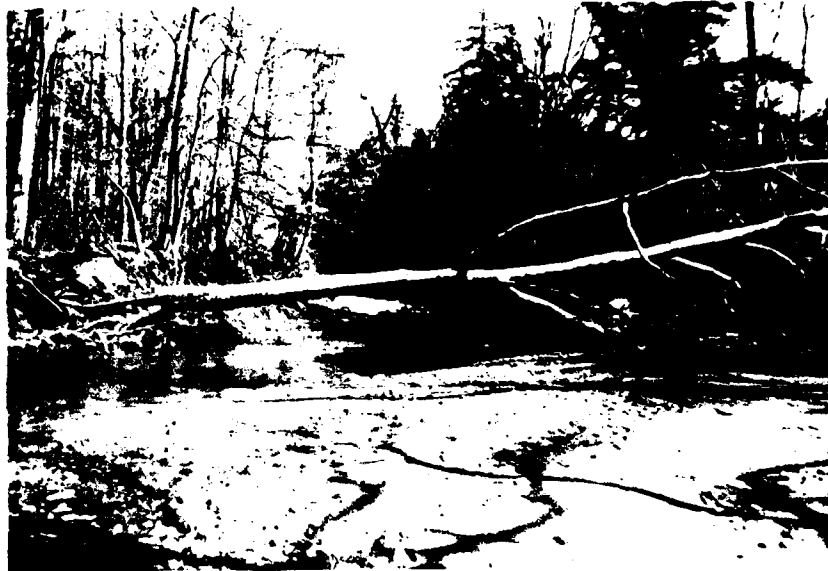
Figure 1 - An example of a natural obstruction to flow on the East Branch of the Chagrin River.

In general, obstructions restrict flood flows and result in overbank flows and unpredictable areas of flooding, destruction and damage to bridges and culverts. It is impossible to predict the degree or location of the accumulation of debris; therefore, for the purposes of this report, it was assumed that there would be no accumulation of debris at any of the bridges or culverts. Examples of obstructions to flow are shown in Figures 1 and 2. Photographs of typical bridges crossing are shown in Figures 3 through 13.

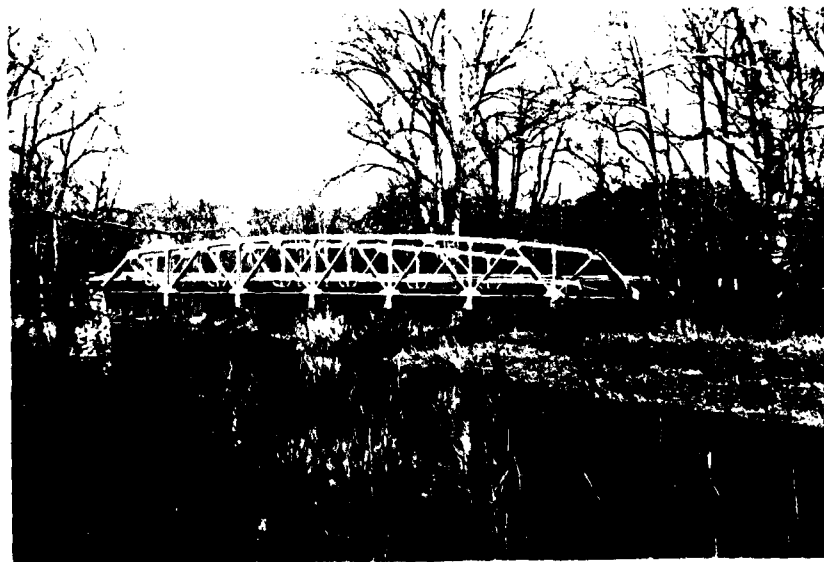
Figure 4 - Upstream view of the Markell Road Bridge at stream mile 2.52.

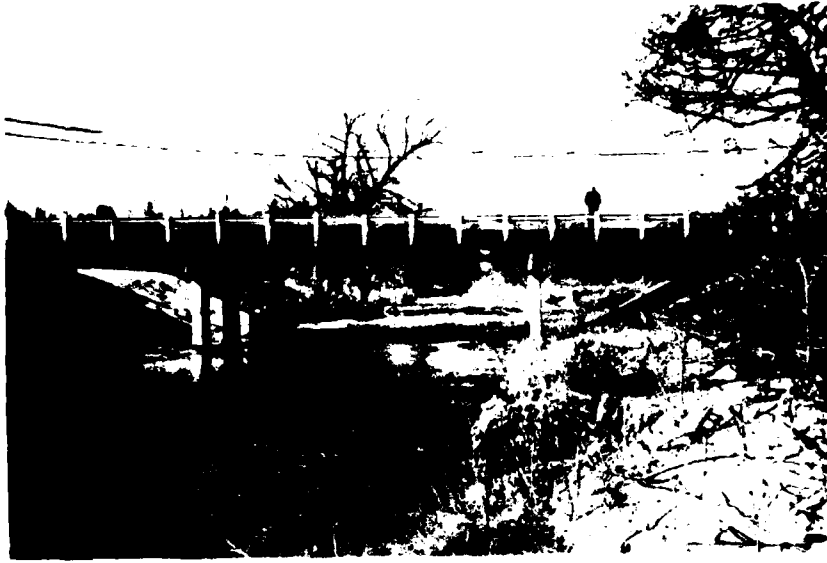
Figure 5 - Upstream view of the Route 306 Bridge at stream mile 2.97.

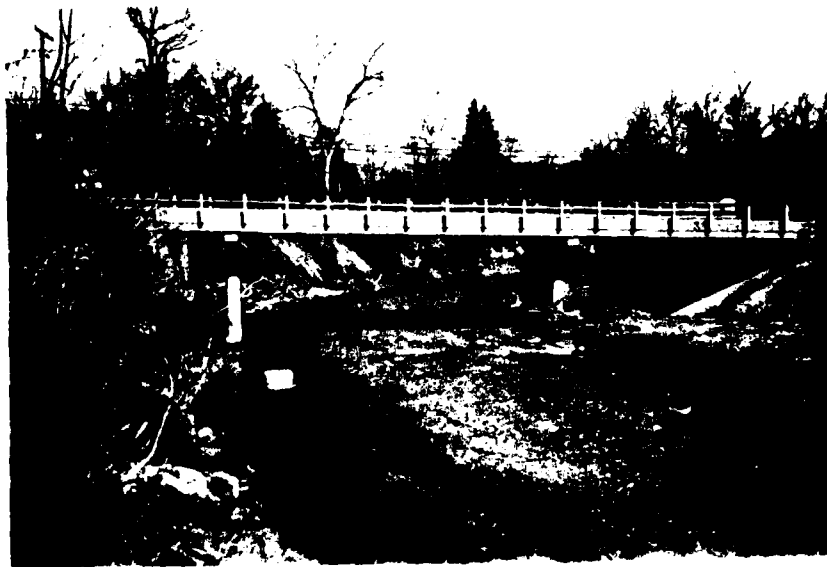
Figure 6 - Upstream view of the Chillicothe Road Bridge at stream mile 3.72.

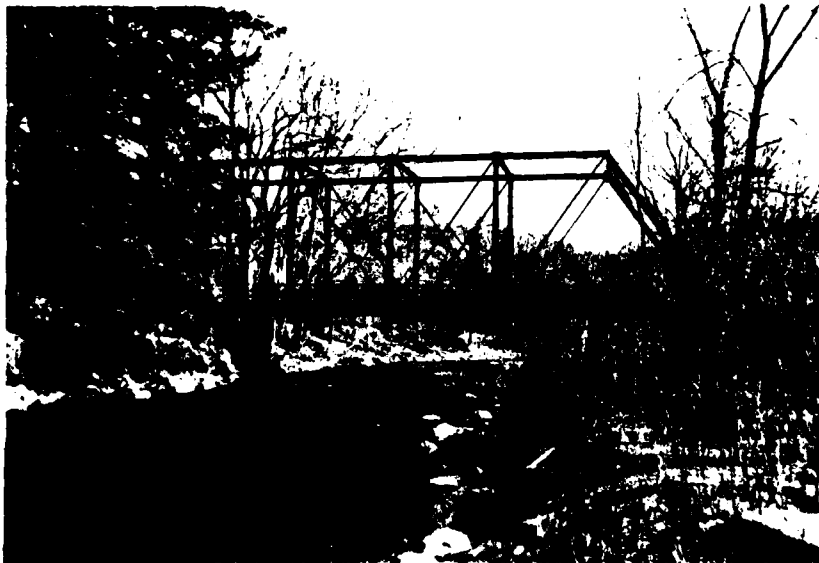
Figure 8 - Upstream view of Mitchells Mill Road Bridge at stream mile 10.81.

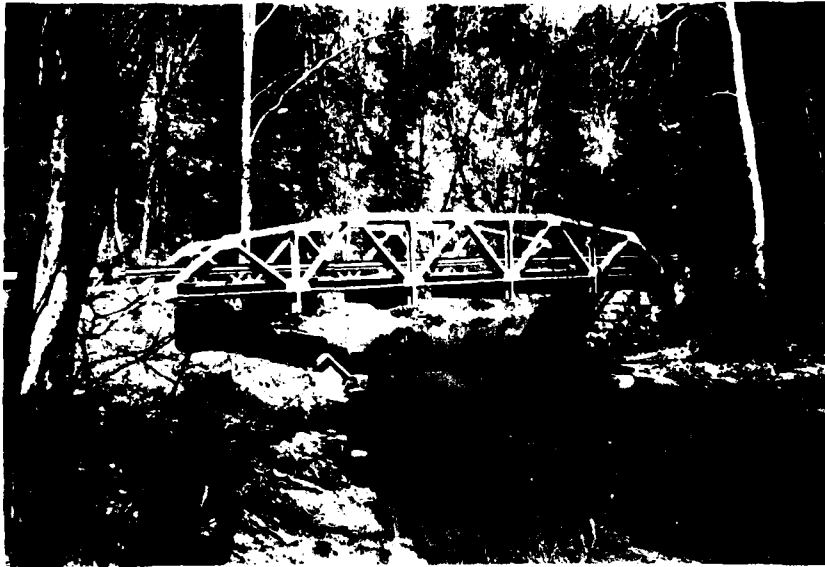
Figure 9 - Upstream view of Wisner Road Bridge at stream mile 12.01.

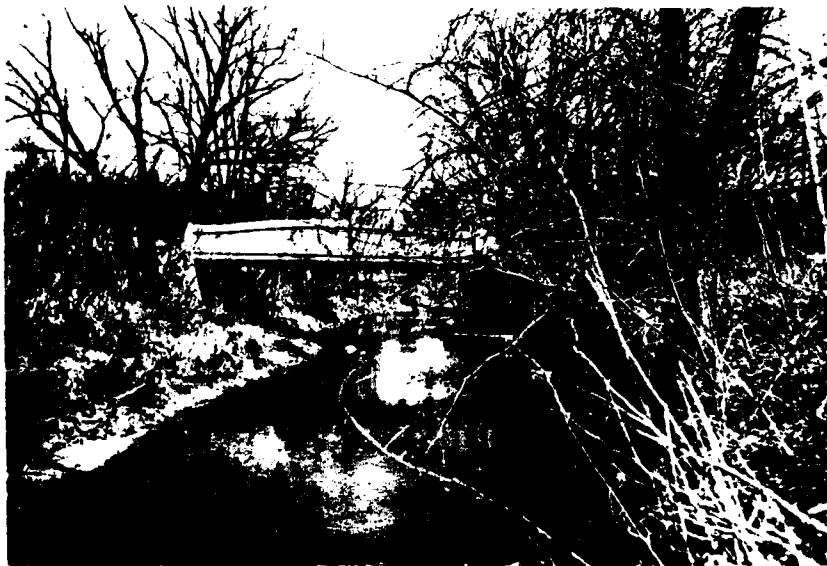
Figure 1 - Upstream view of the Eirtland-Chardon Road Bridge at stream mile 14.9.

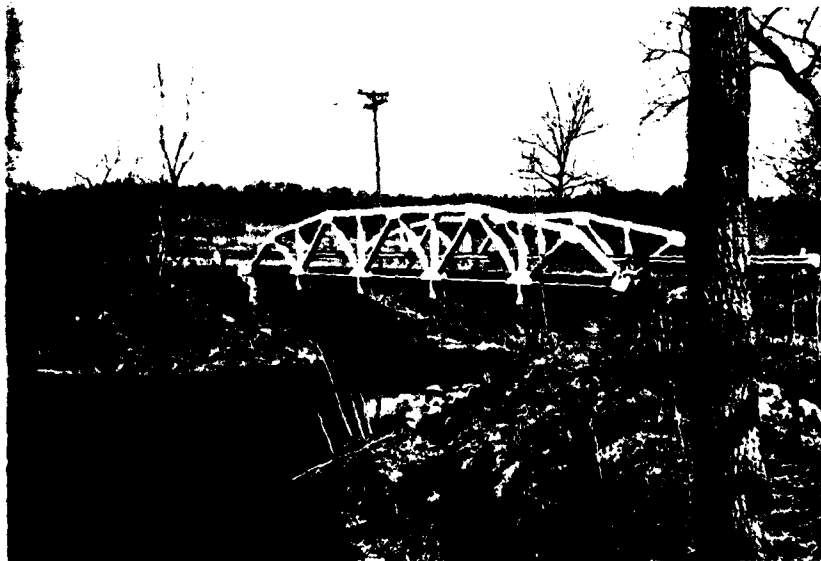
Figure 12 - Upstream view of the Heath Road Bridge at stream mile 15.00.

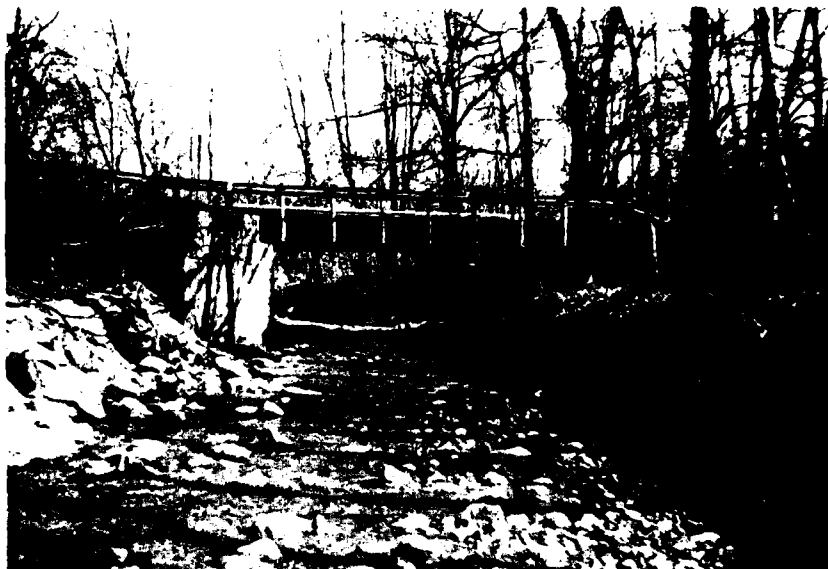
Figure 13 - Upstream view of the Sperry Road Bridge over Pierson Creek at stream mile 0.03.

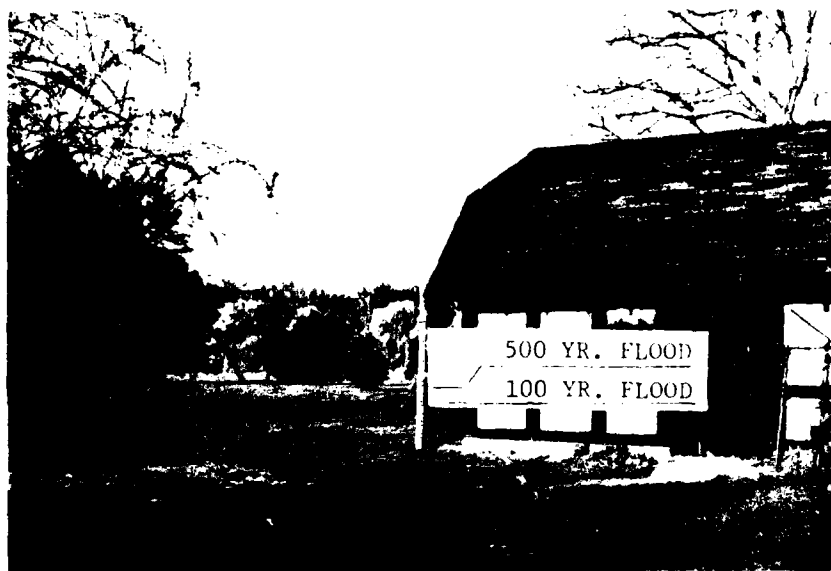
Figure 15 - The 100 and 500 year flood heights on the Pump house at the Kirtland Country Club at stream mile 2.12.
