| REPORT DOCUMENTATION PAGE | | READ INSTRUCTIONS<br>BEFORE COMPLETING FORM |
|---|---|---|
| 4. TITLE (and Subtitle)<br>Flood Plain Information, Cuyahoga River, Akron<br>to Summit-Portage County Line, Ohio. | | 5. TYPE OF REPORT & PERIOD COVERED<br><b>(1) Final</b> |
| 9. PERFORMING ORGANIZATION NAME AND ADDRESS<br>U.S. Army Engineer District, Buffalo<br>1776 Niagara Street<br>Buffalo, New York 14207 | | 8. CONTRACT OR GRANT NUMBER(s)<br><b>(1) 71</b> |

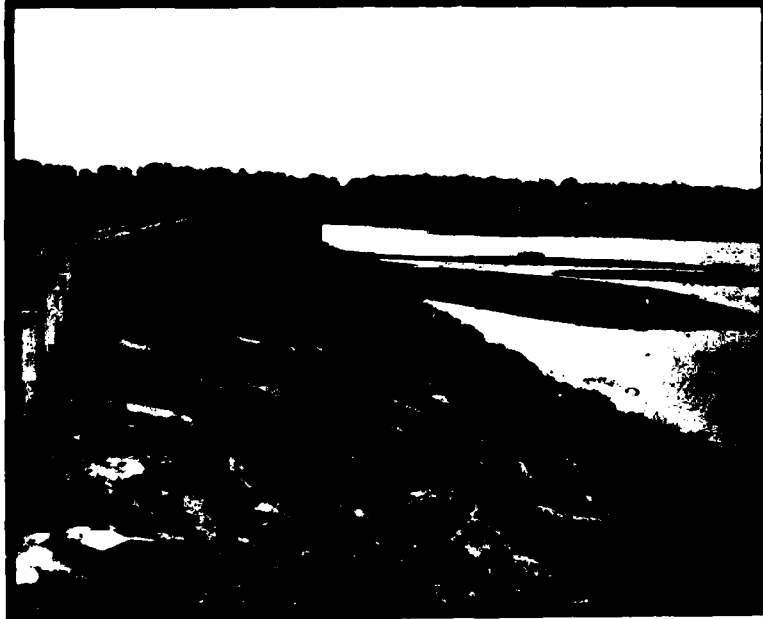
Figure 3 - Upstream face of dam at LaDue Reservoir  
in Geauga County.

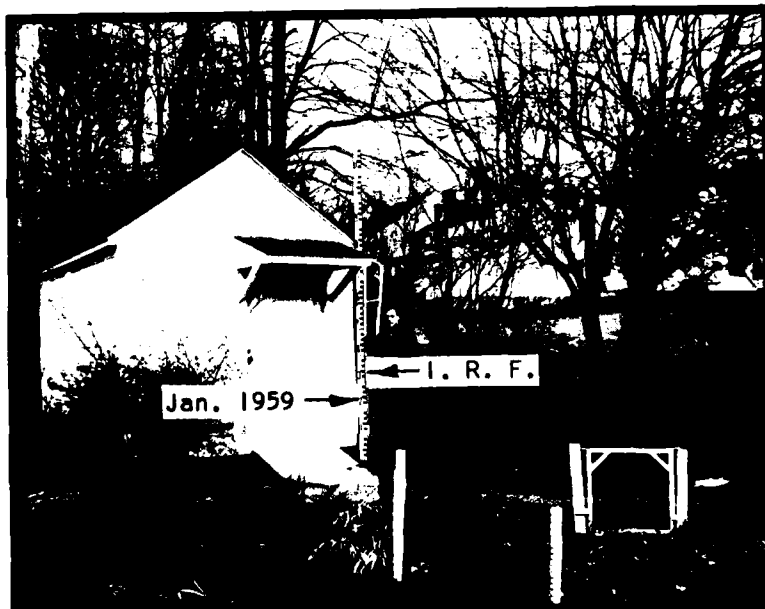
Figure 34 - Arrows indicate the heights of the Intermediate Regional and the January 1959 floods along South Park Drive in the Village of Silver Lake, stream mile 47.95.

The approximate heights of the Standard Project Flood, the Intermediate Regional Flood, and the January 1959 flood at selected sites are shown in figures 29 through 35.
