FLOOD PLAIN INFORMATION

PIKE CREEK

NEW CASTLE COUNTY,
DELAWARE.

DECEMBER 1975

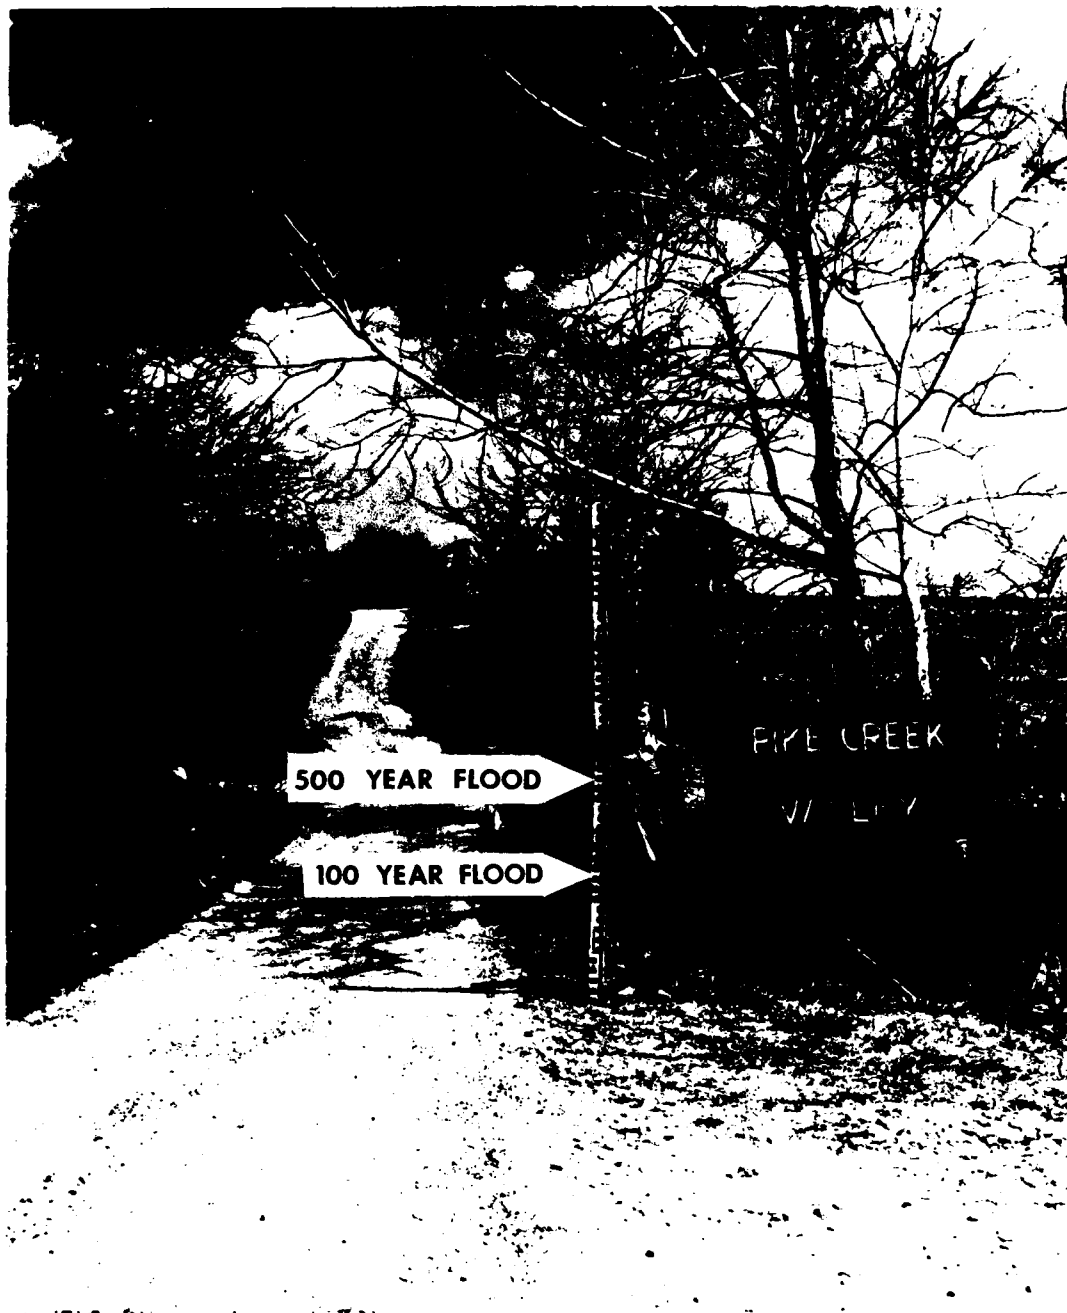
FIGURE 1 - Possible future flood heights at a Private Road Bridge (Mile 3.02) over Pike Creek.

Photographs, possible future flood heights — The levels that the 100-Year and 500-Year Floods are expected to reach at various locations along Pike Creek are indicated on the following photographs.

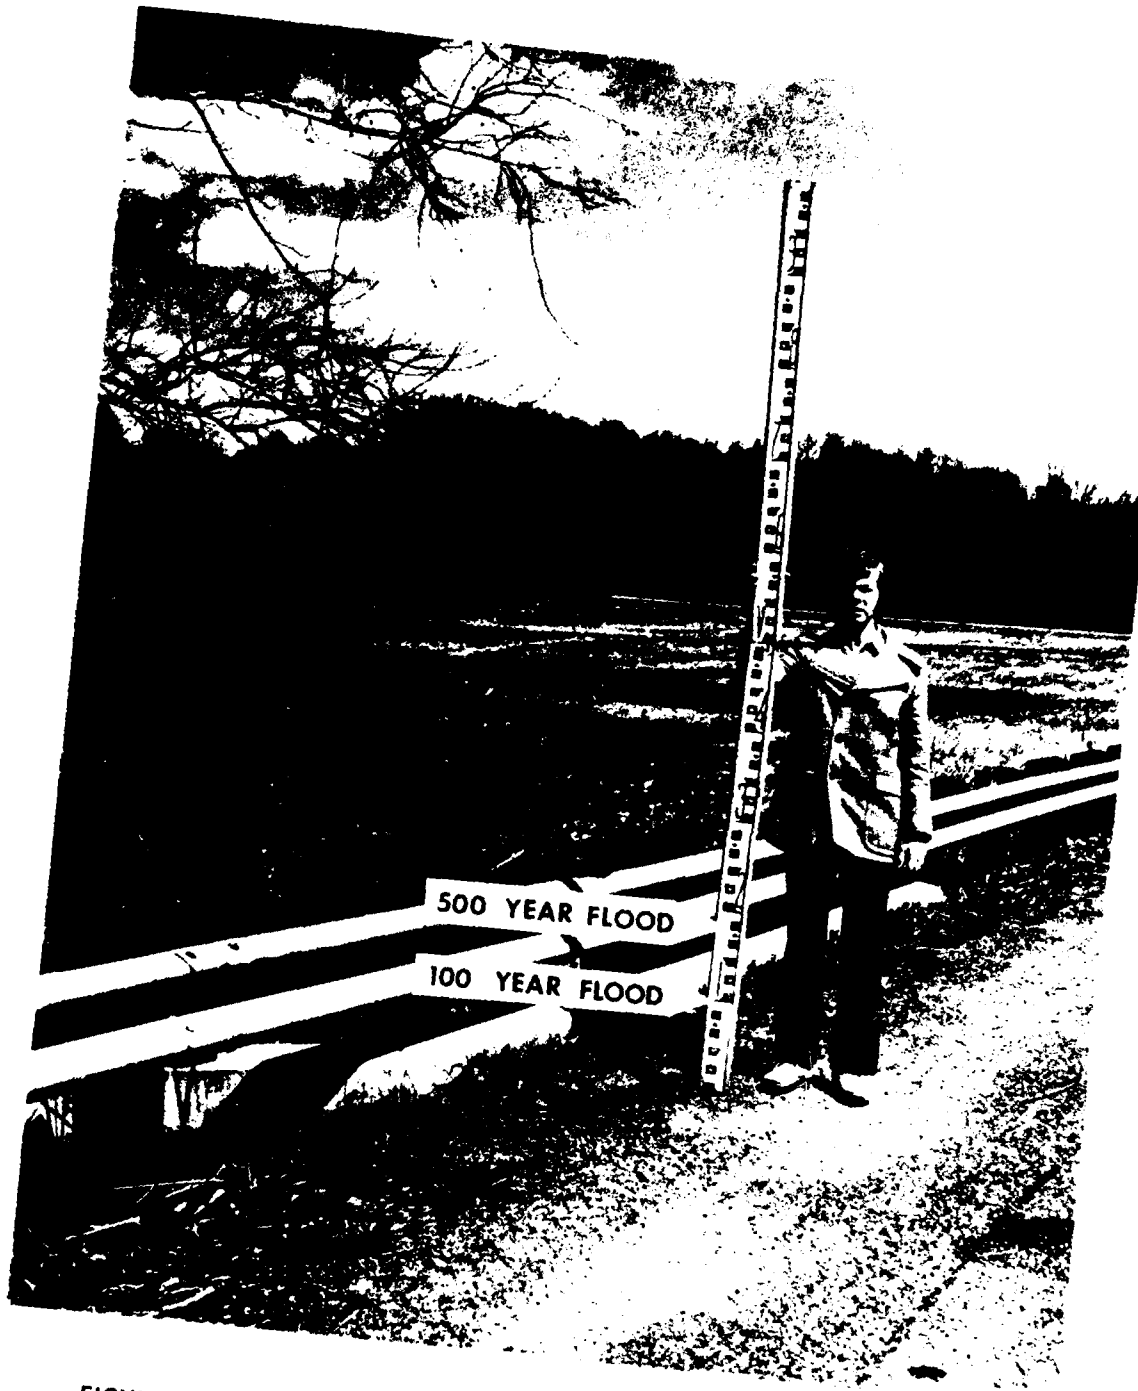
FIGURE 3 - Possible future flood heights at the Delaware Route 72 Bridge over Pike Creek.
