# FLOOD PLAIN INFORMATION

## RED CLAY CREEK

### NEW CASTLE COUNTY DELAWARE

CORPS OF ENGINEERS, U. S. ARMY  
PHILADELPHIA DISTRICT  
FEBRUARY 1971

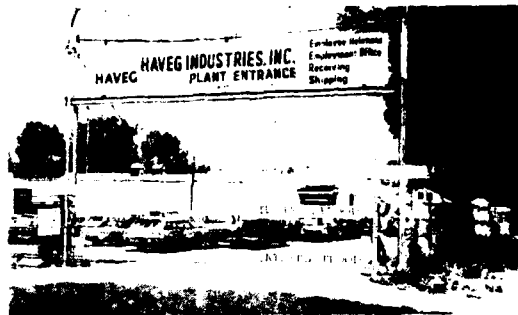
Photograph 1 - Possible future flood heights at the Haveg Industries, Inc., Plant.

The Haveg Industries, Inc., suffered damages to their electrical equipment in Building 24. Many of their electric motors had to be dismantled and baked, while others were rewound. Damages also included a full day's lost time cleaning up and several days' work at 40% production.

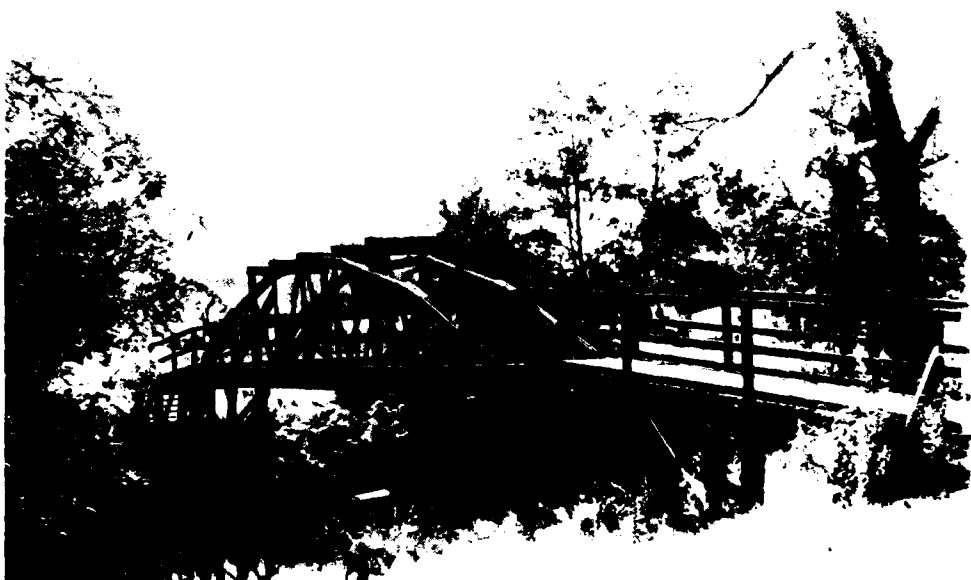
Figure 4.--BRIDGES ACROSS RED CLAY CREEK

Top view shows the downstream view of the Lancaster Pike reinforced concrete bridge. The U.S.G.S. stream gage is located on the upstream side at Mile 5.0. Bottom view shows the wooden foot bridge near the Greenbank Mill at Mile 2.8.
