THE USE OF ACOUSTIC EMISSION FOR DETECTION OF  
ACTIVE CORROSION AND DEGRADED ADHESIVE BONDING IN AIRCRAFT STRUCTURE

John Rodgers, 1Lt USAF  
Steven Moore  
Sacramento Air Logistics Center  
(SM/ALC/MEET)  
McClellan AFB, CA.

Nov 1975

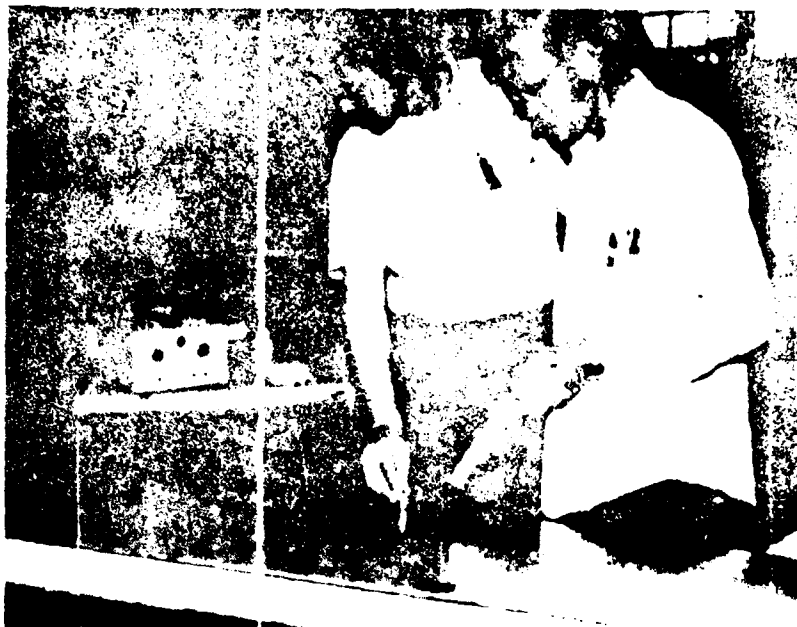
Figure 5. Acoustic emission hand scan technique using AETC Model 201 Signal Processor and hot air gun heating.

Depot procedures we have developed indicate that hand-held sensor monitoring and observing the event indicator light is adequate for most corrosion inspection applications. An operator can be trained in a relatively short time to hold the sensor steady enough not to cause emission activity by hand movements. The standard presently used is one data event per second for 15 seconds or longer minimum to indicate corrosion activity. Inspection intervals are from two to six inches, depending on the part configuration and the degree of mapping desired. Figure 5 demonstrates the manual technique currently used.
