# NAVAL POSTGRADUATE SCHOOL

## THESIS

FATIGUE CHARACTERISTICS AND MICROSTRUCTURAL  
ANALYSIS OF THERMOMECHANICALLY-PROCESSED,  
HIGH-MAGNESIUM ALUMINUM-MAGNESIUM ALLOY.

June 1981

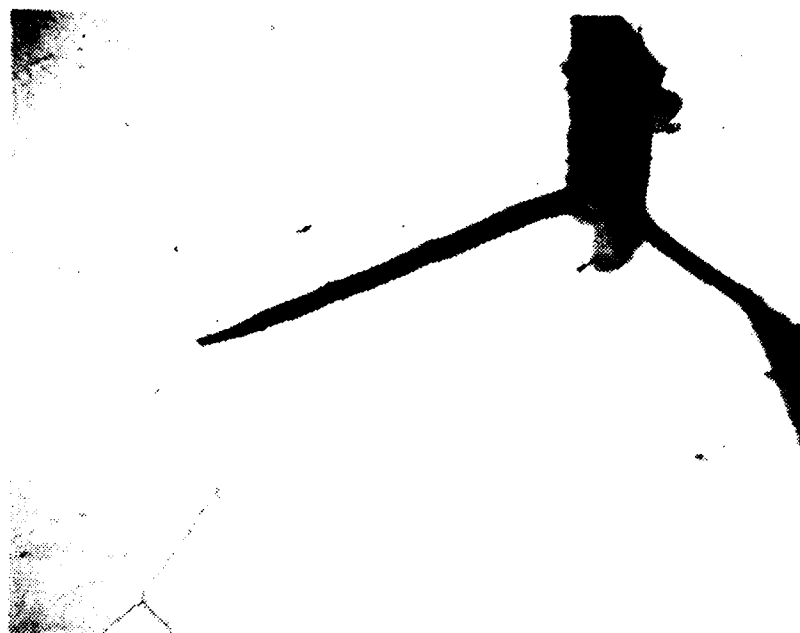
FIGURE 7. Regions of intergranular cracking in billets of Al-8.14 wt pct Mg-0.40 wt pct Cu solution treated and water-quenched. Cracking occurred in both billets after 2 passes in rolling mill (rolling temperature 300°C)

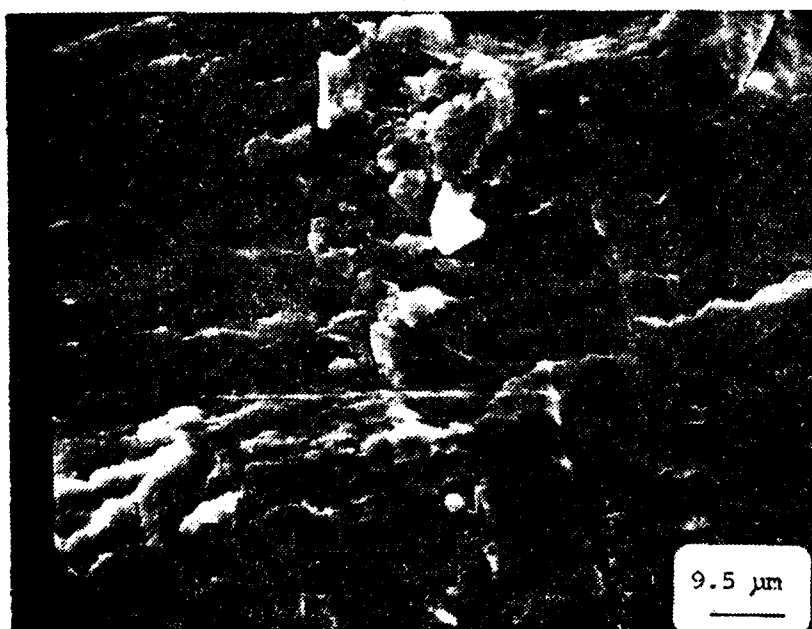
FIGURE 27. (a) Regions of Stage II crack growth in a specimen of Al-10.2 wt pct Mg oil-quenched from homogenization temperature which fractured after  $1.81 \times 10^5$  cycles: (b) overload region of the same specimen (SEM x 1050)

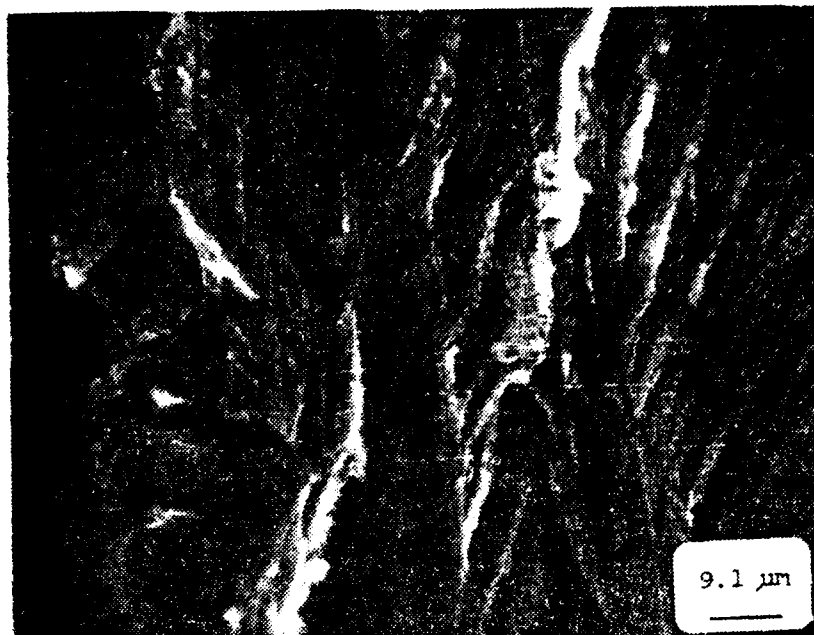
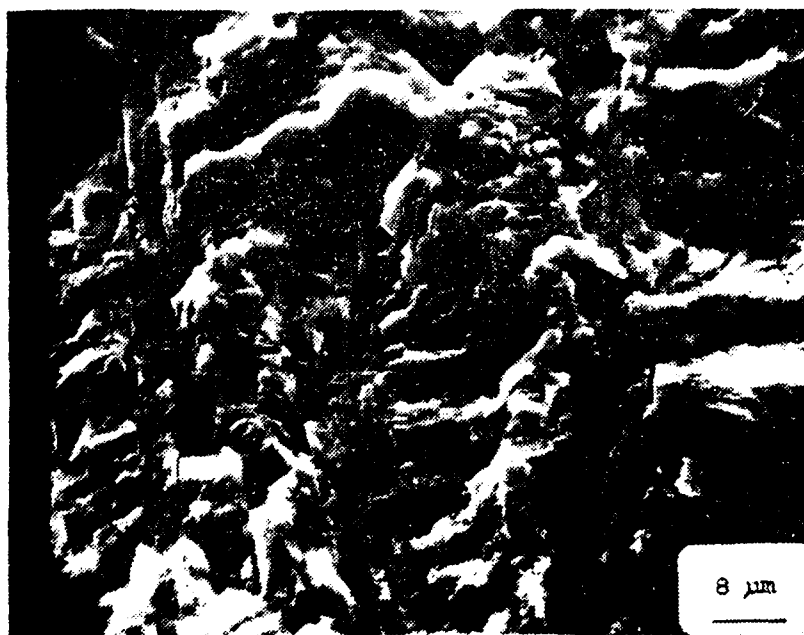
FIGURE 30. (a) Fully developed Stage II crack growth on same specimen shown in Figure 29; magnification 1100x SEM; (b) Stage III fracture appearance; magnification 1250x SEM

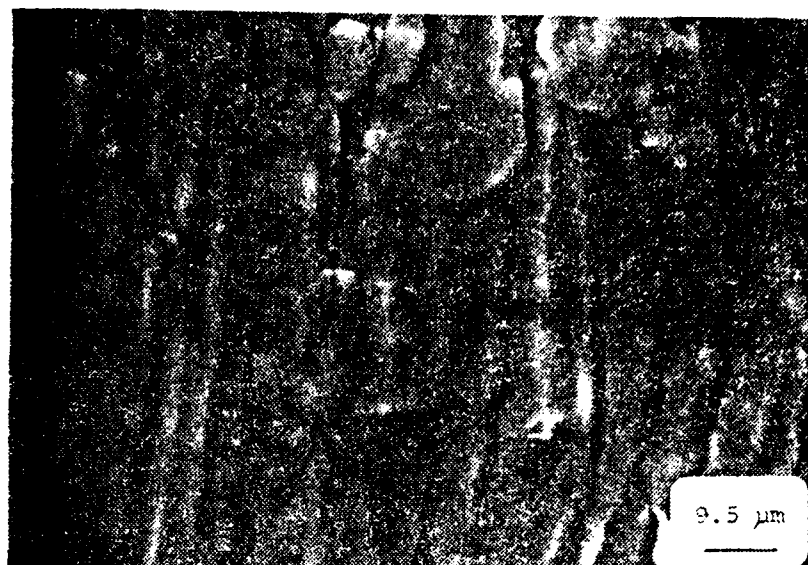
FIGURE 35. SEM fractographs of Al-10.2 wt pct Mg, solution treated, water-quenched and warm-rolled at 300°C, in which fracture occurred after 3400 cycles: (a) Stage II crack growth x1050; (b) overload region x1050

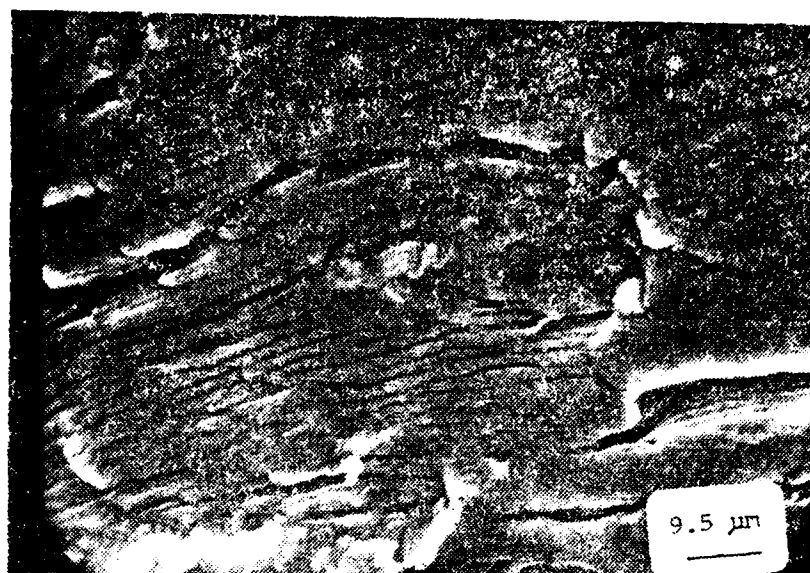
FIGURE 38. SEM fractographs of Al-10.2 wt pct Mg, solution treated, water-quenched and warm-rolled at 300°C, in which failure occurred after  $4.2 \times 10^6$  cycles: (a) Stage II crack growth x1050; (b) Stage III crack growth x1050

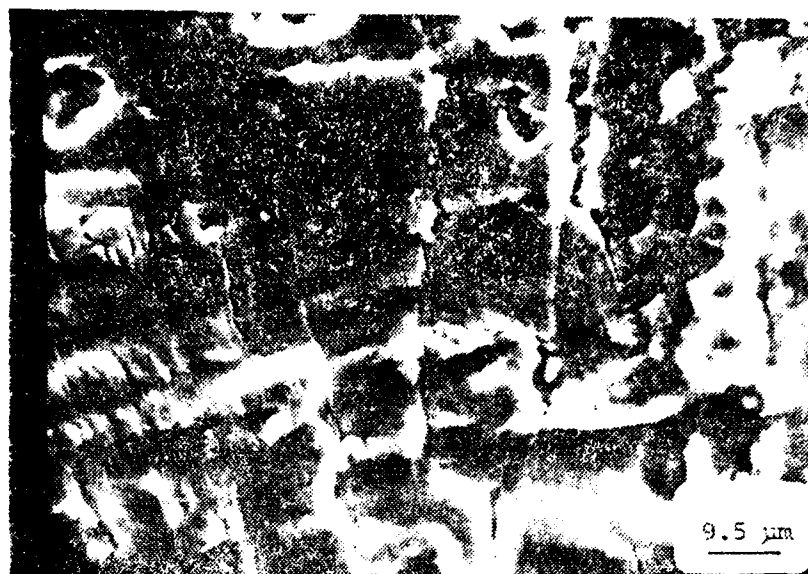
FIGURE 42. SEM fractographs of a specimen of Al-8.14 wt pct Mg-0.40 wt pct Cu solution treated, oil-quenched and warm-rolled at 300°C, in which failure occurred after 110200 cycles; (a) Stage II crack growth x1050; (b) Stage III crack growth x1050

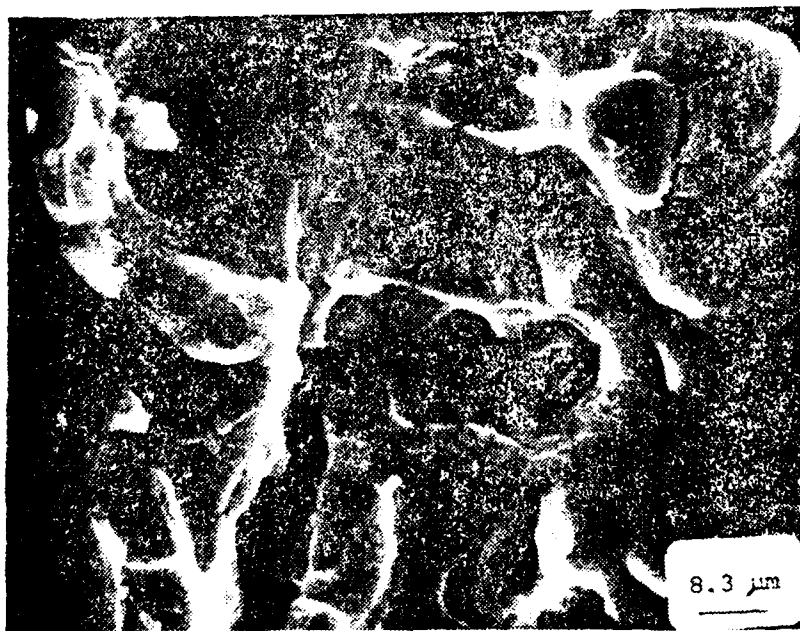
FIGURE 46. SEM fractographs of Al-8.14 wt pct Mg-0.40 wt pct Cu, solution treated, water-quenched and warm-rolled at 300°C; in which failure occurred after 2700 cycles: (a) Stage II crack growth x1200; (b) Stage III crack growth x1200

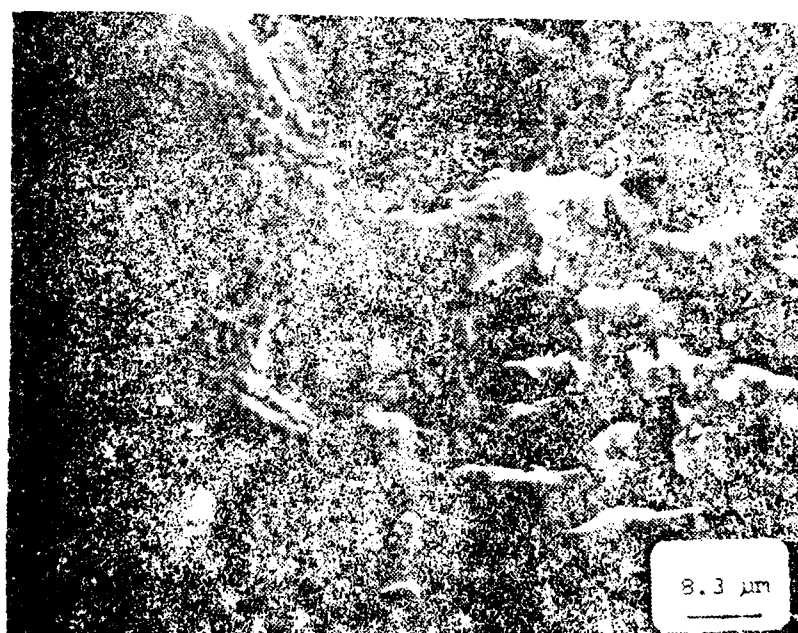
FIGURE 48. SEM fractographs of Al-8.14 wt pct Mg-0.40 wt pct Cu, solution treated, water-quenched and warm-rolled at 300°C, in which failure occurred after  $4.8 \times 10^6$  cycles: (a) Stage II crack growth x1200; (b) Stage III crack growth x1200
