THESIS

THE EFFECTS OF JET EXHAUST BLAST IMPINGEMENTS  
ON GRAPHITE-EPOXY COMPOSITES

June 1981

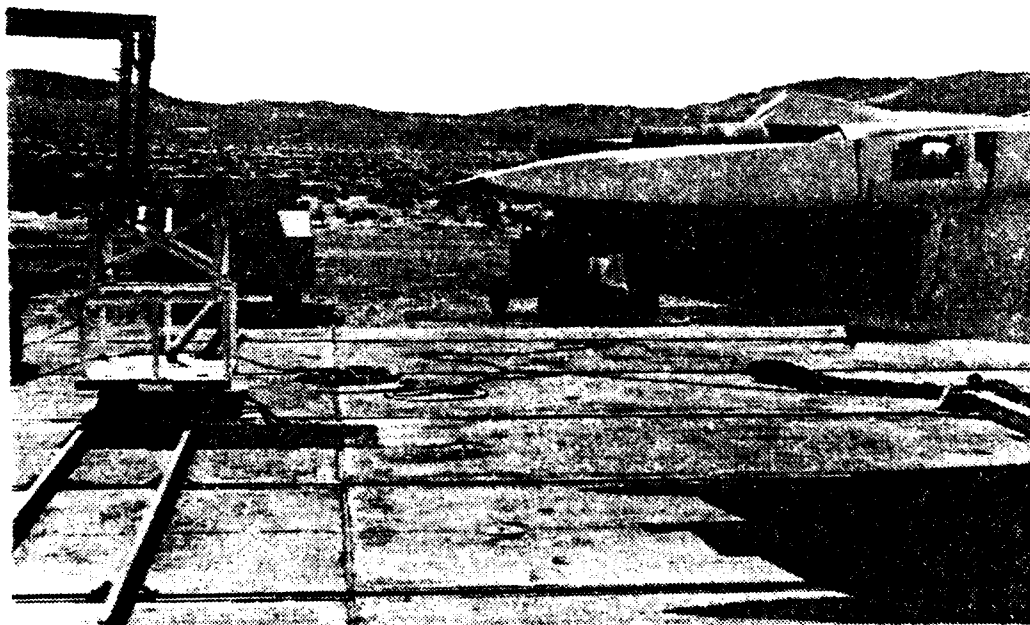
FIGURE 7: POSITION OF WINGBOX BEFORE AND AT CONCLUSION OF EXPOSURE TO JET BLAST

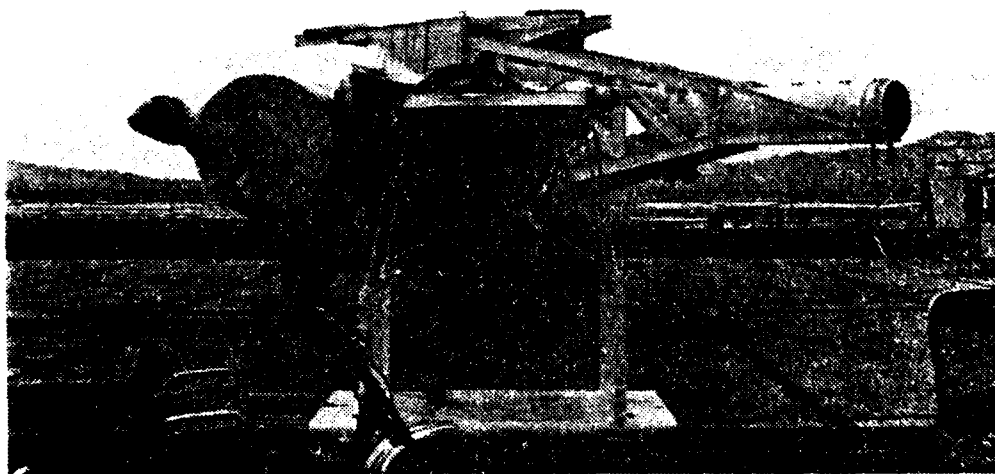
FIGURE 9: LOCATION OF WINGBOX DURING EXPOSURE TO JET BLAST (HEAD VIEW)

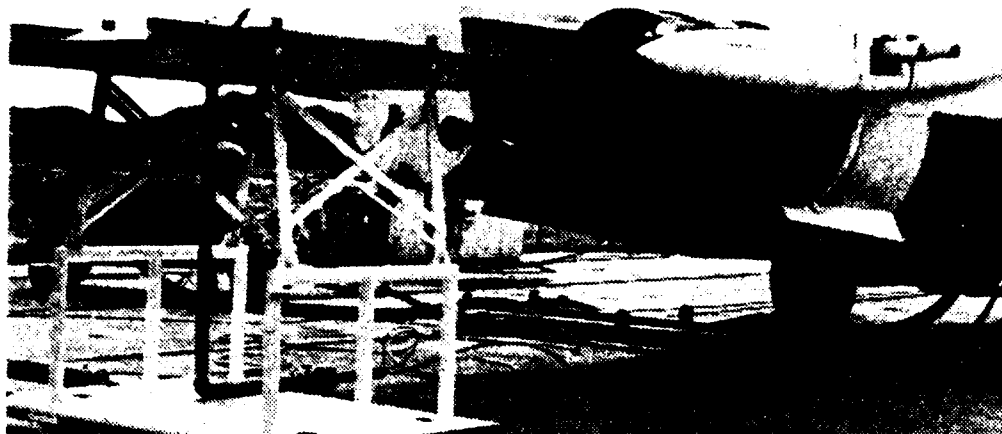
FIGURE 10: LOCATION OF WINGBOX DURING EXPOSURE TO JET BLAST  
(VIEW 45° ASPECT)
