# STRUCTURAL STABILITY EVALUATION LEECH LAKE DAM

Carl E. Pace

September 1981

Final Report

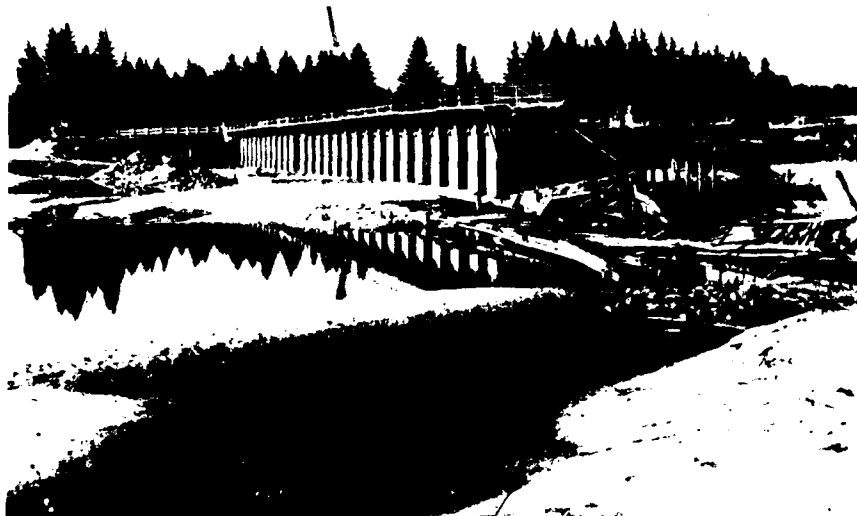
Figure 6. Failure of 14 piers and left abutment  
at Leech Lake Dam

8. The cofferdam failure occurred when a faulty, unapproved cofferdam plan used by the contractor resulted in failure of the sheet-pile cofferdam at pier 26 during dewatering. The cofferdam failure initiated a series of events that resulted in the failure (Figure 6) of the structure between pier 27 and the north abutment. A breach over 100 ft wide, with scour to a depth of about 20 ft occurred, toppling piers 28 through 38 into the scour hole and causing the loss of the pool. The contract work was allowed to continue in the undamaged portion of the structure. The area between the right abutment and pier 21 was completed according to the basic plan with minor modifications.

9. The area of failure beyond pier 25 was redesigned, and a new reinforced concrete T-wall abutment was constructed in the approximate location of pier 26. The old left abutment and pier 39 were removed, and an earth fill was used to replace the lost portion of structure. New steel sheet pile was driven 10 ft upstream from center line to el 1256. All unsuitable materials were removed from the scour hole prior

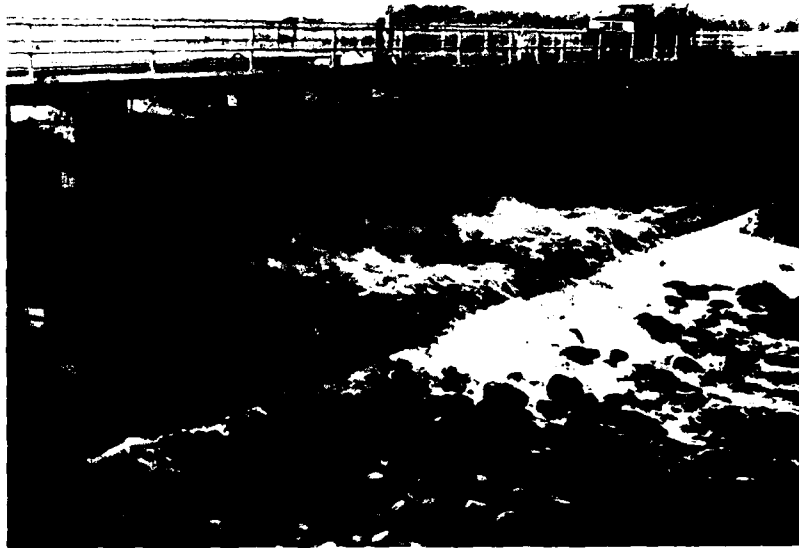
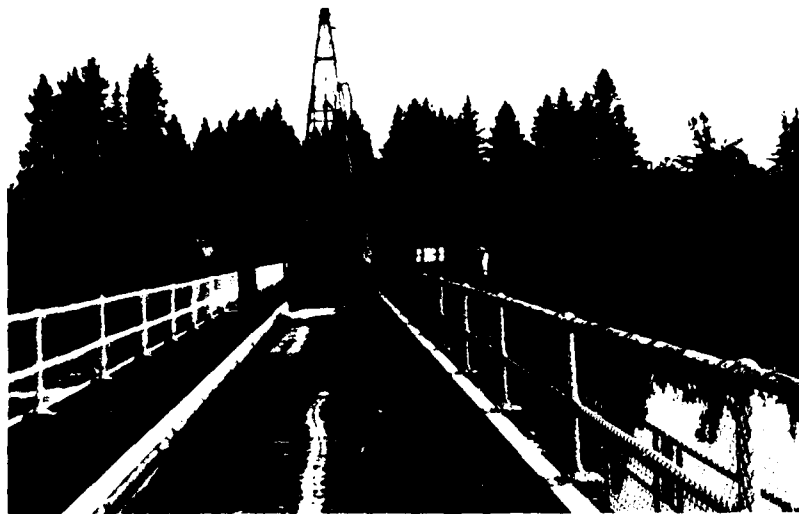
Figure 7. Typical drill rig set-up for obtaining concrete core

18. The in situ strength of the foundation material is an important factor in the analysis of the stability of the dam, which is supported on timber piles embedded in the foundation material. The drill rig was used in performing pressuremeter tests, standard penetration tests, and to obtain disturbed samples of the foundation material.
