## **HOT ISOSTATIC PRESSING OF ALUMINUM ALLOY CASTINGS**

S.J. Vonk, G.S. Hoppin and K.W. Benn  
Garrett Turbine Engine Company  
A Division of the Garrett Corporation

February 1981

Final Technical Report for Period  
October 1979 - January 1981

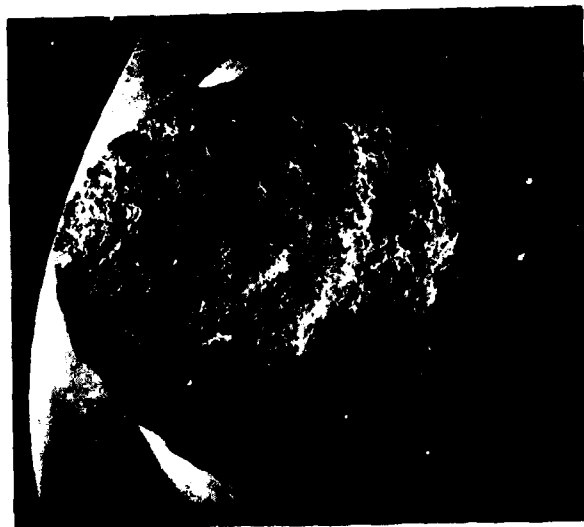
Figure 14. SEM fractographs of A201-T7 tensile bar that failed at 60.0 ksi. Material was HIPed at 980°F/10 ksi/6 hr. Initial radiographic Grade B, post-HIP Grade B+/A-.

A comparison of Figures 14, 15 and 16 shows the impact of eutectic melting. Figure 14 depicts the fracture surface associated with a high-strength fracture. The failure mode is essentially 100-percent ductile-rupture. However, a second test on an identical tensile bar from the same rim section shows a completely different failure (Figure 15). Much of the fracture surface is

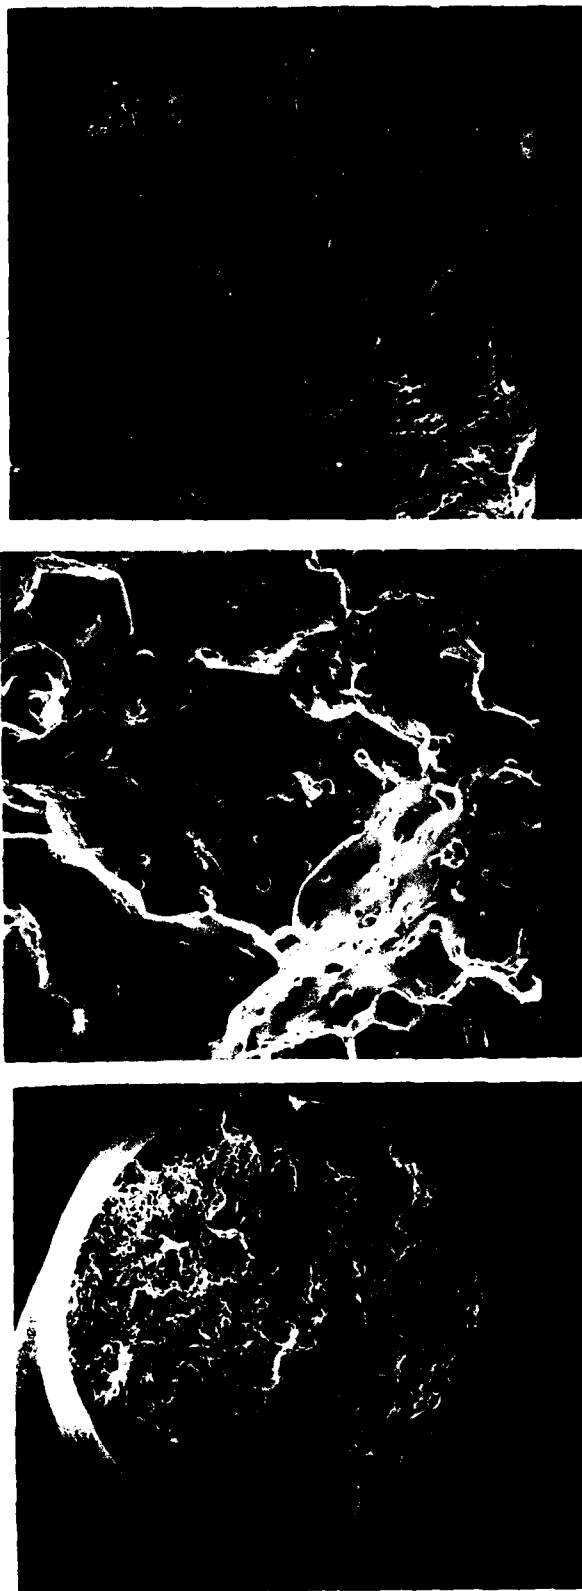
Figure 15. SEM fractographs of A201-T7 tensile bar that failed at 6.4 ksi. Material was HIPed at 980°F/10 ksi/6 hr. Initial radiographic Grade B, post-HIP Grade B+/A-.

covered by porosity, and a eutectic phase that appears to have remelted during the HIP cycle is common to most of the surfaces exhibiting porosity. The third sample (Figure 16) exhibits a mixed fracture mode and, as would be expected, it showed fracture properties intermediate to the other two. The differences in microstructures exhibited in the three figures clearly demonstrates the variability in properties that is associated with eutectic phase melting. It is apparent that the variability is the result of HIP processing, since other factors are similar for the other Grade C material used in this study. The presence of the eutectic phase requires that processing temperatures be maintained at a minimum to reduce the potential for remelting of this phase.

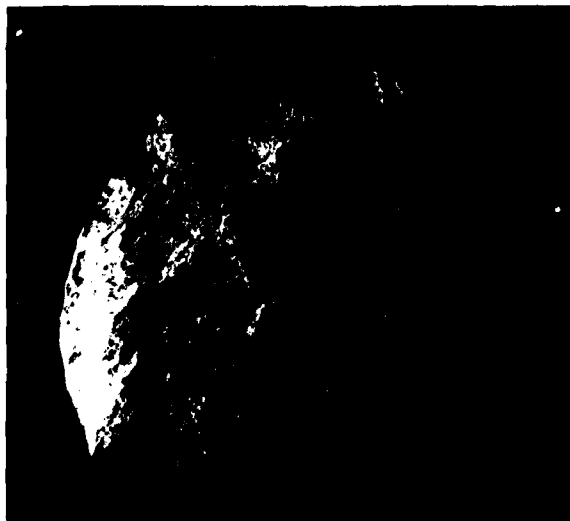
Figure 17. SEM fractographs of A201-T7 tensile bar that failed at 63.1 ksi. Material was HIPed at 950°F/15 ksi/6 hr. Initial radiographic Grade B, post-HIP Grade A.

Fractography, utilizing a scanning electron microscope (SEM), was conducted on selected tensile fractures. Fractographs of particular interest are shown in Figures 12 through 19. The fracture modes vary greatly from ductile-rupture, to cleavage, to intergranular. Data from this evaluation are difficult to analyze as a result of the mixed-mode failures, but some trends are apparent.

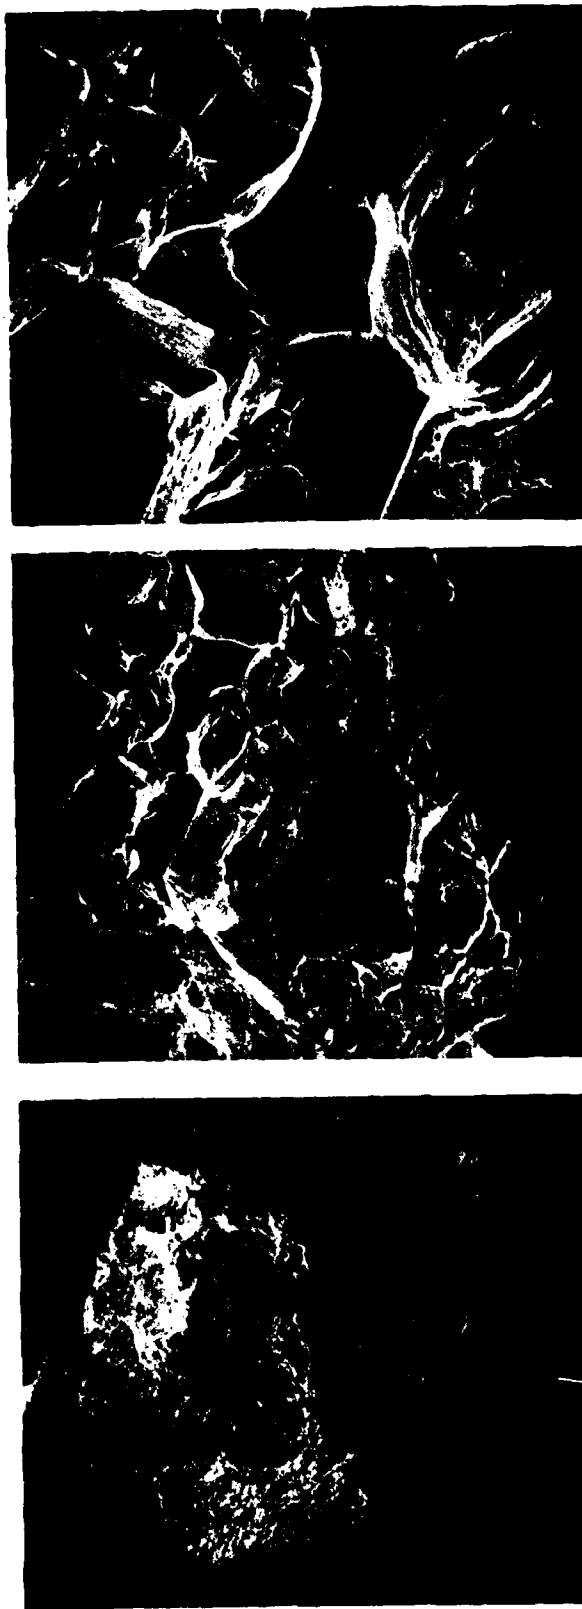
Figure 19. SEM fractographs of A201-T7 tensile bar that failed at 54.8 ksi. Material was HIPed at 950°F/10 ksi/12 hr. Initial radiographic Grade C, post-HIP Grade B/B+.

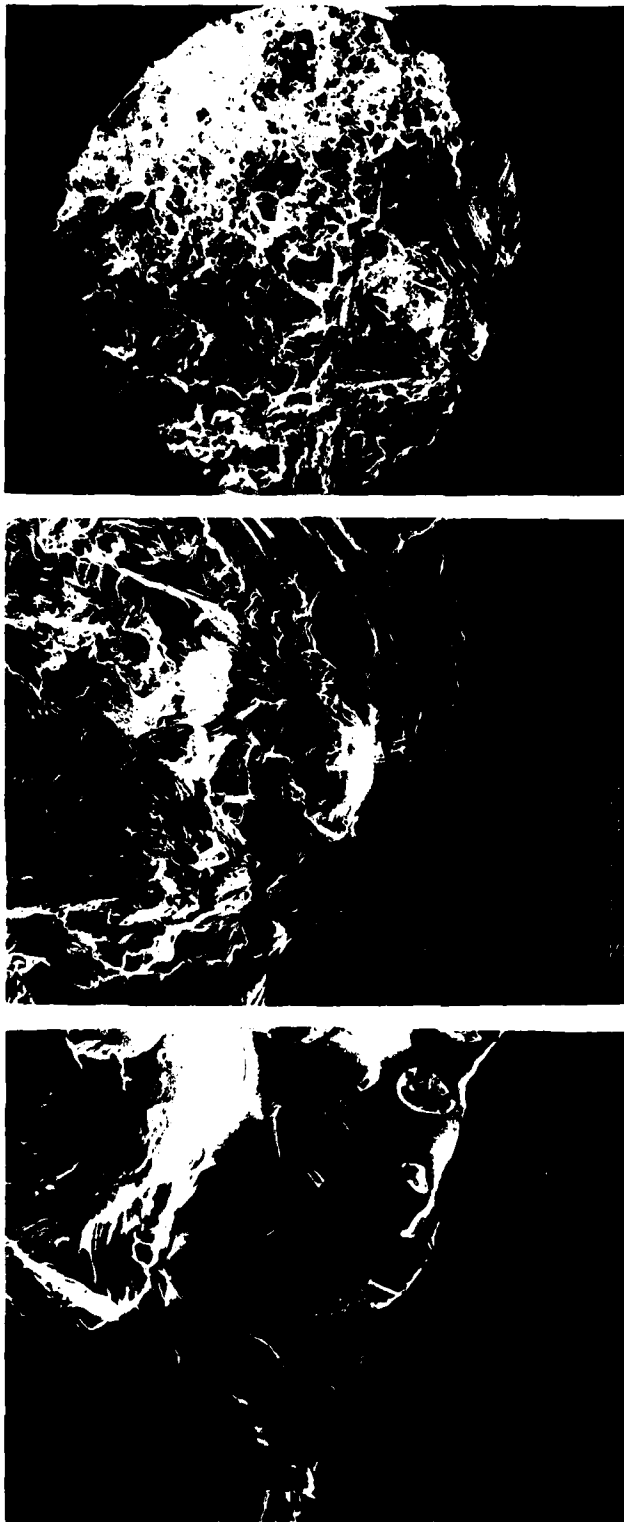
Figure 20. SEM fractographs of a typical HCF failure initiating at internal porosity remaining after HIP cycle. The material HIPed at 950°F/10 ksi/12 hr. The sample failed after 258,000 cycles at a 20-ksi stress level. Initial radiographic, Grade C, post-HIP Grade B/B+.

Figures 20 and 21 show the influence of porosity on fatigue properties of HCF test bars. The fatigue failure shown in Figure 20 clearly originates at a pore in the sample. The presence of this pore significantly reduced the fatigue life. In contrast, the sample in Figure 19, shows no porosity. Initiation of this fatigue crack required a great deal of energy, as evidenced by the ductile region at the initiation site, and the absorption of this energy greatly retarded fatigue crack initiation.

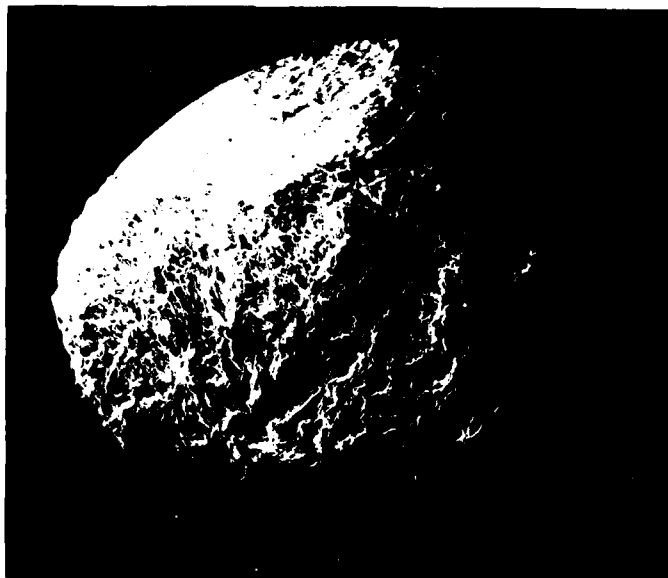
Figure 21. SEM fractographs of a typical HCF failure in a test sample exhibiting no internal porosity after HIP. The material was HIPed at 950°F/15 ksi/6 hr. The sample failed after 290,000 cycles at a 25-ksi stress level. Initial radiographic Grade B, post-HIP Grade A.
