Cold regions testing of an air-transportable shelter

CRREL Report 81-16

Stephen N. Flanders

August 1981

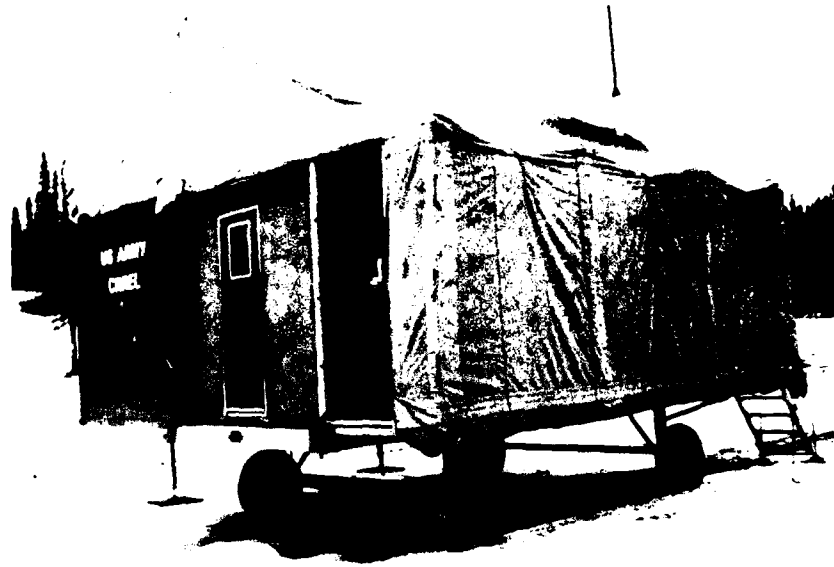
Figure 1. Fully erected shelter on site at Ft. Greely, Alaska.

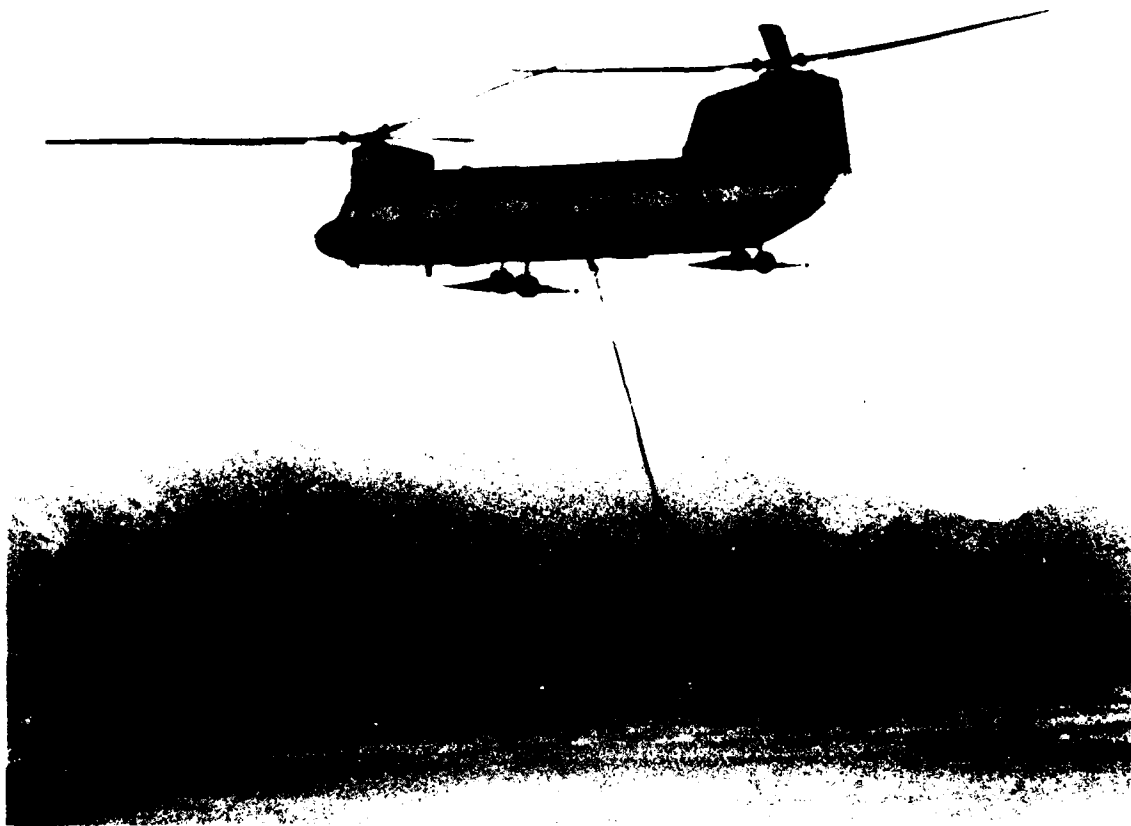
In hover, shown in Figure 6, the shelter rotated about its vertical axis. In forward flight the shelter flew fore-and-aft oriented until the helicopter executed a descending turn; thereafter it rotated and flew broadside to the direction of flight. The helicopter crew recommended a maximum air-speed of 80 knots for transporting the shelter. In sum, the flight crew considered the shelter to be very stable in straight and level flight and suitable for helicopter airlift (Dollahite 1978).

Figure 6. Helicopter flight test of the CRREL shelter at Ft. Greely, Alaska.

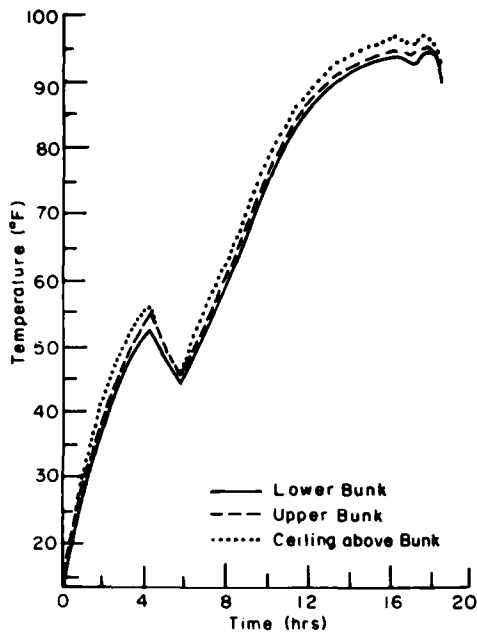
Figure 12. Rate of warming inside the shelter with the primary heater only.

of around 0°F, the shelter warmed to 68°F from 14°F at an average rate of about 9°F/hr using the primary (heat recovery) system only (Fig. 12). With the additional help of the auxiliary heater, the rate of warming was about 14°F/hr when the outdoor ambient temperature was around 20°F.

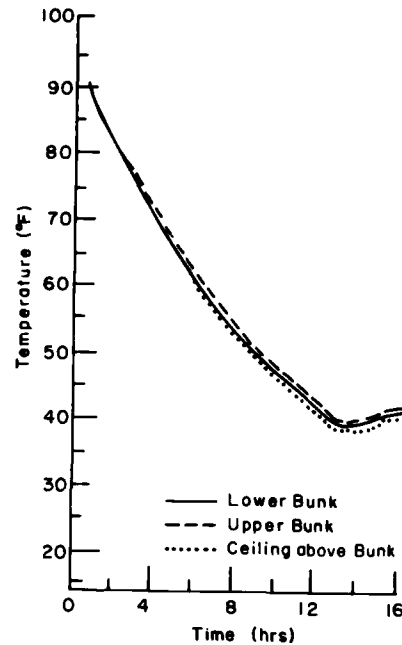
About 12 hours is required for the inside temperature to drop from 68°F to the freezing level after the heat has been turned off with outdoor ambient conditions around 0°F.

Figure 13. Rate of cooling inside the shelter with no heat input.
