MISCELLANEOUS PAPER SL-81-27

# STRUCTURAL STABILITY EVALUATION WINNIBIGOSHISH DAM

September 1981  
Final Report

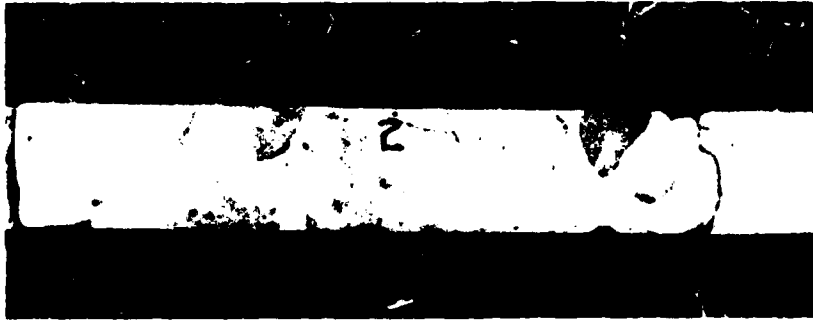
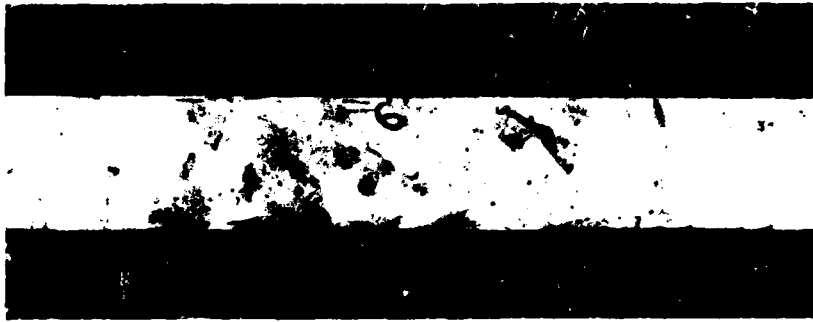
Figure 10. Representative core pictures, Pier 1,  
core W-P1

a. Core depth 2 ft

b. Core depth 6 ft

c. Supporting timber from under dam, core depth 13 ft

47. Hole W-P1 was primarily used to sample the supporting timber decking, beams, and piling under the pier. The timber was in excellent condition. The 12-in.-diam Norway Pine piling that supports the monoliths at Winnibigoshish Dam is approximately 15 ft long. The properties and allowables for the 12-in. Norway Pine piling are as follows:

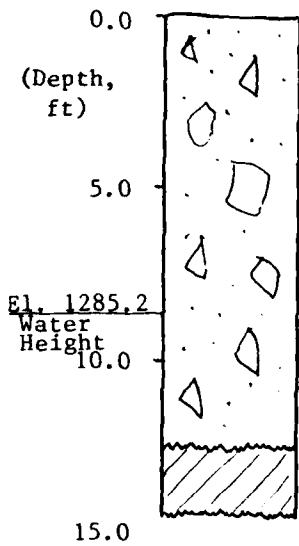
Figure 12. Vertical NX concrete core, W-P1, Winnibigoshish Dam

Slight honeycombing 1.2 to 1.4  
Broken surface coated with alkali-silica gel.

24. The finer sand sizes appeared to be largely individual grains of quartz or feldspar. Breaks in the cores were generally believed to be caused by the drilling operation, although the break at about 1.2 ft in core W-P1 was coated with alkali-silica gel and may have been an old break.

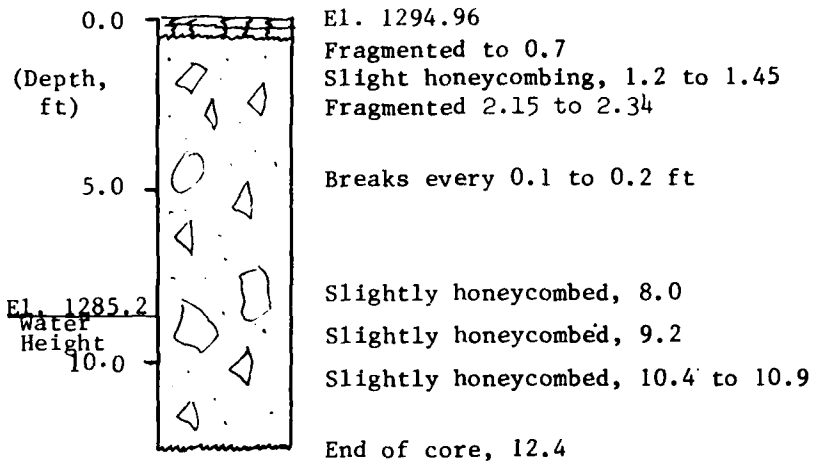
Figure 13. Vertical NX concrete core, W-PlA, Winnibigoshish Dam

2-in. maximum size aggregate.  
Crushed igneous and metamorphic coarse and fine aggregate.  
Good consolidation.  
Nonair-entrained.

26. The first 5.5 ft of core W-PIA (Figure 13) contained breaks every 0.1 to 0.2 ft, while breaks in core W-P1 occurred approximately every foot. Slight honeycombing was found in both cores at approximately 1.2 to 1.4 ft and 10.6 ft.

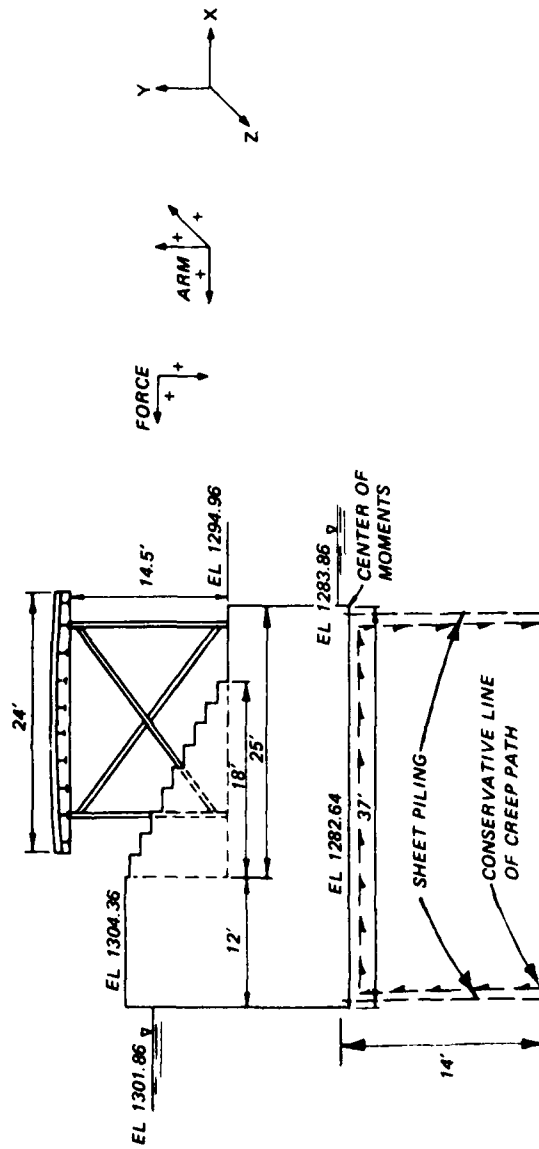
Figure 40. (concluded)

Factor	F <sub>v</sub> kips	F <sub>H</sub> kips	A <sub>TM</sub> ft	A <sub>TM</sub> ft	M <sub>Z</sub> ft-k
Normal operation loadings	800.86	-287.90			14,094.33
Truck load (H15-44)	26.64		4.25		113.22
$e = \frac{14,207.55}{827.5} = 17.17 \text{ ft}$					
		827.5	-287.90		14,207.55

The applied loads and moments on the pile system are presented in Figures 40-45. A summary of the forces and moments on the piling system obtained by conventional stability analysis is presented in Table 8. At this point, the adequacy of the pile foundation could not be evaluated because the allowable vertical and horizontal loads had to be known to judge the adequacy of the piles. These allowables were not known for Winnibigoshish Dam.

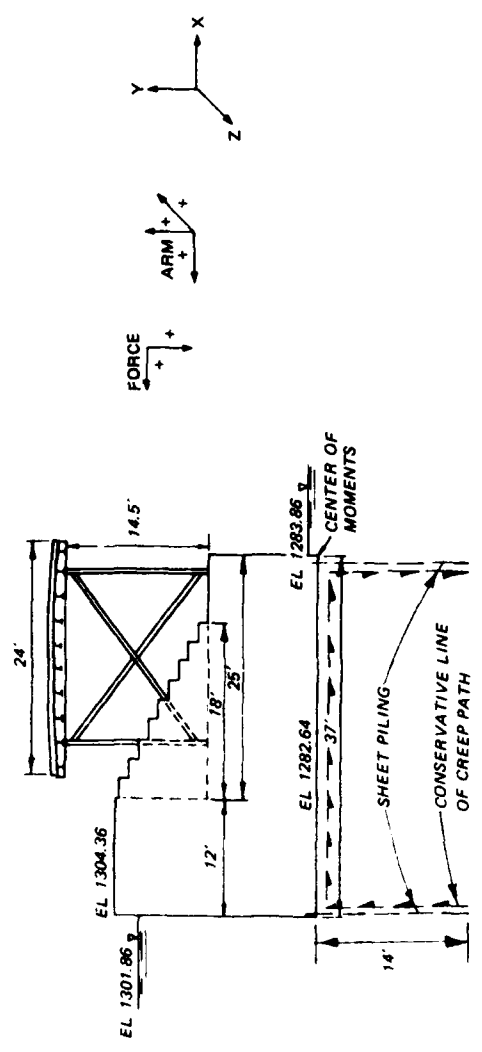
Figure 43. Normal operation with earthquake, centroid weights in YZ plane

Factor	F <sub>V</sub> kips	F <sub>H</sub> kips	Arm <sub>x</sub> ft	Arm <sub>y</sub> ft	M <sub>x</sub> ft-k	M <sub>y</sub> ft-k
W <sub>Conc</sub> (See calculations for normal operation)	1004.41				20,922.76	
W <sub>Bridge</sub> (See calculations for normal operation)	56.42				634.73	
P <sub>Head Water</sub> = (0.0625)(1304.36 - 1282.64) <sup>2</sup> (0.5)(25)	-368.56			7.24	-2,668.37	
P <sub>Tailwater</sub> = (0.0625)(125.86 - 1282.64) <sup>2</sup> (0.5)(0.6)(25)	4.86			1.07	5.20	
Uplift = (-11)(37)[(0.0625)[1285.86-1282.64] + $\frac{(14)(38.5)(0.0625)}{14 + 37 + 14}$ ] - 183.27	-183.27		18.50		-3,390.50	
$-(1/2)(11)(37)[(0.0625)[1304.36-1285.86][\frac{37}{14 + 37 + 14}] - 133.94$	-133.94		24.67		-3,304.30	
	<u>-317.21</u>				<u>-6,694.80</u>	
$e = \frac{12,194.32}{743.62} = 16.40 \text{ ft}$						
Total	743.62	-363.7			12,194.32

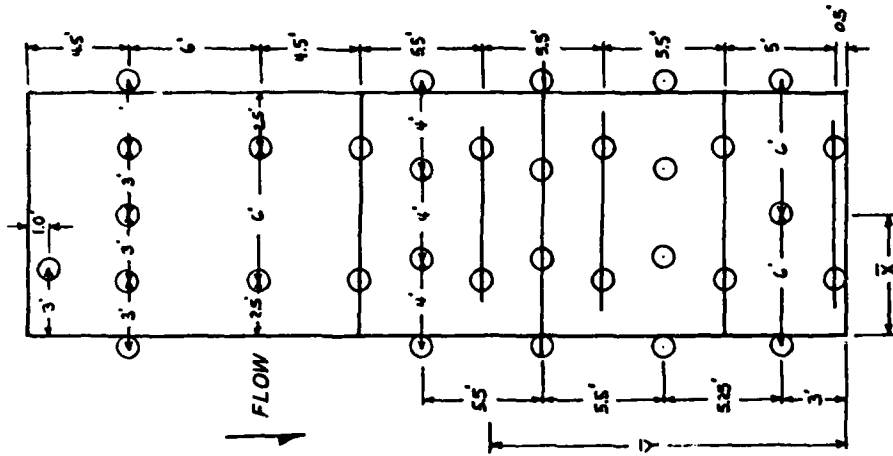
Figure 46. Moment of inertia of pile group

$$I_{YY} = 406.9 \text{ ft}^4 = 8.438 \times 10^6 \text{ in}^4$$
