SHIPBOARD EXPOSURE TESTING

**E. J. Jankowsky and S. J. Ketcham
Aircraft and Crew Systems Department
NAVAL AIR DEVELOPMENT CENTER
Warminster, Pennsylvania 18974**

**PROGRESS REPORT
AIRTASK NO. WF61-542-001
Work Unit No. ZM501**

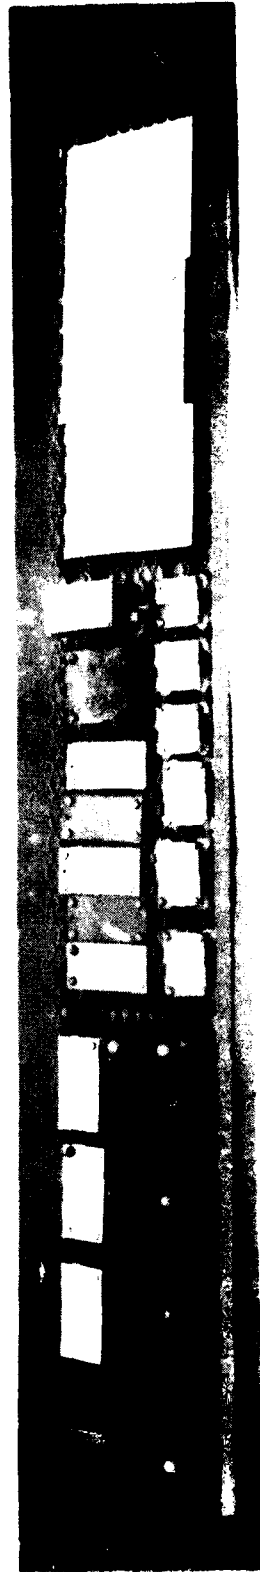
USS NIMITZ RACK

USS CONSTELLATION RACK

Figure 1. Carrier Exposure Racks

Racks, designed to expose the specimens at an angle of 45°, were fabricated from steel, cadmium plated, chromated, and painted with MIL-P-23377 epoxy primer and MIL-C-81773 polyurethane topcoat. The racks were approximately 2.4 metres long by 0.30 metre wide (8' x 1'). The NIMITZ rack was welded to the inboard side of the radar tower aft of the island on the flight deck. The rack was about 3.6-4.3 metres (12'-14') above the deck. A similar rack was installed in the same location on the radar tower of the CONSTELLATION. Specimens were attached to the racks with nylon bolts. MIL-S-8802 sealant was applied in the bolt holes and under the bolt heads to avoid crevice corrosion. Racks with specimens attached are shown in Figure 1.

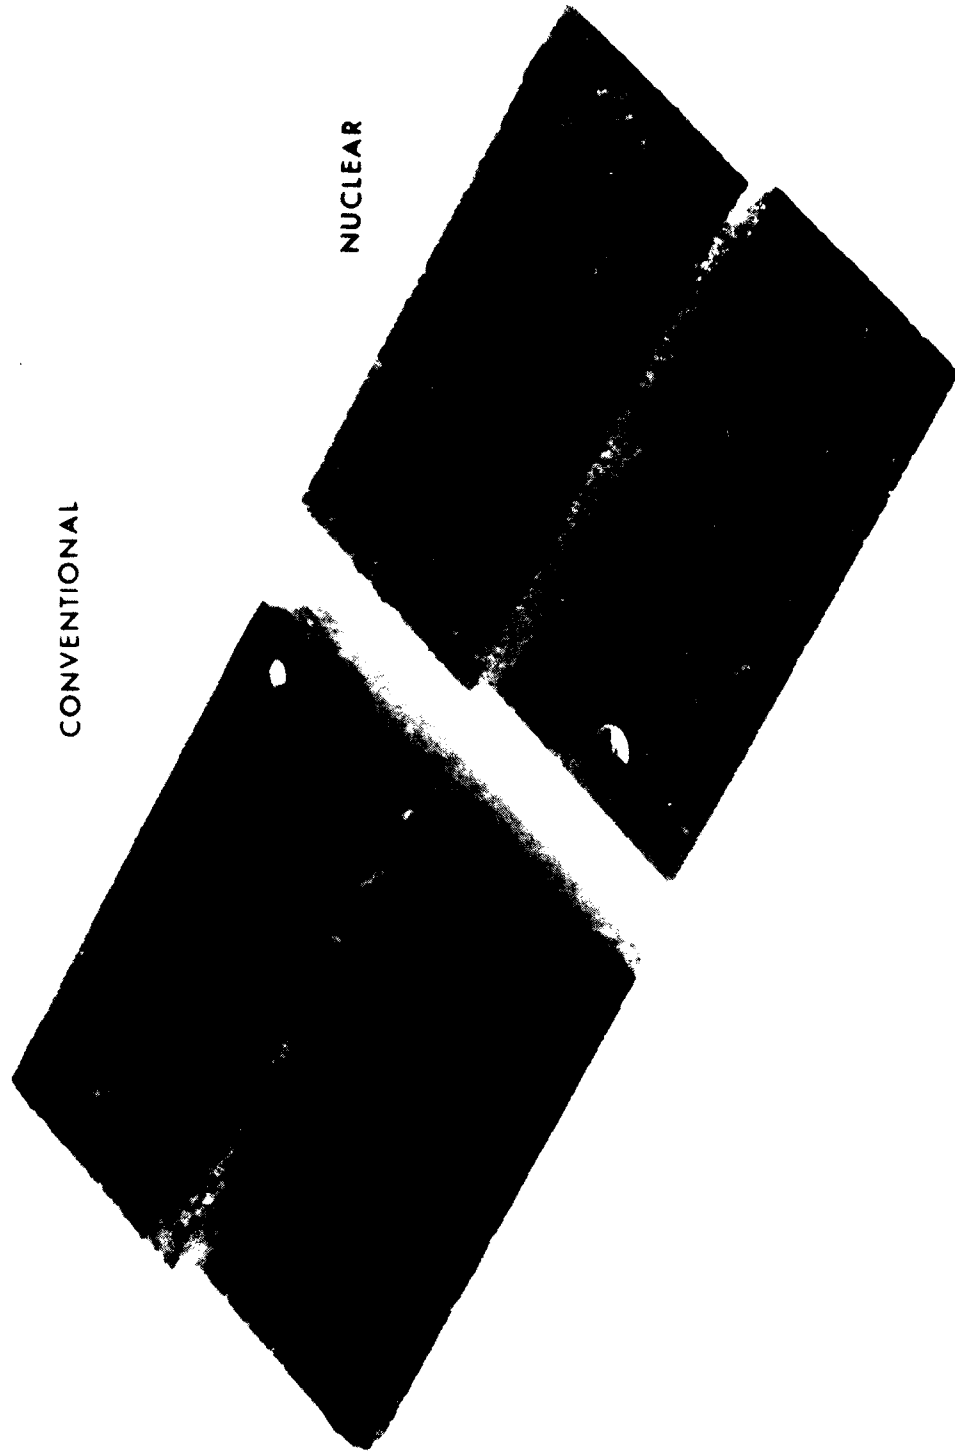
Figure 2. Comparison of Exposure Panels from Nuclear and Conventional Carriers
7075 - 0.5 Inch Extrusion, Low Resistance

Results of the exfoliation tests of aluminum alloys are given in table II for all three carriers. The panels were rated according to ASTM G 34-79. The appearance of a typical NIMITZ exposure panel compared to a typical KENNEDY panel for each group is shown in figures 2 to 9. Figure 10 shows typical exposure panels from the CONSTELLATION. All alloys heat treated for high resistance to exfoliation showed only surface pitting attack and are therefore not shown in the figures.

Results of exposure on the NIMITZ were surprising in that corrosion was worse than it had been for the same materials exposed on the KENNEDY. The difference in behavior was attributed to the effect of temperature. The nuclear carrier was in the Indian Ocean for five months where temperatures ranged from 80 to 95° F. The first conventional carrier was in the Mediterranean for its entire deployment where temperatures were 20 to 30 degrees lower most of the time. In the Indian Ocean, there was little rain to wash off salt accumulations. With the sun shining on the panels, surface temperatures could be much higher than ambient.

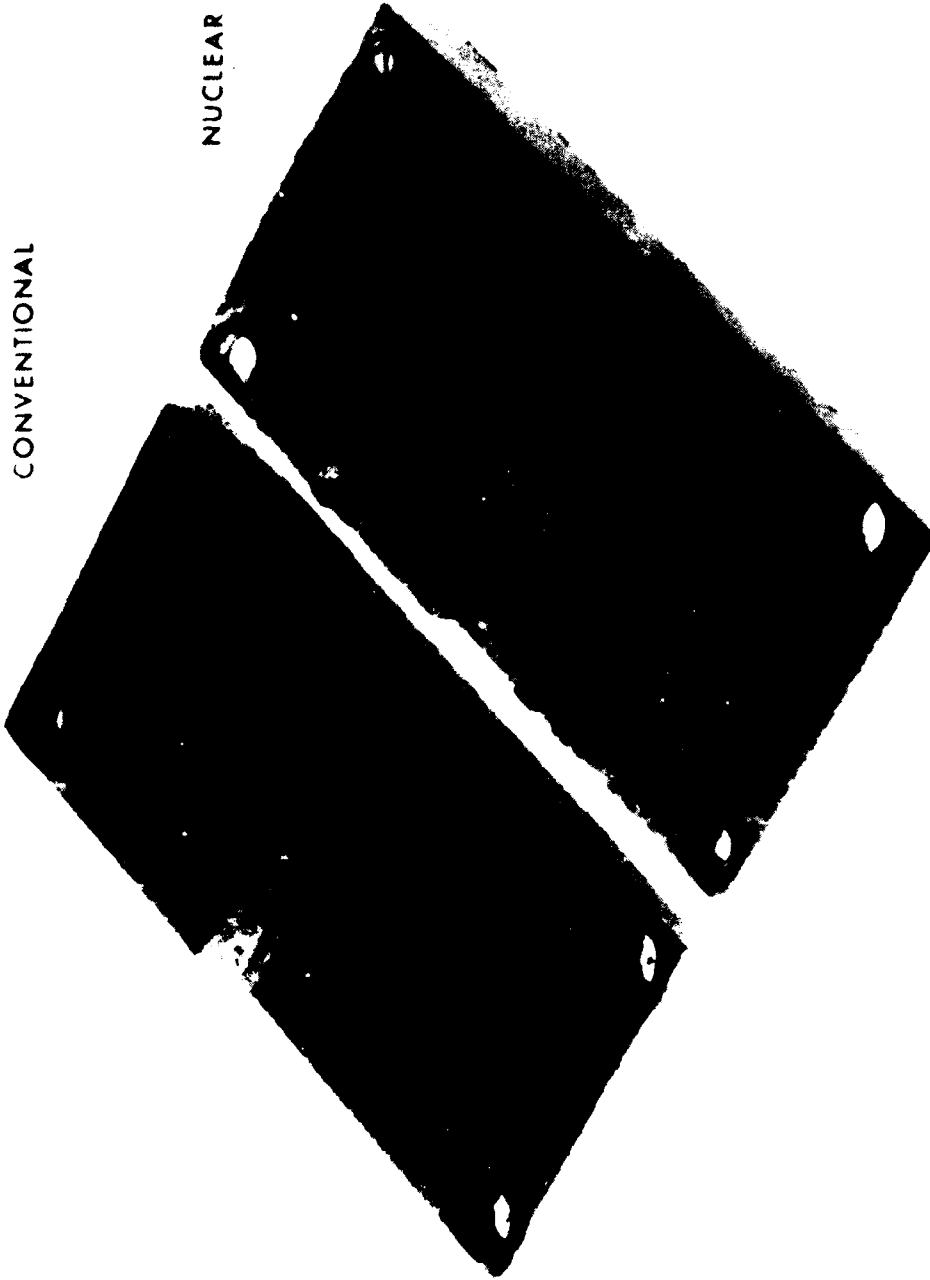
Figure 7. Comparison of Exposure Panels from Nuclear and Conventional Carriers
2124 - 0.5 Inch Plate, Intermediate Resistance

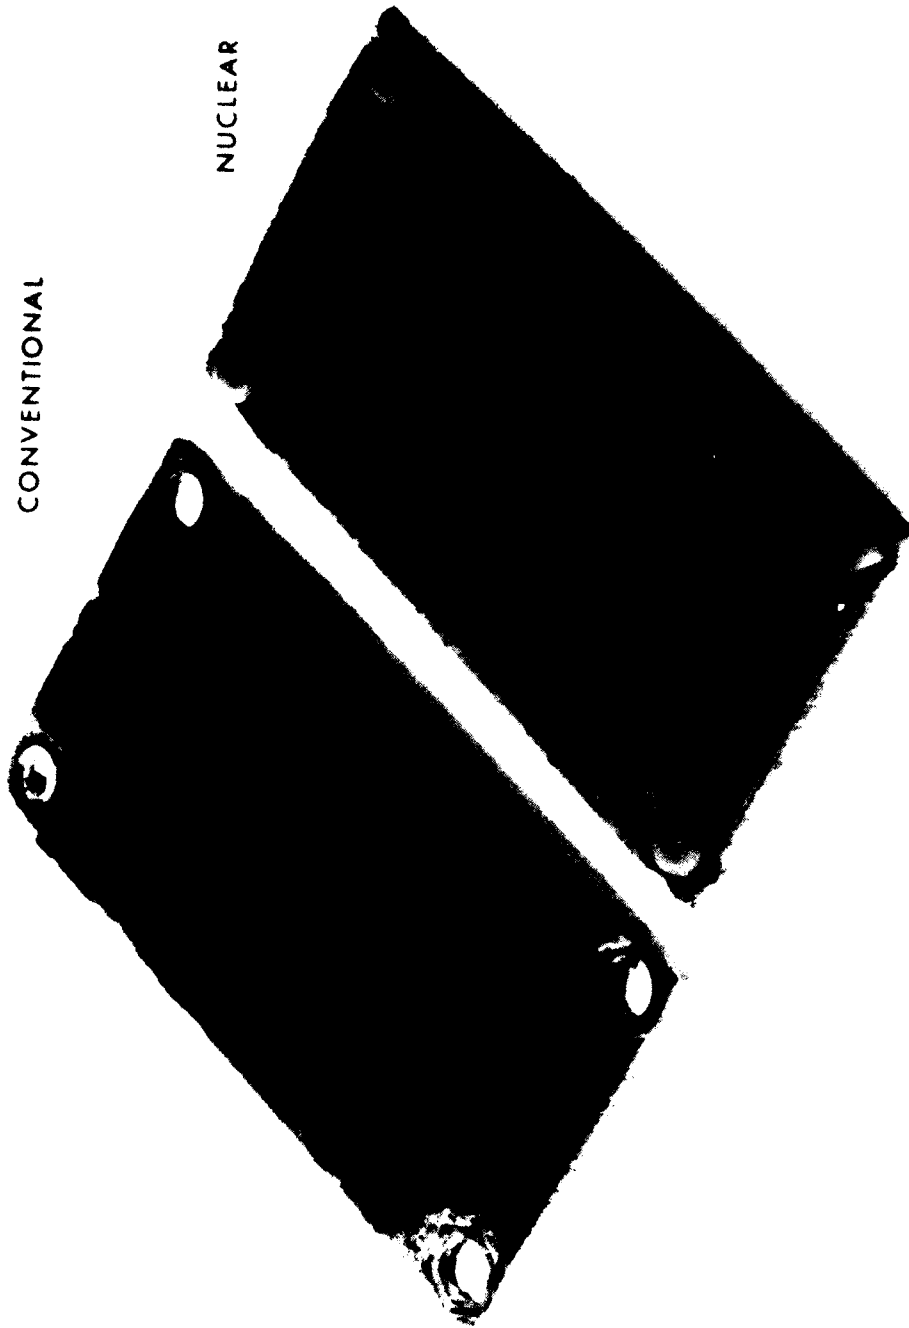
Figure 8. Comparison of Exposure Panels from Nuclear and Conventional Carriers
7178 - .091 Inch Sheet, Low Resistance

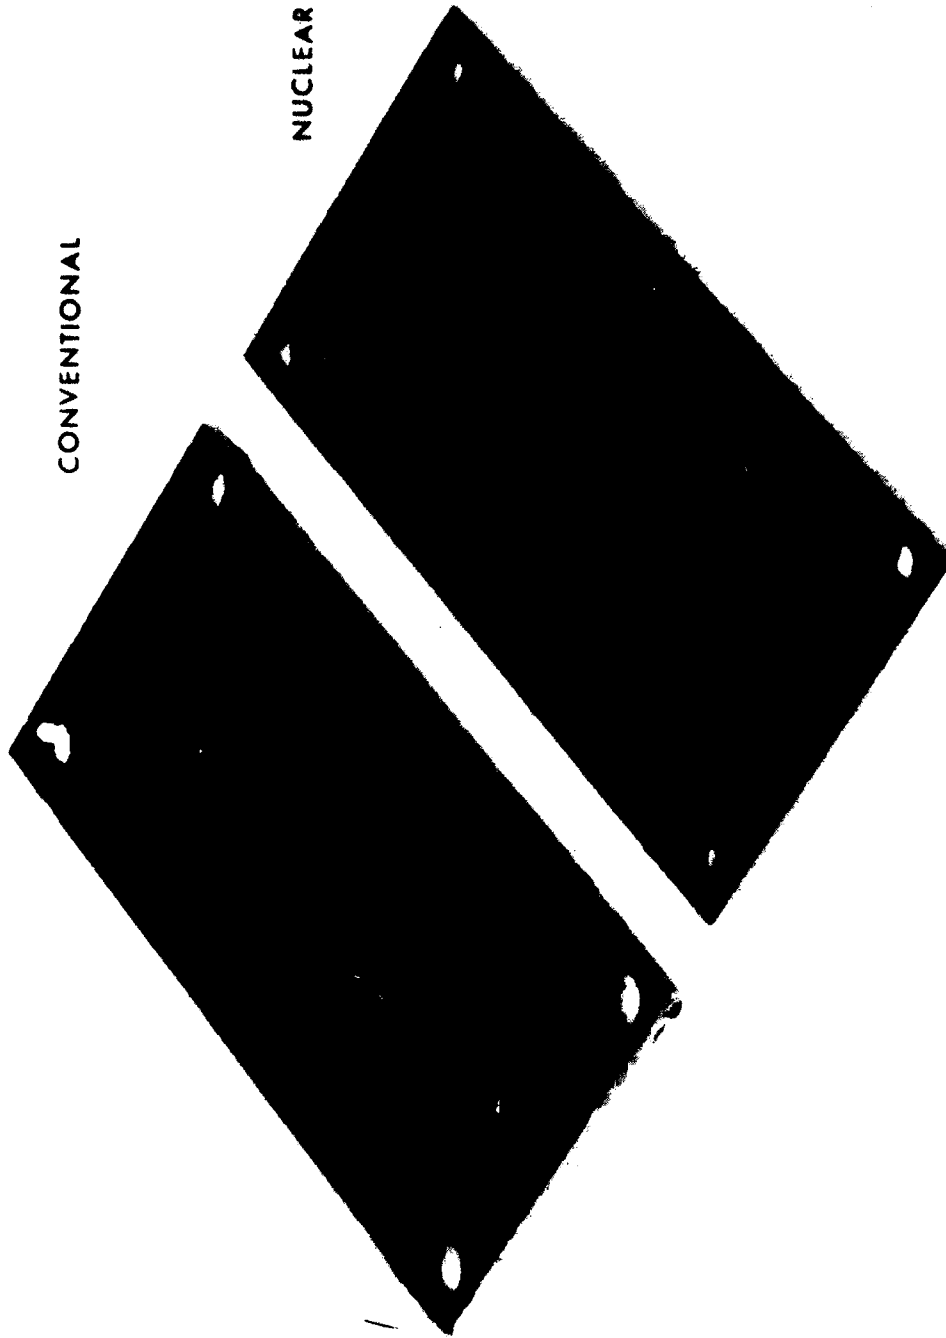
Figure 9. Comparison of Exposure Panels from Nuclear and Conventional Carriers
7178 - 0.091 Inch, Intermediate Resistance

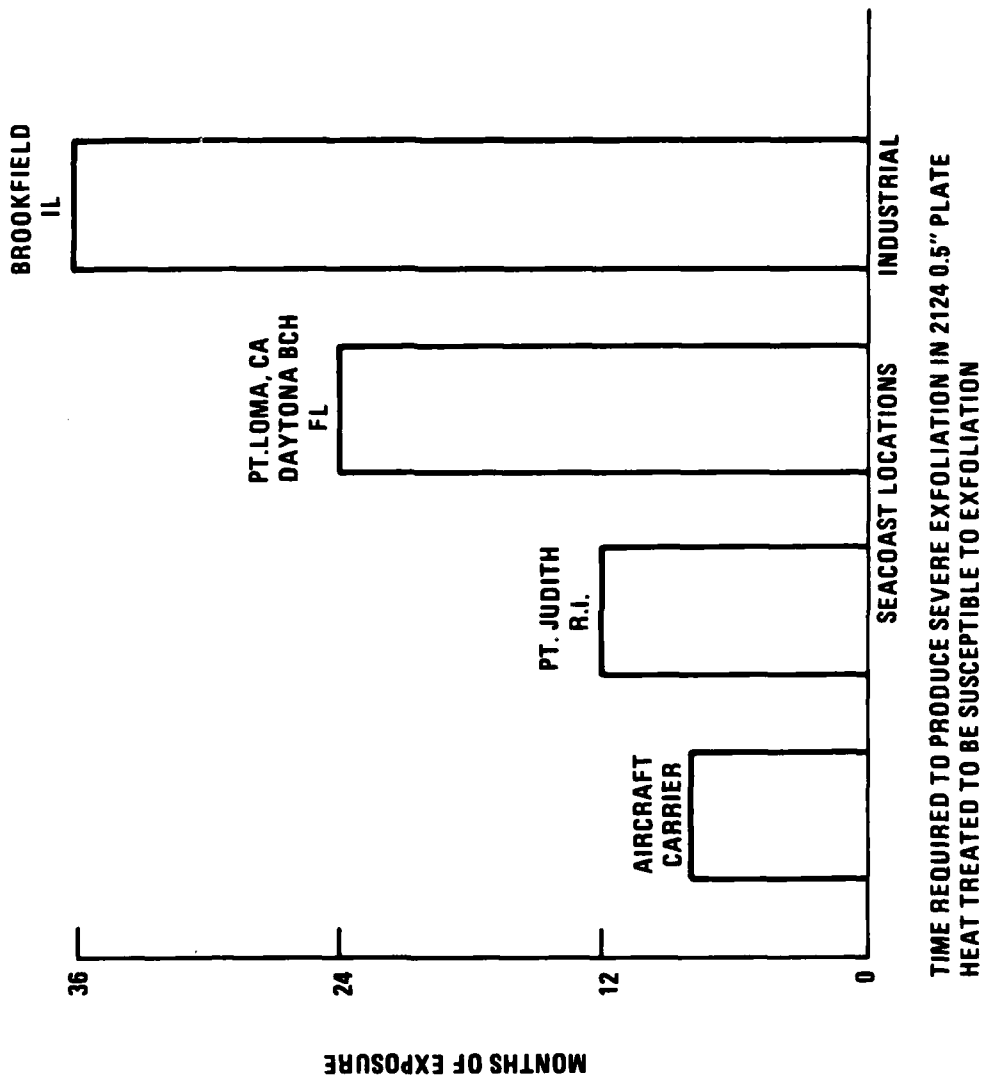
Figure 11. Comparative Corrosivity of Environments

Results with the aluminum alloys show that the environment of an aircraft carrier, however powered, is considerably more corrosive than seacoast or industrial environments. This is vividly demonstrated in figure 11 which is based on data from Sprowls et al., reference (e). It took only eight months on a carrier to develop severe exfoliation corrosion on susceptible alloys whereas at the most severe seacoast location (Point Judith, Rhode Island) it took 12 months and in the most severe industrial location (Brookfield, Illinois) 3 years.

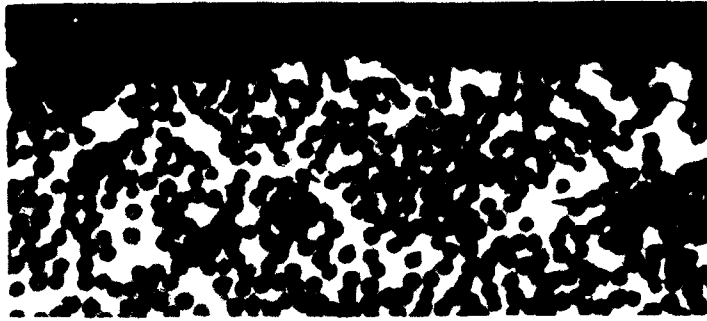
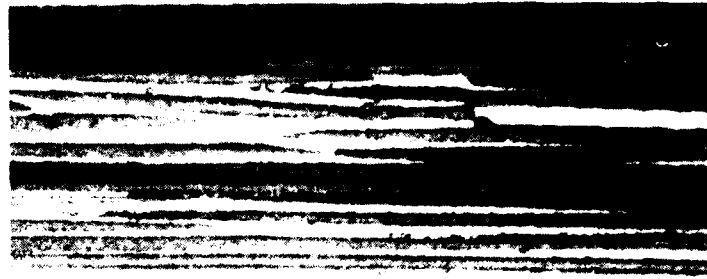
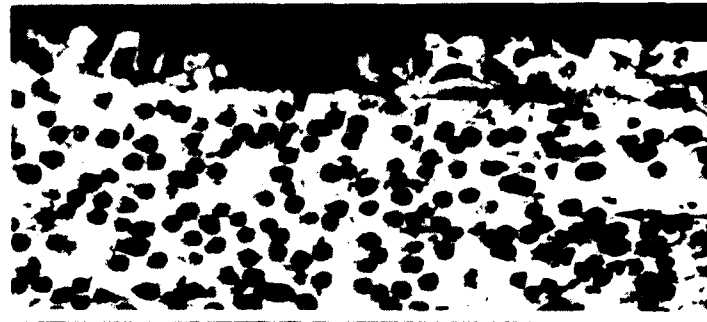
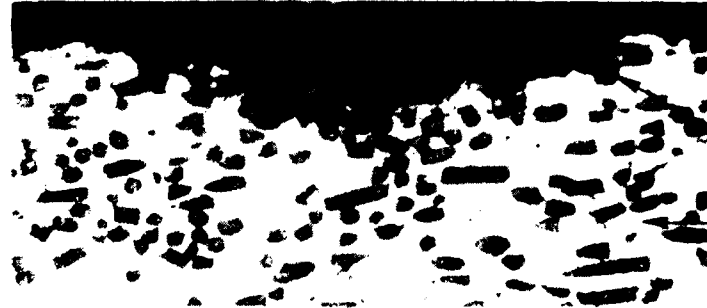
LIQUID INFILTRATION COMPOSITE 100 X

POWDER METALLURGY COMPOSITE 100 X

Figure 12. Photomicrographs of Aluminum-Aluminum Oxide Composites

Eight months of exposure on a conventional carrier resulted in only slight pitting of the aluminum oxide/6061 aluminum composites. Attack was equivalent to that observed on the aluminum alloy specimens heat treated to have high resistance to exfoliation corrosion. Metallographic examination of the mounted and polished cross sections of the panels revealed preferential attack on the matrix but no deep attack or obvious detrimental effect. There was slightly more attack on the powder metallurgy composite than the liquid infiltration composite as shown in figure 12.

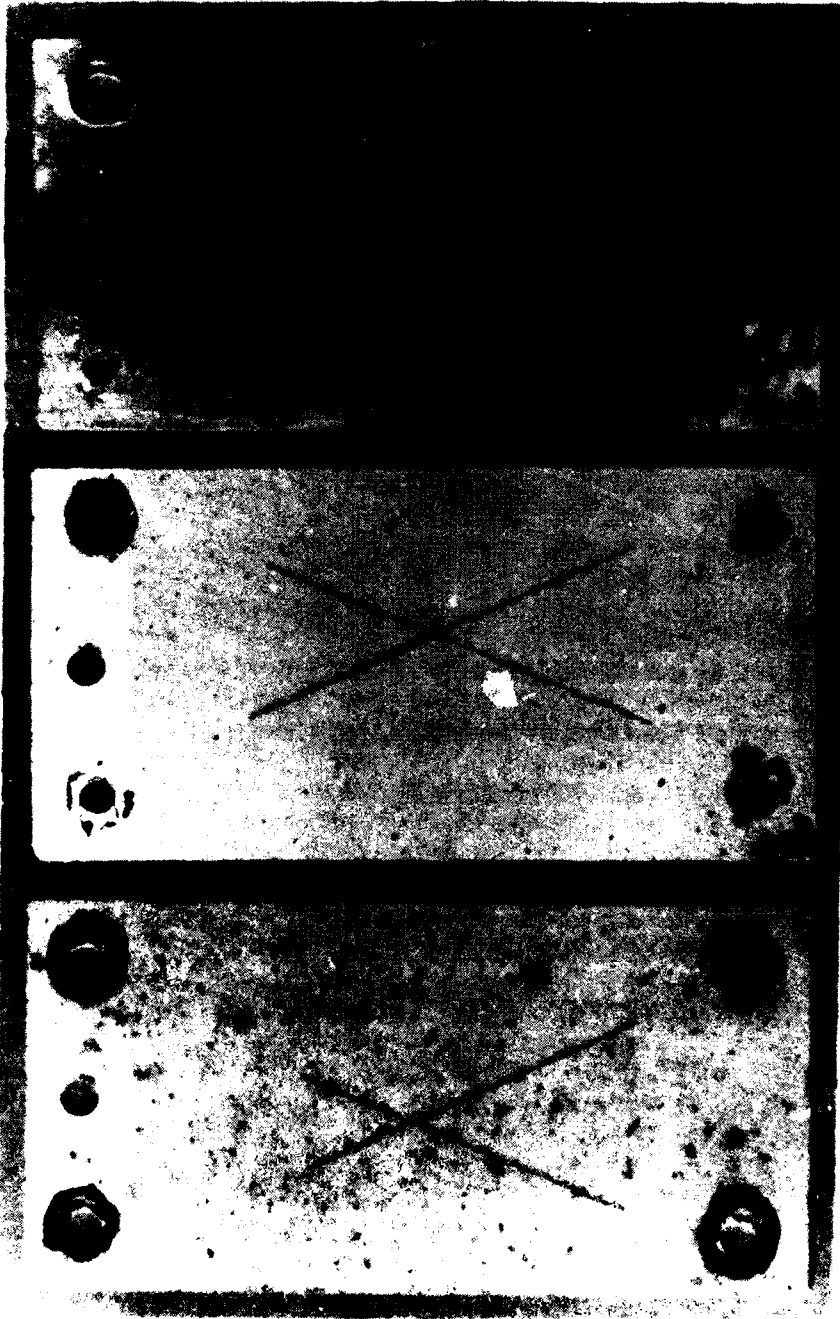
AS REMOVED DETERGENT CLEANED AFTER WDP REMOVED

NOTE: DARK SPOTS ON PANEL B - ACCIDENTAL PAINT SPLATTER DURING EXPOSURE PERIOD

Figure 13. Water Displacing Paint (WDP) Exposure Panels from U.S.S. Constellation
After Eight Months of Exposure

Typical water displacing paint panels are shown in figure 13. Adhesion was good, but there was some slight corrosion of the basis metal and slight blistering of the paint at the scribe marks. All in all, results were very promising. Additional information on water displacing paint can be found in reference (f).

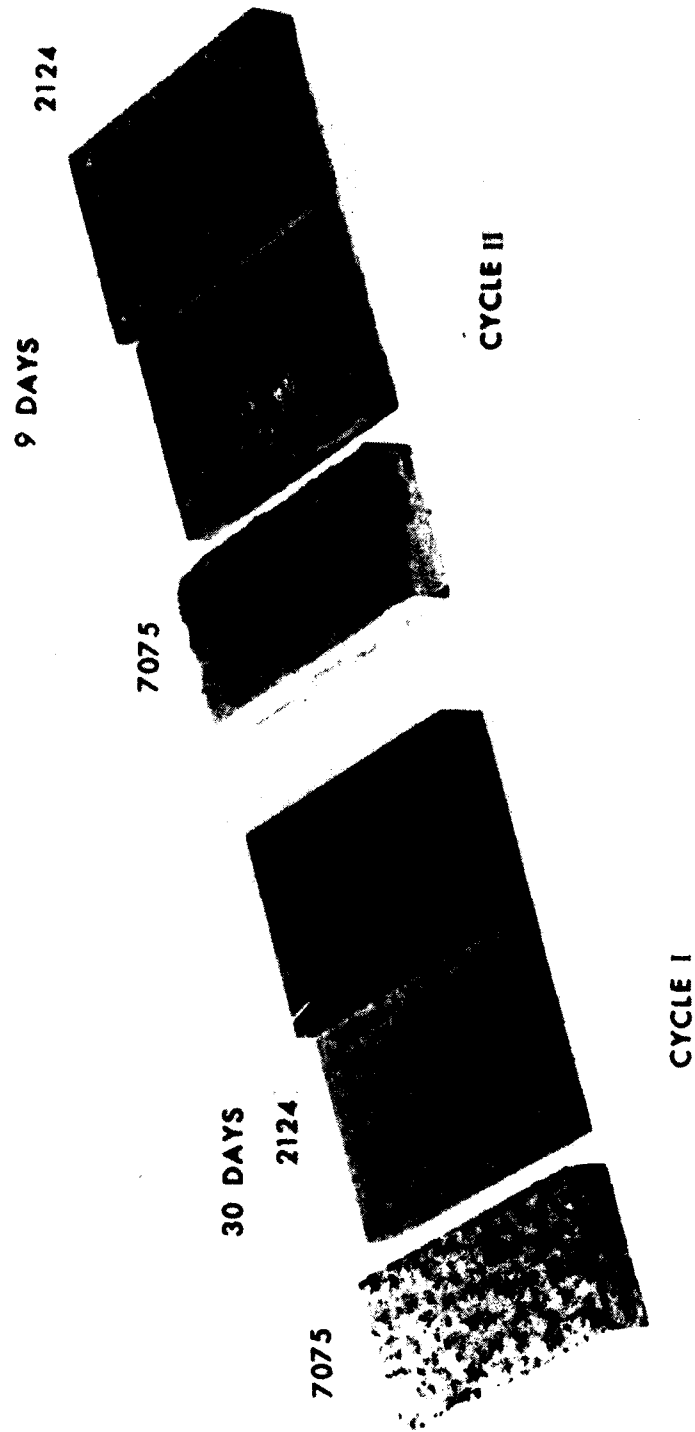
Figure 14. Cycle I and Cycle II - Cyclic SO₂ - Salt Spray

In the cyclic SO₂-salt-spray tests, Cycle I, the spray-soak-SO₂ cycle, resulted in very little exfoliation, mainly surface attack even after 30 days of exposure. Cycle II simulated carrier exposure attack more closely than Cycle I with both 7075 and 2124 exfoliating in relatively short times. Cycle III came closest to giving the same type of attack as carrier exposure. The major differences were the somewhat darker color of corrosion products in the laboratory test and a slight reversal of attack. On the carrier, 2124 was more severely attacked than 7075 while the reverse was true in the laboratory test. Cycle IV formed more surface lumps than the other cycles without distinct layering, 2124 was very black after a few days of exposure. Results of cyclic exposure are shown in figures 14 and 15 for cycles I, II, and III.

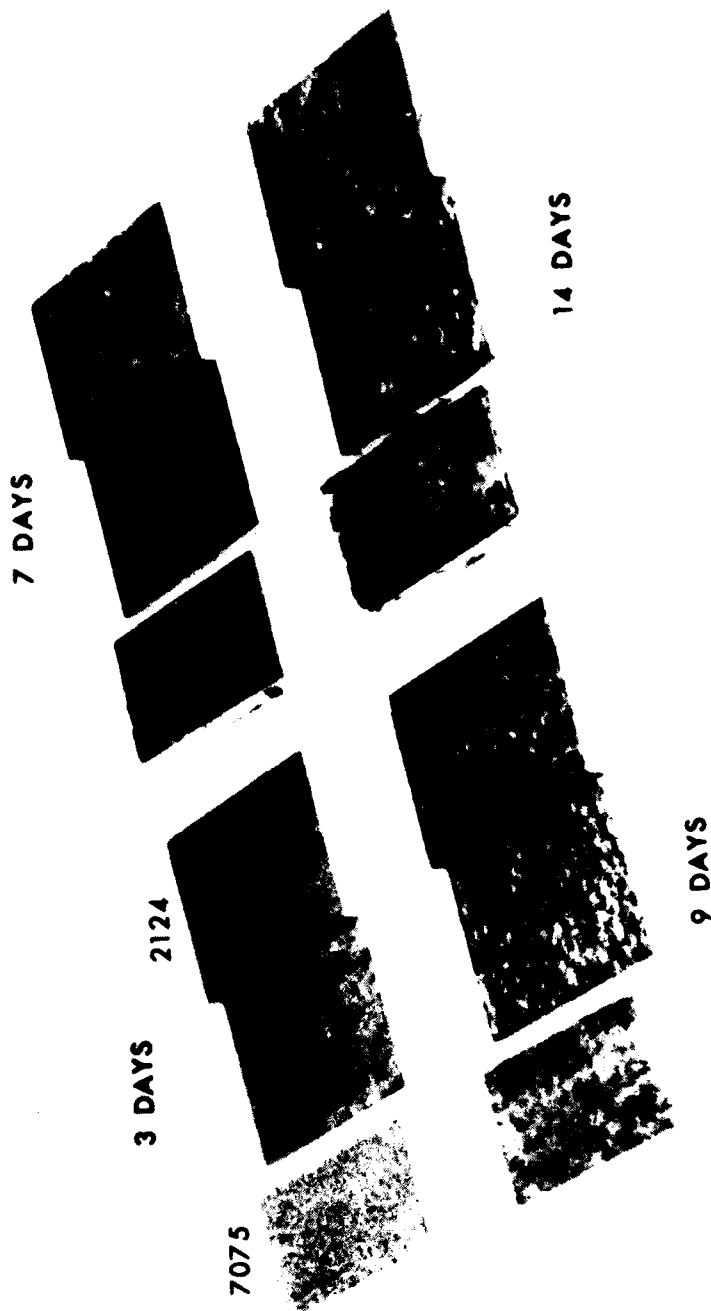
Figure 15. Cycle III - Cyclic SO₂ - Salt Spray
