HUGHES AIRCRAFT CO TORRANCE CA TORRANCE RESEARCH CENTER

RELIABILITY INVESTIGATION OF LOW NOISE GAAS FETS.(U)

JUL 81 L S BOWMAN, W TARN

RADC-TR-61-161  
Final Technical Report  
July 1961

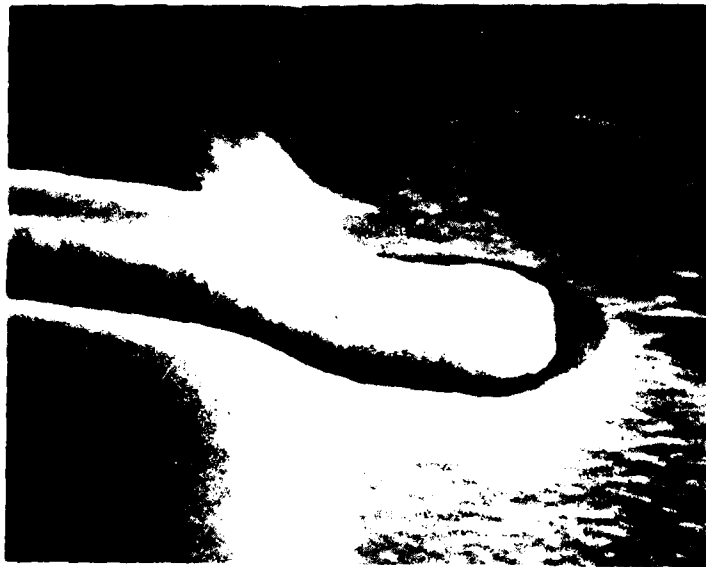
Figure 2-26 SEM photograph of gate finger end, FET R-5 at 18,000X. Estimate 500-1000Å of CR, overlaid by 4500-5000Å of Au.

The gate edges are quite steep and sharp, and the gate is centered in the etched channel. This centering could only have been done by a self-aligned process, so it can be concluded that the gate was achieved by liftoff. The process was well done, however, because the gate edges show no evidence of any shearing of metal during the lifting process. Interestingly, the EDAX scan shows evidence of chromium and nickel in deep probing of the source and drain pads.

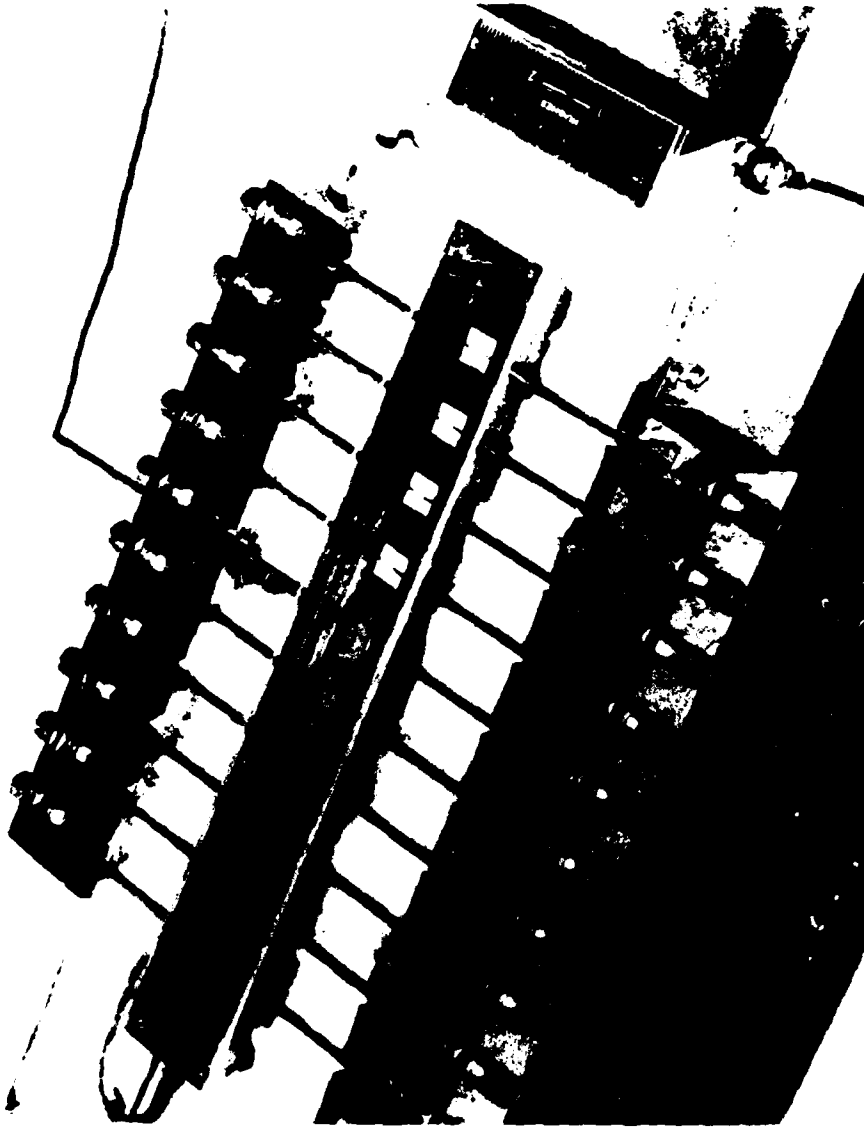
Each oven has 10 positions for DC-biased samples and approximately 20 positions for unbiased samples. The alumina microstrip carriers of the biased devices were firmly held in place with clamps, as shown in Figure 5-1. The unbiased devices were simply placed on top of the clamps. Gate and drain bias lines were brought into each sample

Figure 5-1 HRL-developed bias oven with the insulated cover removed. The samples in positions 1 through 6 are covered by the hold-down clamps; those in positions 7 through 10 are shown uncovered. During operation the alumina microstrip carriers of all biased FETs are held down with the clamps.
