TENNESSEE STATE DEPT OF CONSERVATION NASHVILLE DIV 0--ETC F/6 13/13
NATIONAL PROGRAM OF INSPECTION OF NON-FEDERAL DAMS, TENNESSEE, --ETC(U)
SEP 81 W E BUSH DACW62-81-C-0056

19. KEY WORDS (Continue on reverse side if necessary and identify by block number)		
Dams Dam Safety National Dam Safety Program Grand Valley Dam No. 2, TN Hickory Valley, TN		Hardeman County, TN Embankments Visual Inspection Structural Analysis

PHASE I INSPECTION
GRAND VALLEY DAM NO. 2
HARDEMAN COUNTY, TENNESSEE

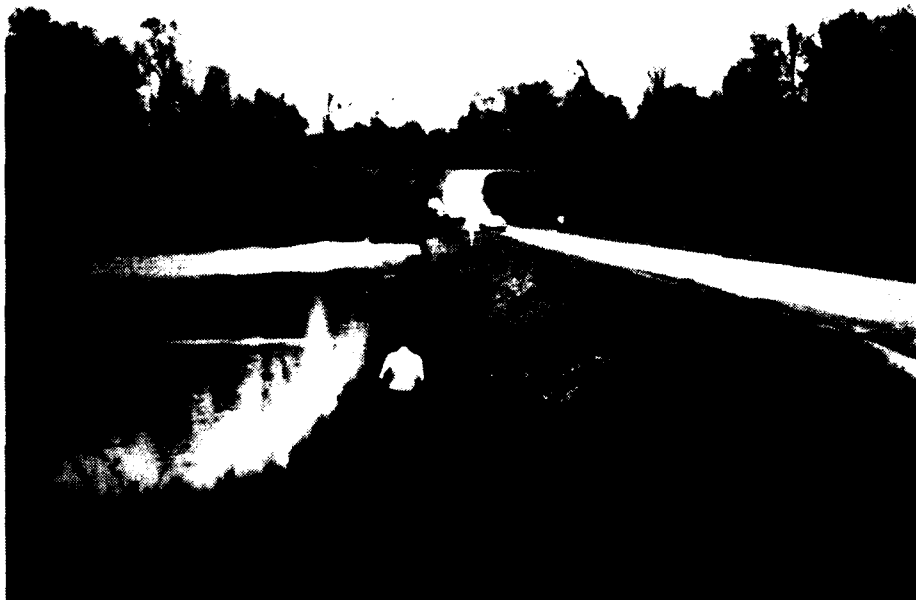
Abutments - There was some erosion noted along the contact of the embankment with the abutment in the form of gullies at both ends of the dam. Also, a good bit of sand has eroded out of a gulley that parallels the road at the left abutment.

1. Upstream slope and top of Grand Valley Dam No. 2. Note erosion at road side ditch in left abutment.

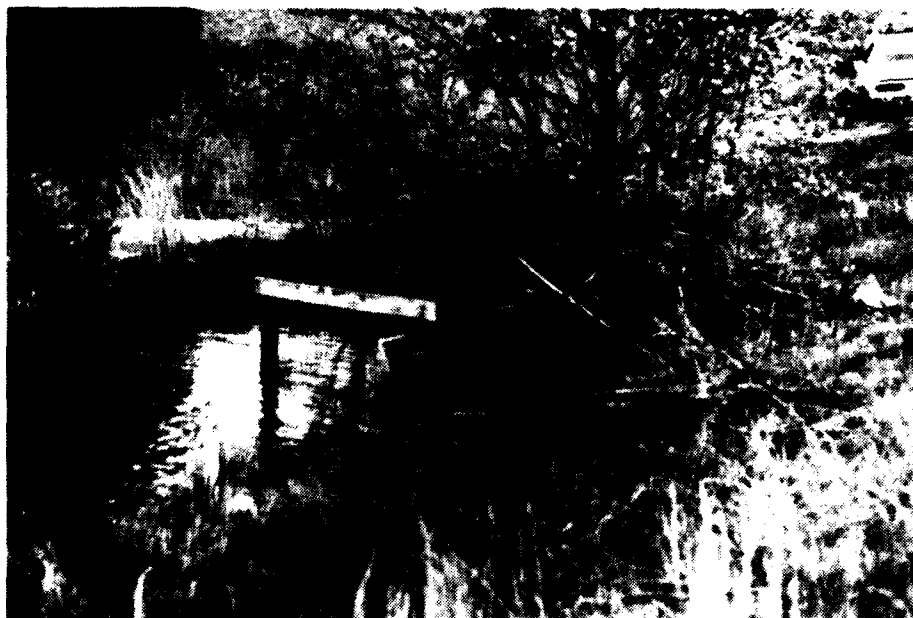
3.1.4 Spillways - The service spillway is essentially a culvert through the dam and provides no method to completely draw down the impoundment. The spillway is susceptible to being closed with debris and it was reported to have been closed up by beavers on several occasions. The wire enclosure appears to be adequate at the present time. The condition of the outlet structure is fair. The bituminous coating has failed on the exposed pipe with approximately 80 percent of the coating sloughed off. Rust spots were observed on the outside of the exposed pipe. The inlet end was partially underwater and could not be fully observed, but rust is appearing at the inlet end. Leakage was observed at the outlet along both sides and under the pipe.

3. Inlet for service spillway, Grand Valley Dam No. 2. Note debris at pipe.

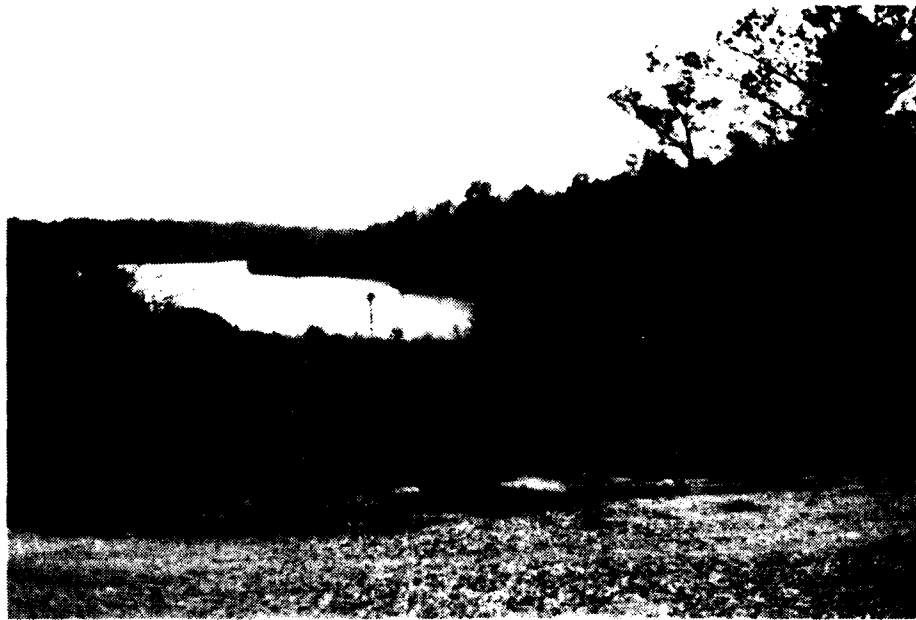
Emergency Spillway - There is approximately two feet of fall along the crest from the right abutment to the left abutment. The emergency spillway was originally designed in the right abutment. Flow through this emergency spillway was effectively cut off by the building of the road fill and consequently the low portion of the crest at the left abutment presently acts as the emergency spillway. Should flow occur over the dam at this point, the increased velocity of the water crossing the pavement and down the backslope would cause severe erosion of the backslope and possible failure of the structure.

5. Emergency spillway cut into right abutment of Grand Valley Dam No. 2.
Note road fill across control section.

EMERGENCY SPILLWAY. There is approximately two feet of fall along the crest from the right abutment to the left abutment. The emergency spillway was designed in the right abutment. The flow through the emergency spillway was effectively cut off by the building of the road and consequently the low portion at the crest at the left abutment now acts as the emergency spillway. Should flow occur over the dam at this point, the increased velocity of the water across the pavement and over the backslope would cause severe erosion of the backslope and possibly failure of the structure.

Recommendations. The road should be regraded or else a culvert pipe should be jacked under the road, in order to permit the emergency spillway to act as intended. The seepage at the foot of the left abutment is not serious but should be watched, particularly that occurring at the contact between the service spillway and the adjacent fill. Many dam failures have been started by seepage at this contact. The seepage should be measured about every 3 months by collecting it in a container of known volume. Signs of soil color or suspended matter in the seepage water should be noted particularly. If the rate of seepage increases significantly or if the leakage shows suspended solids, engineering assistance should be secured immediately.

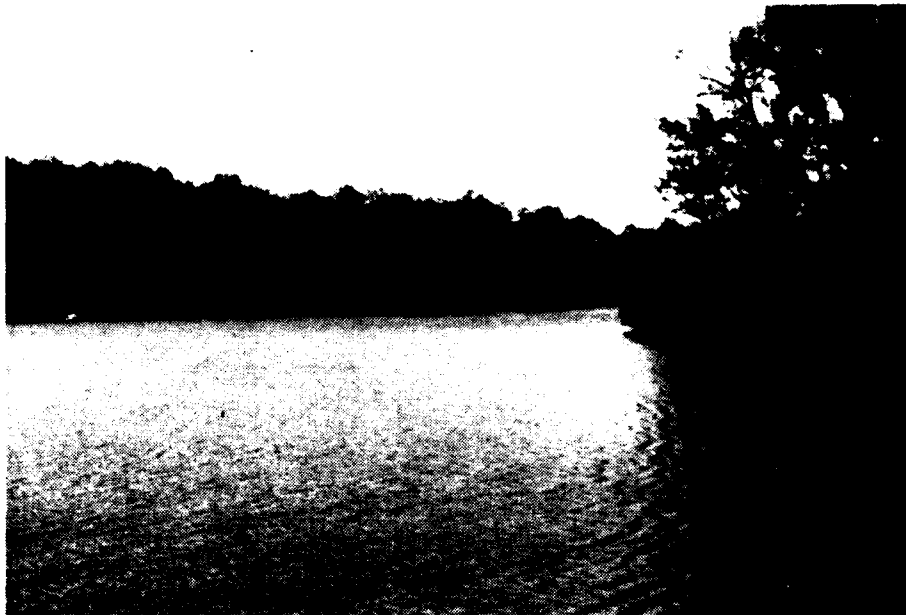
7. Impoundment above Grand Valley Dam No. 2.

RESERVOIR. The reservoir slopes are in fair condition. Sedimentation within the reservoir is unknown. Very little turbidity was noted at the time of
