NAVAL POSTGRADUATE SCHOOL MONTEREY CA

THESIS

A PRELIMINARY INVESTIGATION OF THE  
CORROSION AND STRESS-CORROSION SUSCEPTIBILITY  
OF THERMOMECHANICALLY PROCESSED HIGH MAGNESIUM  
ALUMINUM MAGNESIUM ALLOYS

September 1981

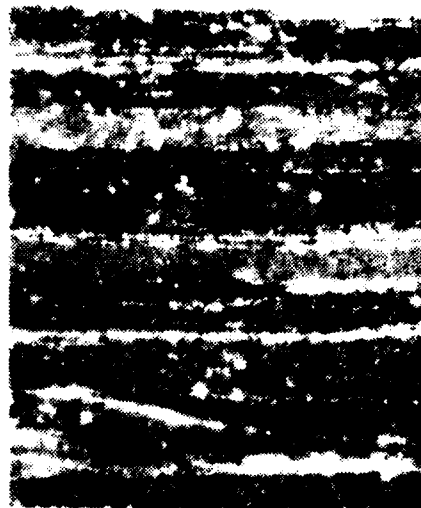
Figure 15. The as rolled material after a seven day 100 °C anneal. a) 8% Mg, b) 10% Mg, c) 10% Mg, 0.4% Cu d) 10% Mg, 0.4% Cu, 0.5% Mn. Etched at 20 volts for 20 seconds in Barkers Reagent. 500X.

The microstructural effect of the seven-day, 100°C anneal is presented in Figure 15. Annealing results in additional  $\beta$  precipitation in both the 8% Mg and 10% Mg alloys (Figs. 15a and b, respectively). The most notable effect in the 8% Mg alloy is increased precipitation on slip bands within grains, although there is also some increased grain boundary precipitation. The 10% Mg alloy is similarly affected, although increased grain boundary precipitation appears to be more the case with this material. In both alloys, the  $\beta$  particles have coarsened. The 10% Mg - 0.4% Cu alloy appears to be somewhat less affected by the anneal (Fig. 15c), although it now appears to pit in the electrolytic etch. The 10% Mg - 0.4% Cu - 0.5% Mn alloy (Fig. 15d) shows no discernable microstructural effect of this anneal.

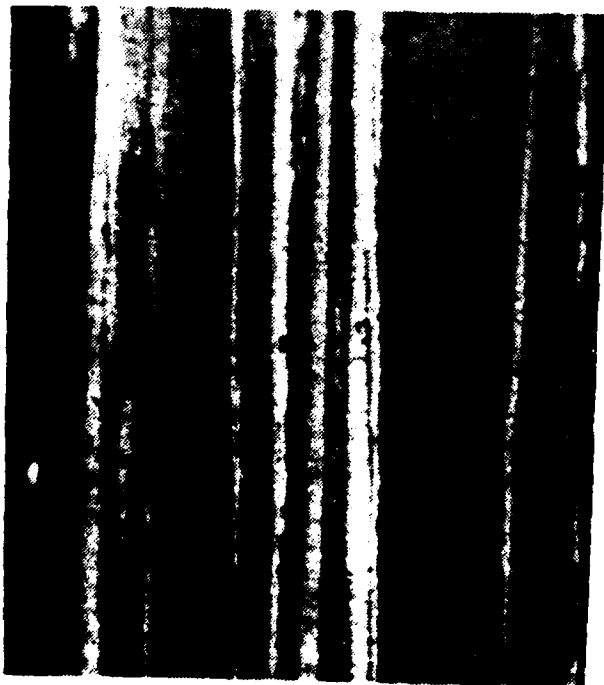
Figure 18. The as rolled/as received material after 740 hours of alternate immersion stress corrosion exposure: a) 8% Mg, b) 10% Mg, c) 10% Mg, 0.4% Cu, d) 10% Mg, 0.4% Cu, 0.5% Mn, e) 7075-T6. The Al-Mg alloys were etched for 20 seconds at 20 volts in Barkers reagent, the 7075-T6 was etched in Kellers etch for 20 seconds.

Figure 18. (continued) The as rolled/as received material after 740 hours of alternate immersion stress corrosion exposure: a) 8% Mg, b) 10% Mg, c) 10% Mg, 0.4% Cu, d) 10% Mg, 0.5% Mn, e) 7075-T6. The Al-Mg alloys were etched for 20 seconds at 20 volts in Bakers reagent, 7075-T6 was etched for 20 seconds in Kellers etch. 500X.

Figure 18. (continued) The as rolled/as received material after 740 hours of alternate immersion stress corrosion exposure: a) 8% Mg, b) 10% Mg c) 10% Mg, 0.4% Cu, d) 10% Mg, 0.4% Cu, 0.5% Mn, e) 7075-T6. The Al-Mg alloys were etched for 20 seconds at 20 volts in Barkers reagent, 7075-T6 was etched in Kellers etch for 20 seconds. 500X.

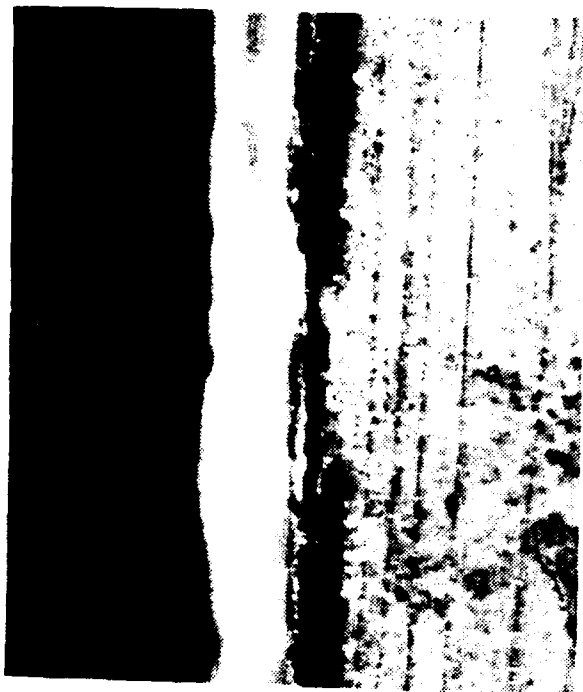
Figure 21. The annealed Al-Mg alloys after 740 hours of alternate immersion stress corrosion exposure: a) 8% Mg, b) 10% Mg, c) 10% Mg, 0.4% Cu d) 10% Mg, 0.4% Cu, 0.5% Mn. Etched at 20 volts for 20 seconds in Barkers reagent. 500X.

Figure 21. (continued) The annealed Al-Mg alloys after 740 hours of alternate immersion stress corrosion exposure: a) 8% Mg, b) 10% Mg, c) 10% Mg 0.4% Cu, d) 10% Mg, 0.4% Cu, 0.5% Mn. Etched at 20 volts for 20 seconds in Barkers reagent. 500X.

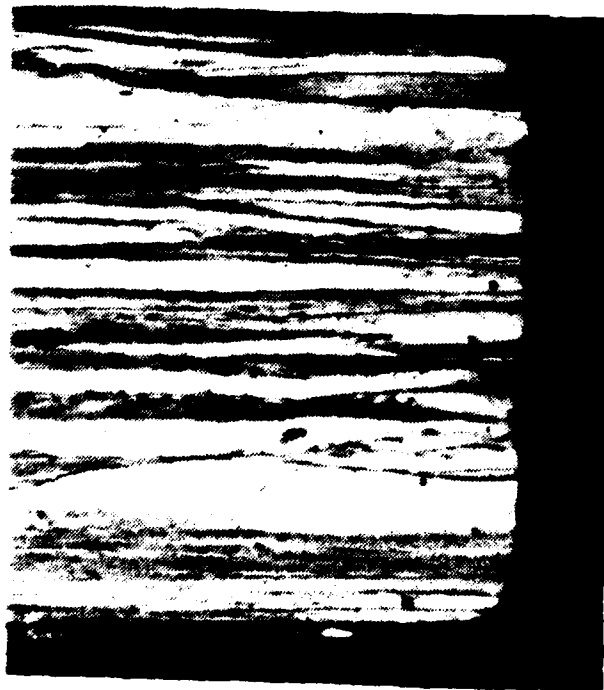
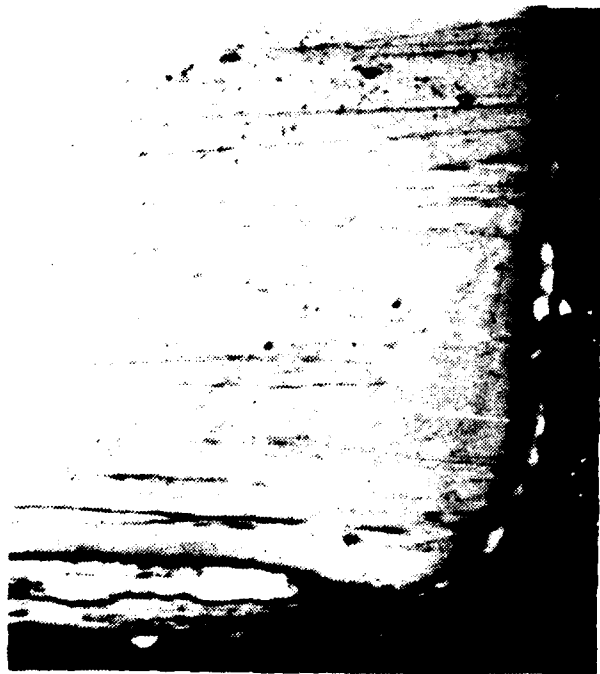
Figure 34. The ends of the general corrosion samples after 1000 hours of salt spray exposure: a) 8% Mg, b) 10% Mg, c) 10% Mg, 0.4% Cu, d) 10% Mg, 0.4% Cu, 0.5% Mn, e) 7075-T6. The Al-Mg alloys were etched at 20 volts for 20 seconds in Barkers reagent, 7075-T6 was etched in Kellers etch for 20 seconds. 500X.

Figure 34. (continued) The ends of the general corrosion samples after 1000 hours of salt spray exposure: a) 8% Mg, b) 10% Mg, c) 10% Hg, 0.4% Cu, d) 10% Mg, 0.4% Cu, 0.5% Mn, e) 7075-T6. The Al-Mg alloys were etched at 20 volts for 20 seconds in Barkers reagent, 7075-T6 was etched in Kellers etch for 20 seconds. 500X

Figure 34. (continued) The ends of the general corrosion samples after 1000 hours of salt spray exposure: a) 8% Mg, b) 10% Mg, c) 10% Mg, 0.4% Cu, d) 10% Mg, 0.4% Cu, 0.5% Mn, e) 7075-T6. The Al-Mg alloys were etched at 20 volts for 20 seconds in Barkers reagent, 7075-T6 was etched for 20 seconds in Kellers etch. 500X
