## THESIS

A CORRELATION BETWEEN THE HEAT  
AFFECTED ZONE MICROSTRUCTURE AND THE  
THERMAL HISTORY DURING WELDING OF HY-130 STEEL

MASTER OF SCIENCE IN MECHANICAL ENGINEERING

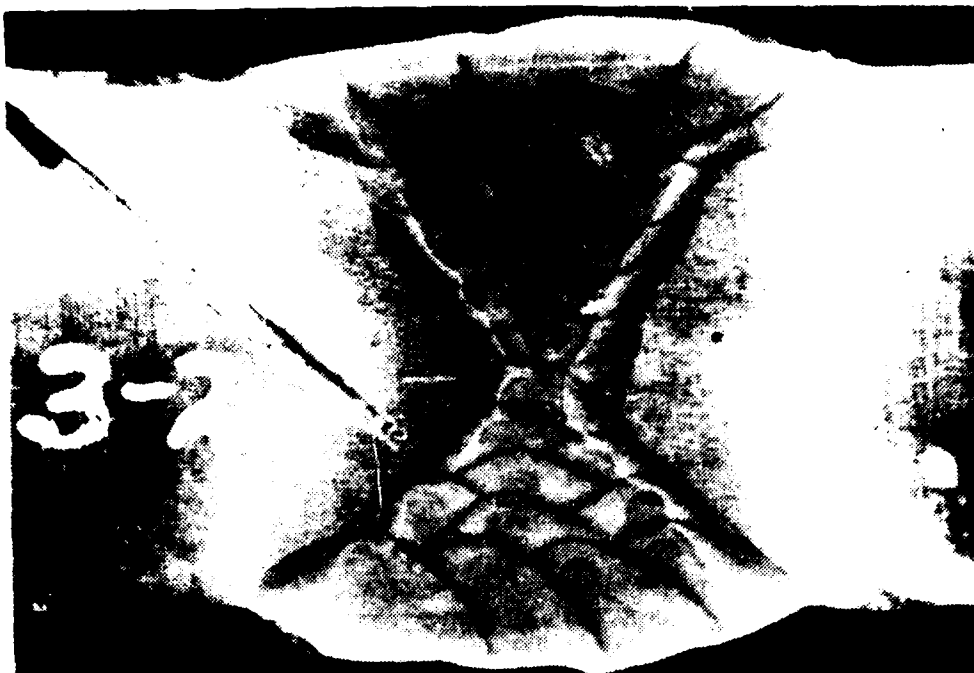
Figure 9. Location of thermocouple 3-2.

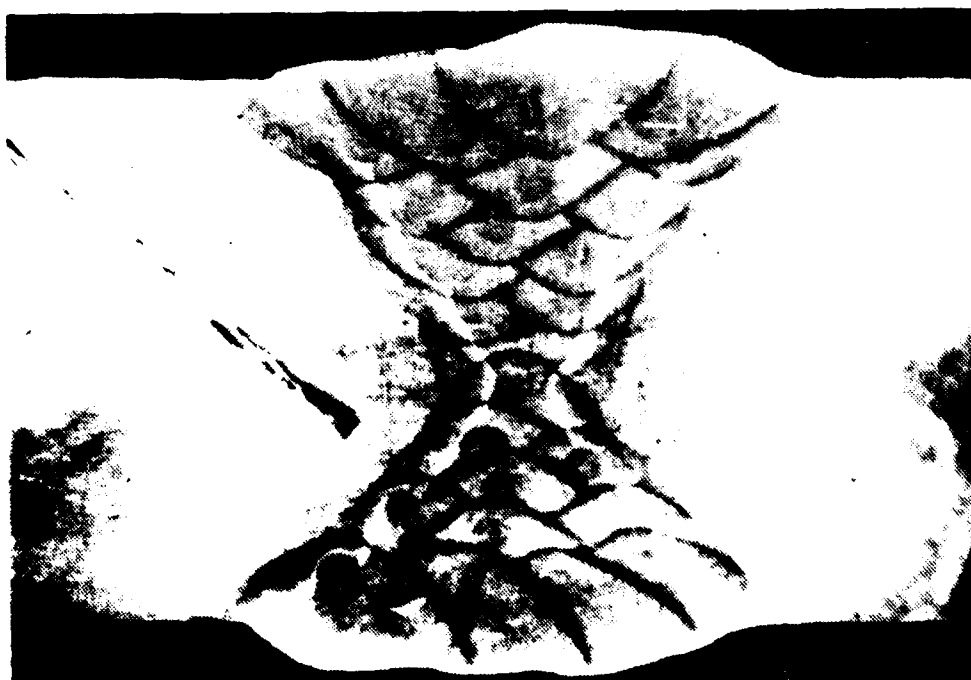
Figure 10. Location of thermocouple 3-3.
