BAYELLE COLUMBUS LABS OH  
TREND INSPECTION STATION FOR PRINTED CIRCUIT BOARD SOLDER JOINTS—ETC(U)  
SEP 81 T S SMILLIDAY, P B STULEN

Final Engineering Rept. Phase 2.2  
29 Sept. 81

Contract F09603-80-G-0420

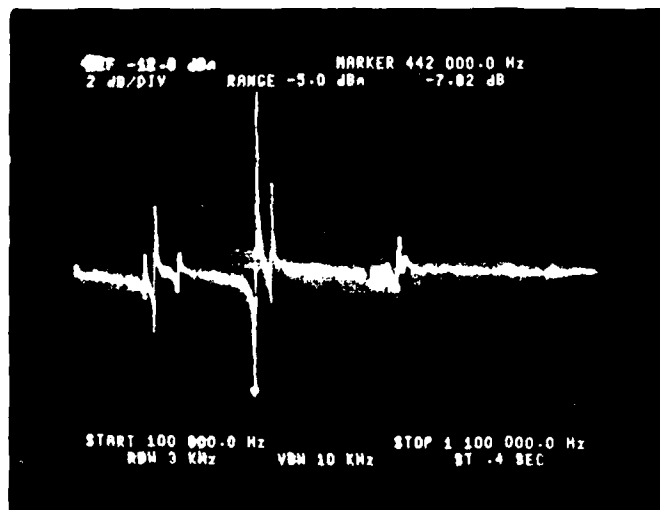
FIGURE 5b. IMPEDANCE DIAGRAM OF LONGITUDINAL TRANSMITTER  
(  $|Z|$  vs  $f$  )

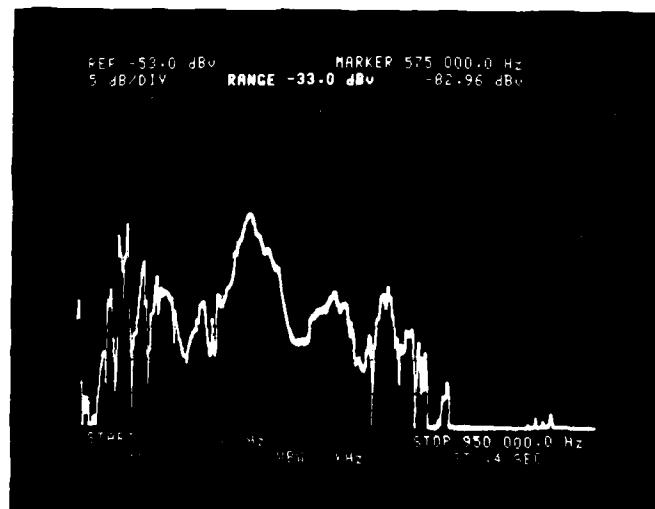
FIGURE 12a. Empty Solder-Coated Bonding Pad on Board 81-1

FIGURE 12b. A Good Joint (J1-1) on Board 81-1

FIGURE 12. TYPICAL SPECTRA FROM THE CURRENTLY USED ULTRASONIC PROBE SET
