**EROSION CONTROL DEMONSTRATION
PROJECTS STUDY
(P. L. 93-251 SECTION 32)**

**MRD HYDRAULIC LABORATORY SERIES
REPORT NO. 9**

**LABORATORY INVESTIGATION OF
EROSION CONTROL USING HARD POINTS**

U.S. Army Engineer District, Omaha District
Missouri River Division, Omaha, Nebraska
November 1977

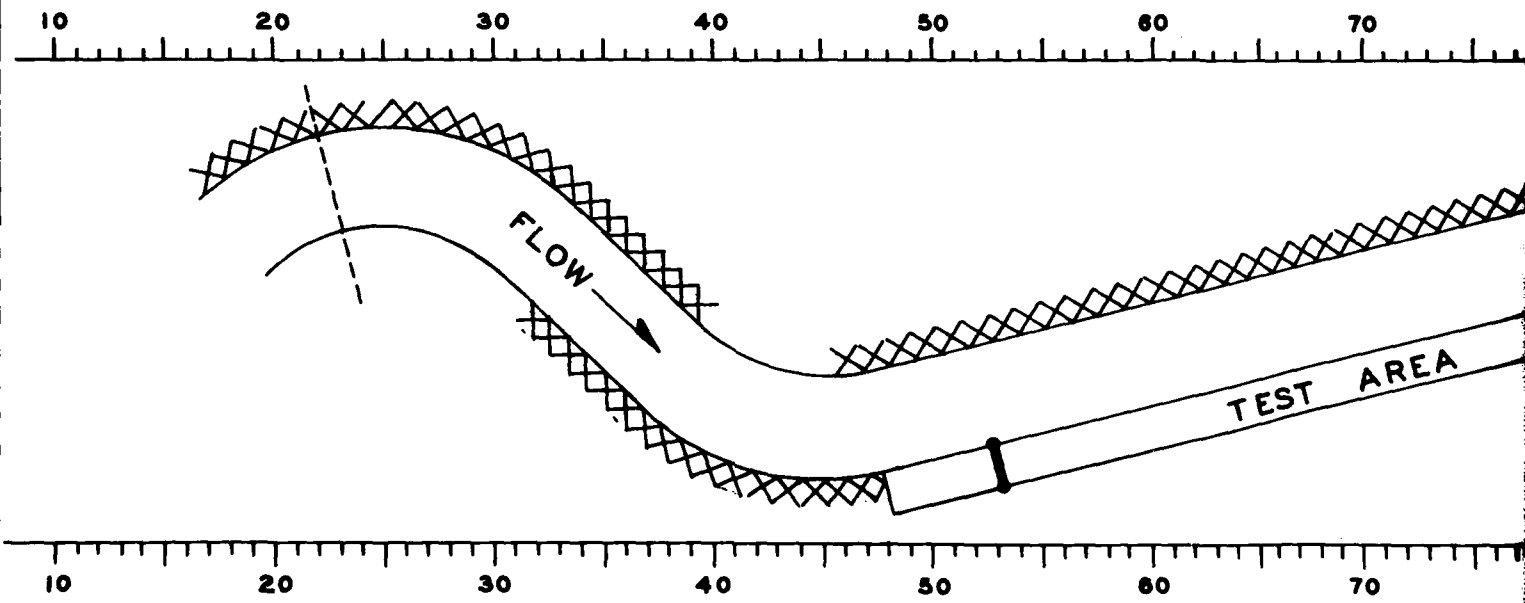
SECTION 32 DESIGN STUDY
EROSION CONTROL USING HARD POINTS
BASIN LAYOUT
U. S. ARMY ENGINEER DISTRICT, OMAHA
CORPS OF ENGINEERS OMAHA, NEBRASKA
NOV. 1977

SCALE: 1 INCH = 8 FEET

The model test channel was a straight reach alignment about 40 feet long between two curves with different radii of curvature. The basin used is shown in picture 1 and plate 1. The upstream approach and downstream exit portions of the test reach were controlled regions lined with permanent revetment. The stream bank opposite the erodible test bank was also permanently revetted to maintain a uniform flow depth. Erosion could only take place in the channel bed or along the test bank of the model.

2. In the morning after the erosion process had reached an apparent equilibrium condition, point velocity readings were taken at a control section. The location of the control section is shown on plate 1. The data obtained was used for a check on the selected control parameters.
