BONDABILITY OF TI ADHERENDS

Martin Marietta Laboratories  
1450 South Rolling Road  
Baltimore, Maryland 21227

30 April 1980

Final Report 4/1/79 - 3/31/80

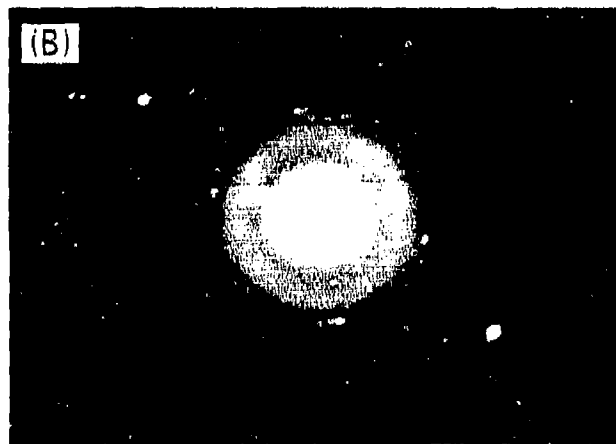
Figure 11. (A) bright field transmission electron micrograph and (B) electron diffraction pattern of an oxide grown using the 10V CAA process. The diffraction pattern identifies the oxide as having a rutile crystal structure.
