USAAEFA PROJECT NO. 79-13

# CLIMATIC LABORATORY EVALUATION YCH-47D HELICOPTER

FINAL REPORT

AUGUST 1981

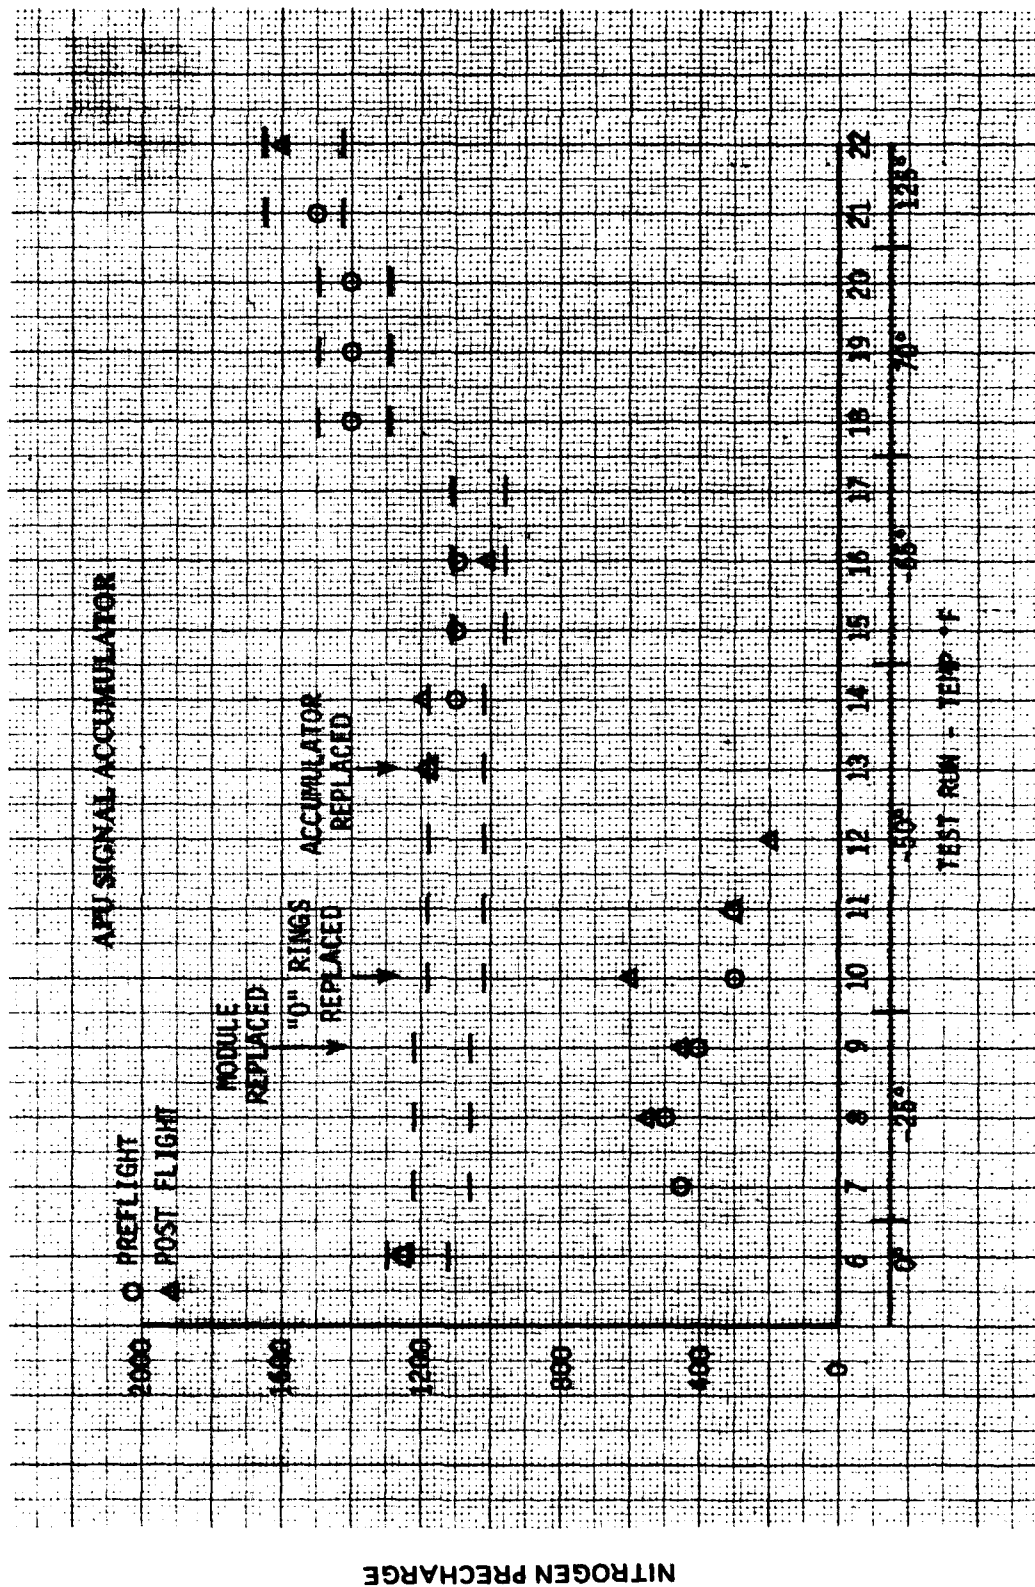
FIGURE 1  
HYDRAULIC ACCUMULATORS  
YCH47D US ARMY S/N 76-8008

DASH LINES DENOTE HANDBOOK RANGE

17. The APU start and signal accumulators would not hold a precharge below -25° F. The start accumulator failed to accept or hold a charge on one occasion at -65° F and was removed from the aircraft. Upon reaching 70° F the APU start accumulator functioned normally and was reinstalled and used for the remainder of the testing including additional runs at -65° F. The hydraulic section (para 46) has a more detailed discussion of the failure of the accumulators to hold a precharge.

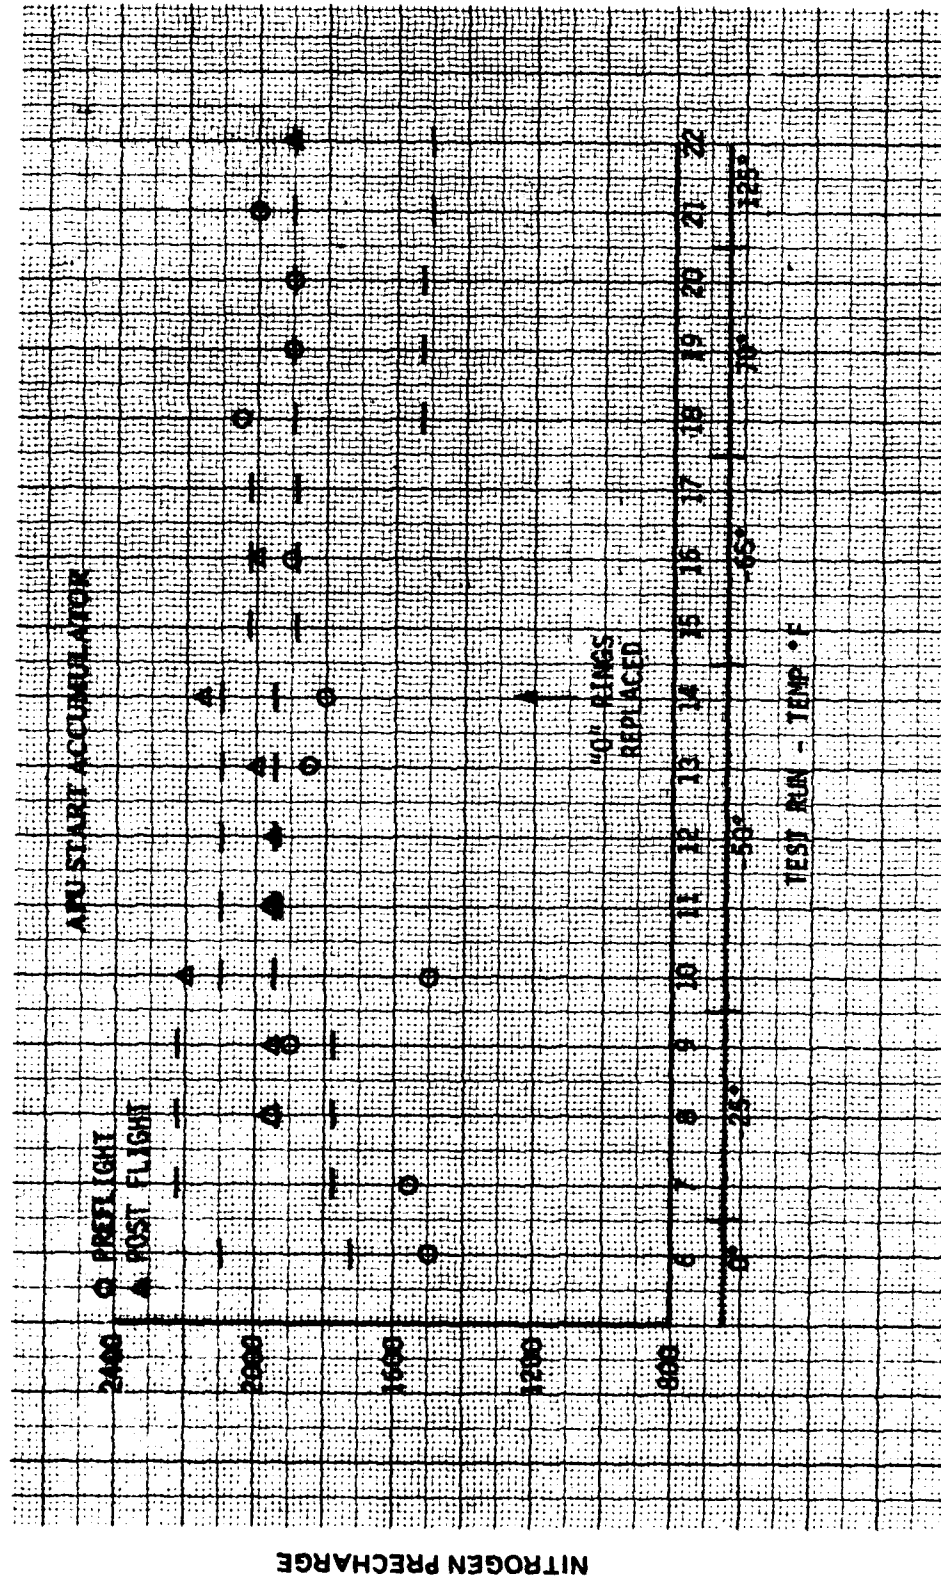
FIGURE 2  
HYDRAULIC ACCUMULATORS  
YCH-47D US ARMY S/N 76-8008

DASH LINES DENOTE HANDBOOK RANGE

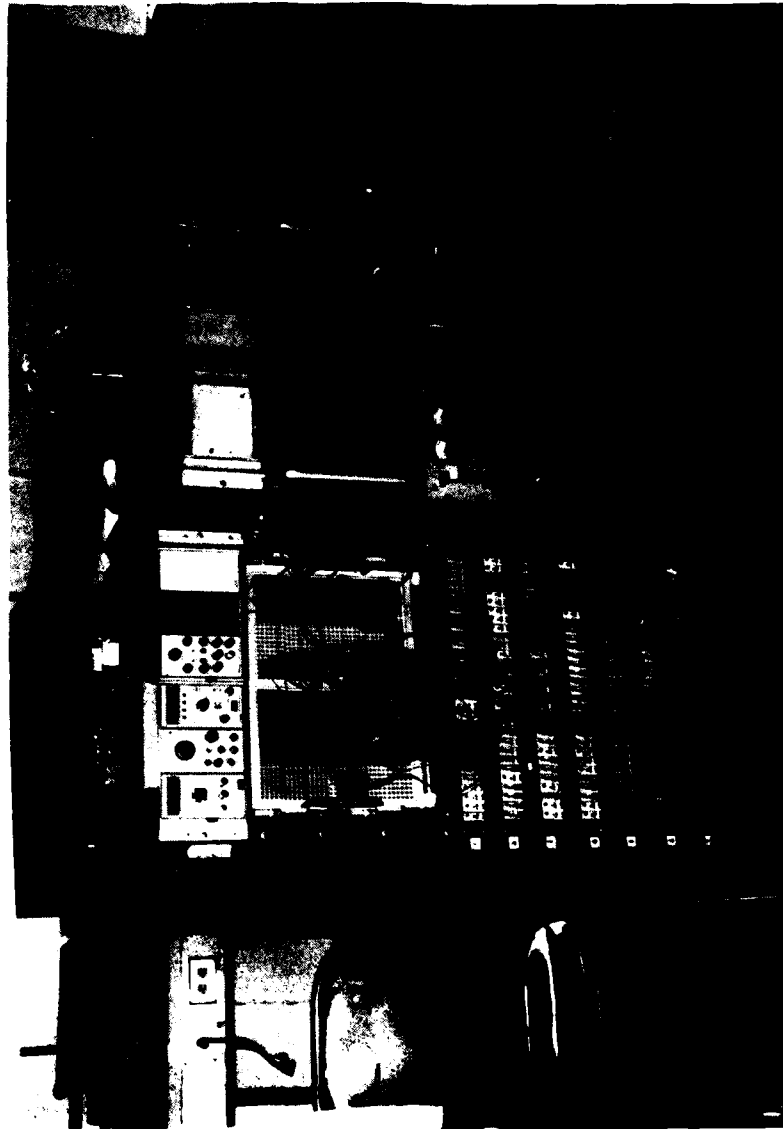
Photo 1. Instrumentation Package

2. The following calibrated test instrumentation was installed on the aircraft. The parameters annotated in the display column by CRT (CRT display furnished by the Climatic Laboratory) were displayed during the tests and retained as desired on permanent copy. All parameters were recorded on magnetic tape. The four CRT data presentations utilized on this program are included in table 1.
