CONTRACTOR REPORT ARLCB-CR-82014

CHARACTERIZATION OF "WHITE LAYER" AND CHROME PLATING  
ON FIRED CANNON AND ON LABORATORY SIMULATION SAMPLES

R. M. Fisher and A. Szirmae  
U. S. Steel Corp., Research Laboratory  
Monroeville, Pa. 15146

June 1982

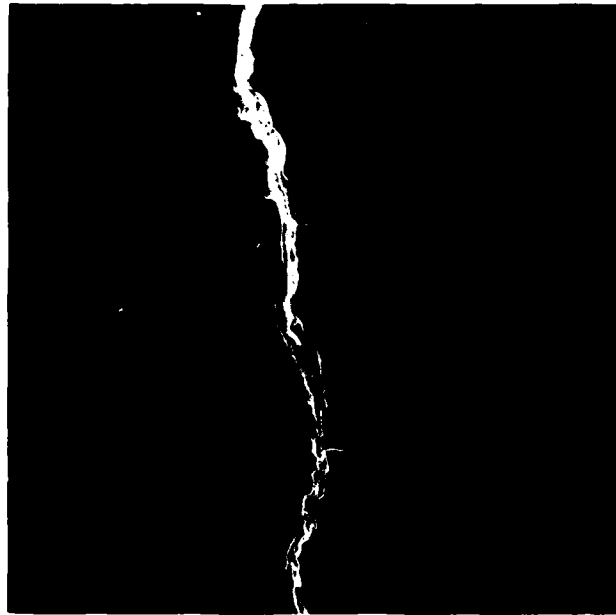
Figure 6

Scanning micrographs and X-ray spectra of material in cracks about 200  $\mu\text{m}$  below the surface.

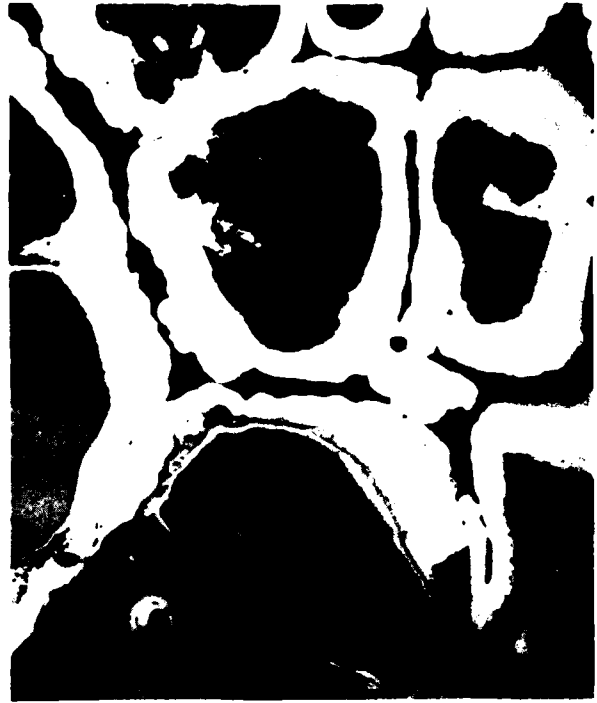
Figure 12

Optical and scanning electron micrographs of 3° Ni-plated cross section of T-45. White areas are nickel plating. Areas marked in (c) were analyzed for carbon by Auger spectroscopy.

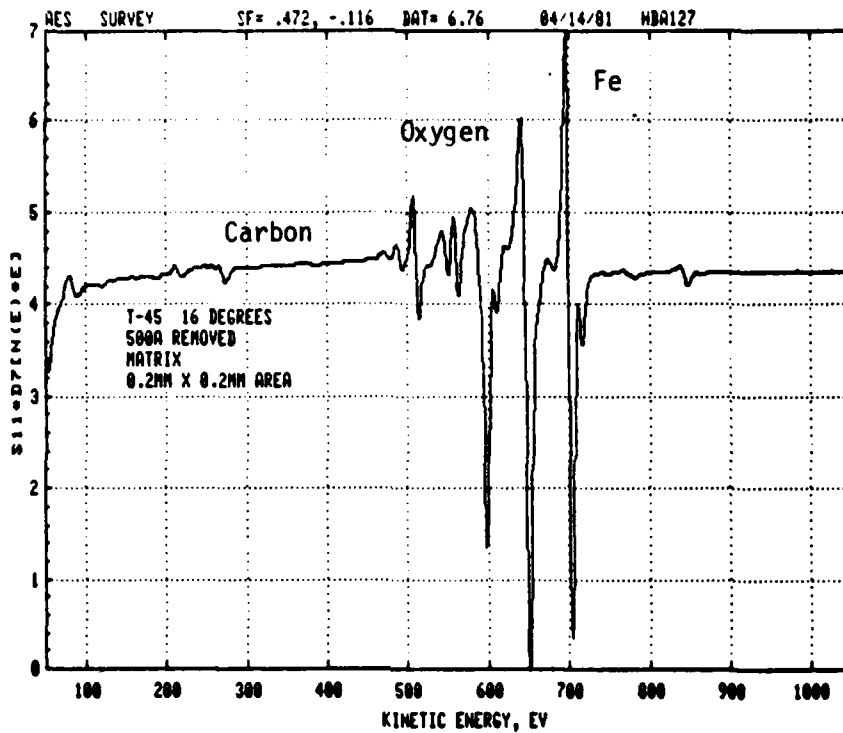
Fig. 13. Auger spectra of steel matrix (top) and sub-surface austenite (bottom - see figure 14).

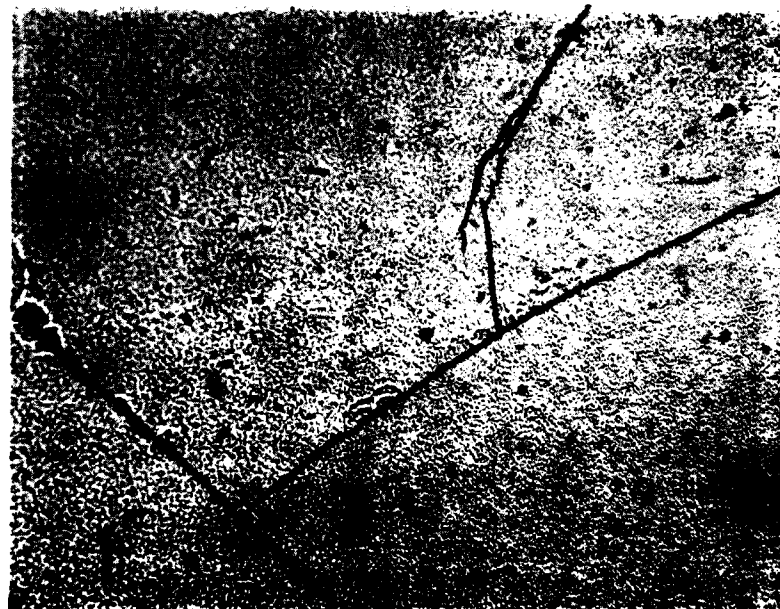
Figure 8

Optical micrographs of chromium electrodeposited at 85°C showing Knoop hardness values (a), and coarse microcracks in cross section (b), and surface section (c).

Sample B, (chromium electrodeposited at 85°C) was examined in the manner described in the preceding section of this report. Optical micrographs of the cross and surface sections are shown in Figure 8, and scanning electron micrographs in Figure 9. It may be noted that the hardness of 650 KHN is about half that of sample A and the crack spacing is about 10X coarser. High-voltage electron microscopy of ion-thinned sections of the 85°C sample revealed a much coarser grain size and more random grain orientations, as illustrated in Figure 10.

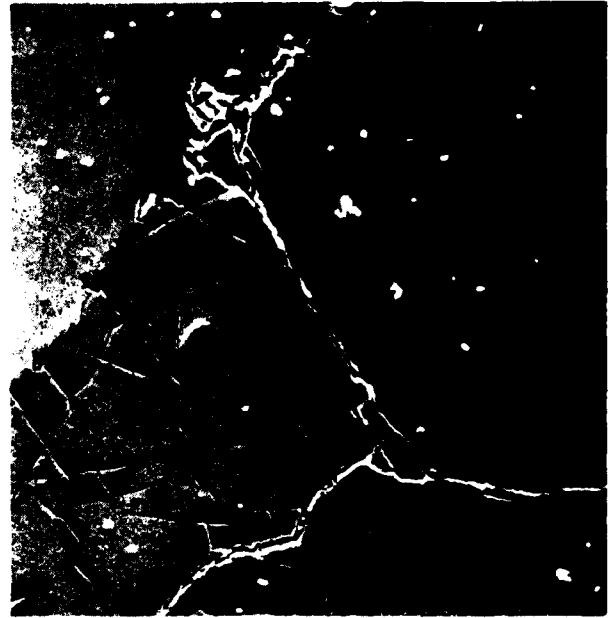
Scanning electron micrographs of mechanically polished cross section of chromium electroplate on a fired cannon.

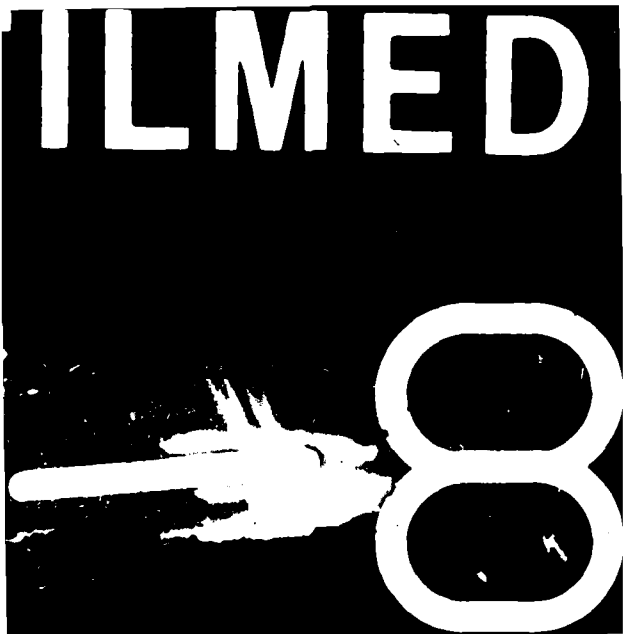
HVEM of chromium electroplate stripped from surface of  
fired cannon.

14 after electropolishing. The grain, dislocation, and crack structures in thin foils are illustrated in the high-voltage micrographs in Figure 15. The cracks are wider and more complex after firing as compared with annealing at 870 to 900°C for laboratory samples. During firing the surface is heated to >1100°C for a few milliseconds and is also exposed to explosive pressures. More detailed study of the crack structures should be carried out.
