AFWAL-TR-82-4016

DEVELOPMENT AND EVALUATION OF WIDE CLEARANCE  
BRAZE JOINTS IN GAMMA PRIME ALLOYS

J. W. Chasteen  
University of Dayton  
Research Institute  
Dayton, Ohio 45469

Final Report for Period May 1, 1979 - May 1, 1981

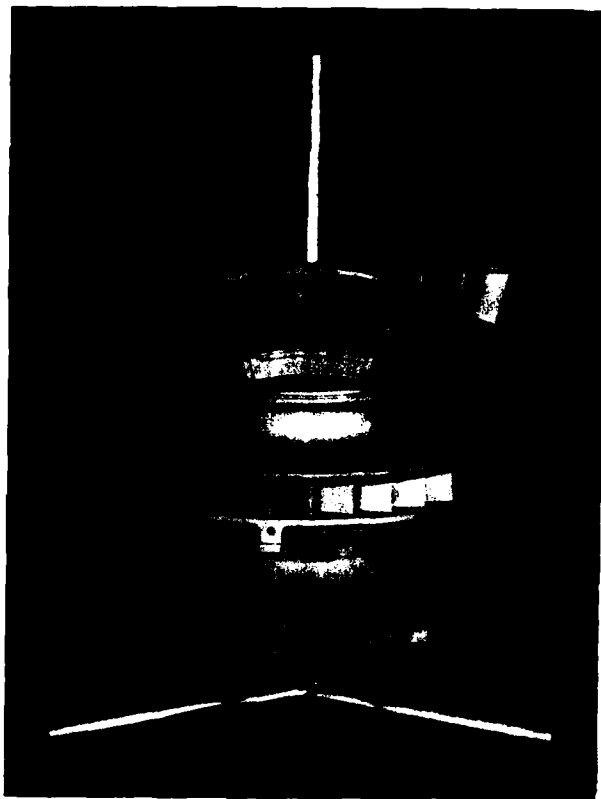
Figure 11. Fixture tree assembly of parts as they were placed in the fluorocarbon cleaning retort.

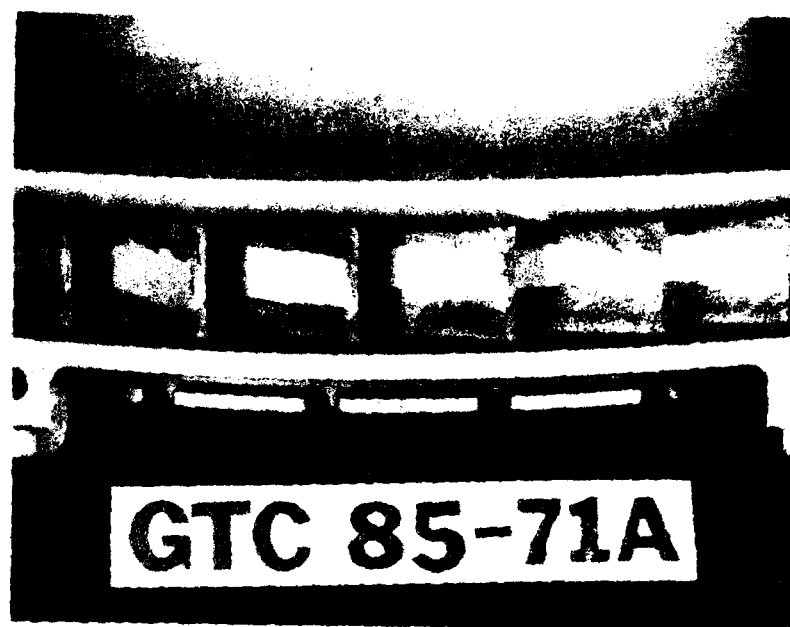
Figure 15. The nozzle of Figure 14 after application of the area brazes.

The leading edges were built-up by applying a 2:1 mixture of Nicrogap 108 and Nicrobraz 200 suspended in Nicrobraz Cement No. 500. The mixture was applied by layers dropped on with an eyedropper. The dried green deposits were then dressed with an abrasive cloth and made to conform to the blade contour. This assembly was then brazed in vacuum at 2065°F for 1/2 hr. The result of this operation is shown in Figure 13. The edges were then mechanically dressed (see Figure 14) and the area brazes were applied. These were brushed on from a suspension of Nicrobraz 200 in Nicrobraz Cement No. 500 thinned with acetone. Area braze was applied to the other nozzle as well. Photographs of the nozzles at this stage of repair are presented in Figures 15 and 16.
