Special Report 82-6

Cold Regions Research &
Engineering Laboratory

Meteorological conditions causing major ice jam formation and flooding on the Ottauquechee River, Vermont

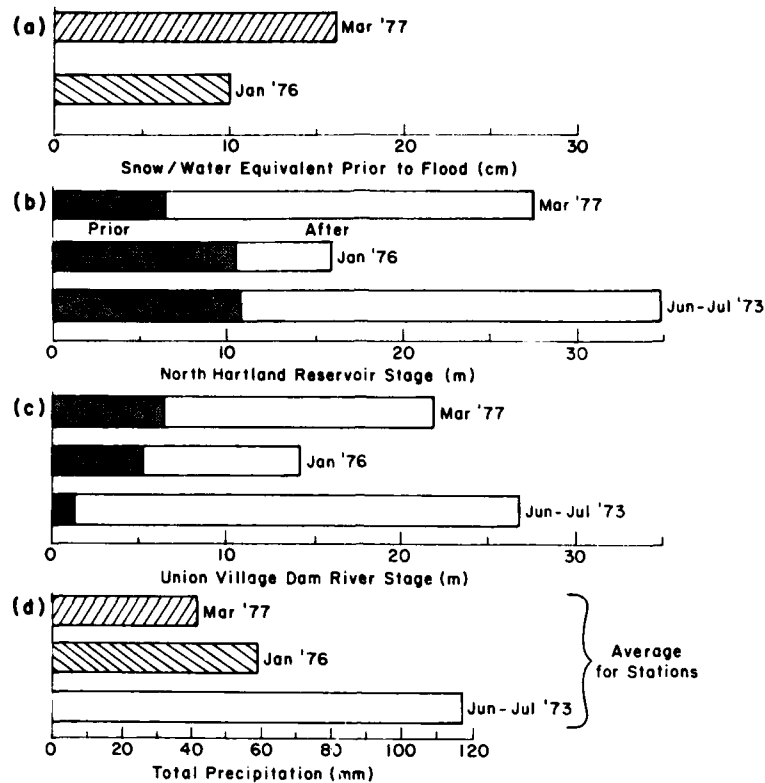
Figure 3. Snow water equivalencies, stage heights and precipitation totals.

In January, the precipitation for Woodstock, Vermont, was 164% of the normal amount and precipitation during the flood period accounted for over one half of this amount (Table 1, Fig. 1). Figure 1 shows that all three drainage basins - the Ottauquechee River, White River and Ompompanoosuc River - received greater than 60 mm (2.4 in.) of rainfall. The combination of above-freezing temperatures and heavy precipitation on a snow cover with an already high water equivalent (greater than 10 cm, Fig. 2) caused the river to rise (Fig. 3b, 3c), inducing extensive flooding and jamming.

Furthermore, as demonstrated in Table 3 and Figures 3b and 3c, the river stages at Union Village Dam and at North Hartland Reservoir were much higher in the summertime flood than in either wintertime flood. The reason for lower stage levels during the wintertime floods is reflected in the nature of the river ice cover. The rafted ice cover and jamming upstream formed a dam that restricted peak water flow from reaching the North Hartland Flood Control Dam recording gage. The increased water flow down the river caused by rain and tributary flow raised the level of the ice cover

which was weakened in both January 1976 and March 1977 by warm temperatures and runoff from the high water equivalency of the snow cover (Fig. 2, 3a, 5). Given these meteorological conditions, the weakened ice broke up and moved downstream, where it became grounded and jammed at the various locations along the Ottauquechee River.

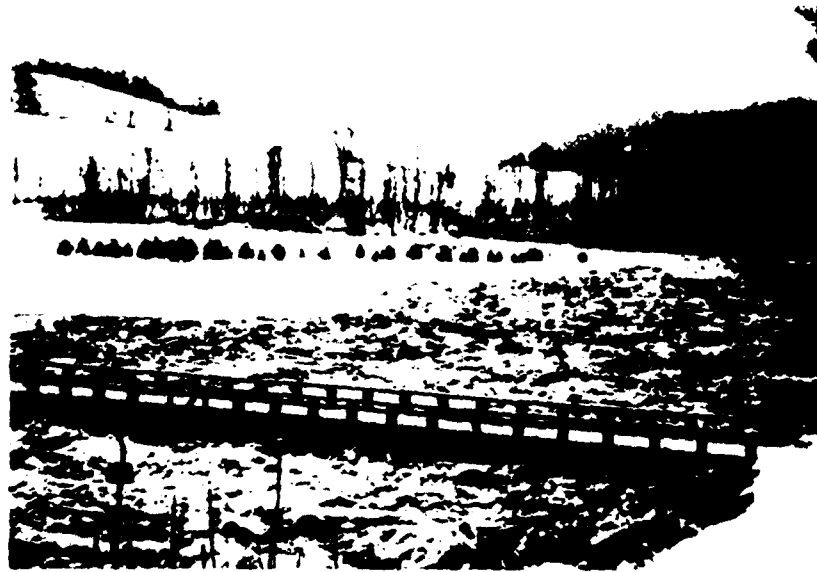
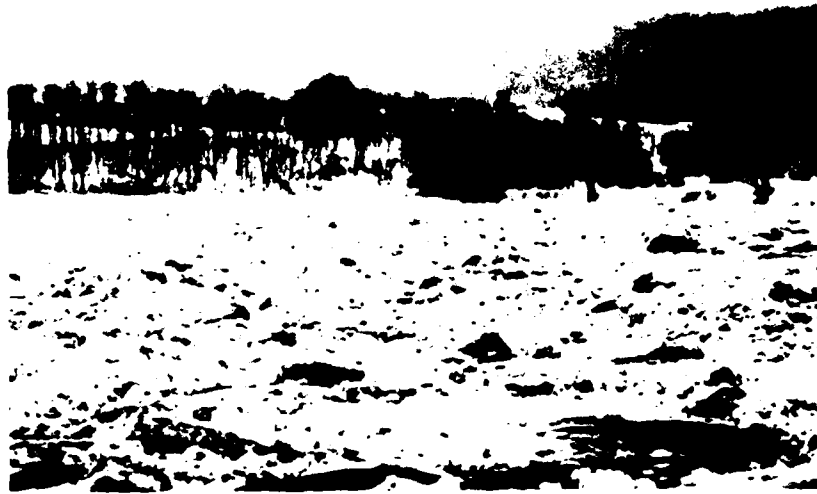
Figure B1. January 1976, Quechee.

Figure B2. January 1976, Quechee.

Figure B3. January 1976, Quechee.

During the period 26-28 January 1976 severe ice jamming and flooding was observed on the Ottauquechee River (Fig. B1-B3). Prior to the ice jam of January 1976, greater amounts of ice were observed in the Ottauquechee River than during the same period of the next two winters.

1. Bridges: Elm St. Bridge in Woodstock
Quechee Lakes Bridge (see Fig. B1)
2. Dams/ponds: Taftsville Pond
Quechee Mill Pond
Hartland COE Dam/Pond
3. Near the Woodstock sewage treatment plant (double oxbow)
4. Deep-water pools and low water velocity areas where there is little elevation change (thus facilitating grounding of the ice cover).
5. Shallow areas where the river bends or changes direction.

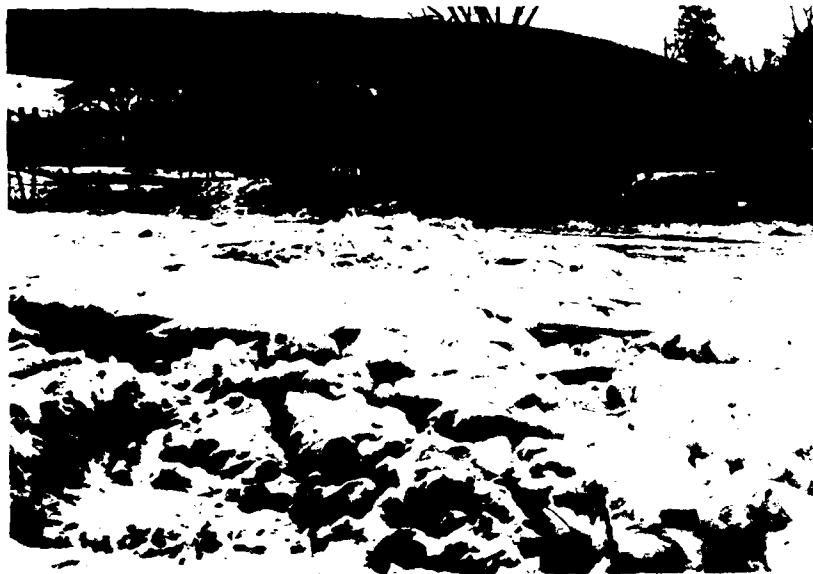
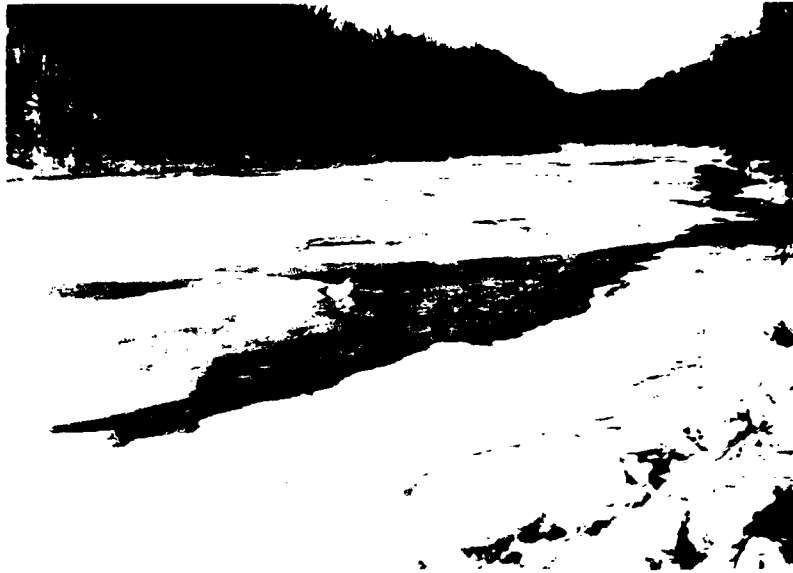
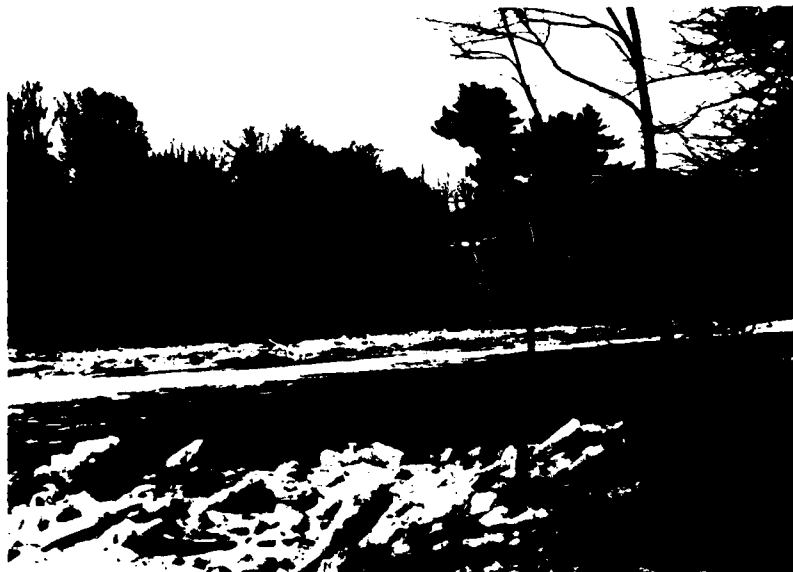
Figure B4. December 1976, Taftsville.

Figure B5. December 1976, Taftsville.

Figure B6. December 1976, Taftsville.

All three winter periods (1975-76, 1976-77, 1977-78) monitored by CRREL personnel along the Ottauquechee River were characterized by the occurrence of ice jams in either December or January. For example two small ice jams unaccompanied by significant rainfall formed during 11-12 December 1976 (Fig. B4-B6) and 4-9 January 78. A third jam formed in late

An ice jam that formed on 11-12 December 1976 and froze in place on the Taftsville and Quechee mill ponds preceded the severe ice jam of 13-14 March 1977 (Fig. B4-B6). This early winter ice jam was caused by warm
