CERAMIC GAS TURBINE ENGINE DEMONSTRATION PROGRAM

May 1982

Final Report, January 1976 to May 1981

GARRETT TURBINE ENGINE COMPANY
A DIVISION OF THE GARRETT CORPORATION
P.O. BOX 5217, PHOENIX, AZ 85010

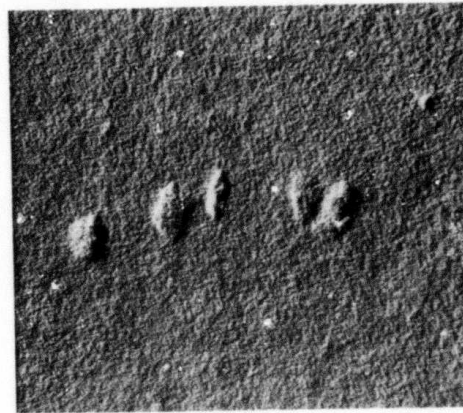
P59885-2

(B) CARBON INCLUSIONS - BOTH COMPUTERIZED OUTPUTS
ARE OF 0.010 INCH CARBON.

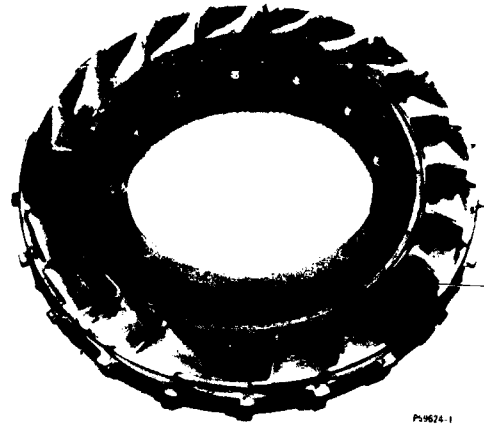
ARROW INDICATES CIRCUMFERENTIAL SEPARATION WHICH INITIATED AT AN OD SUPPORT LUG AND TERMINATED IN THE AXIAL DIRECTION ON THE FRONT AND REAR SURFACES

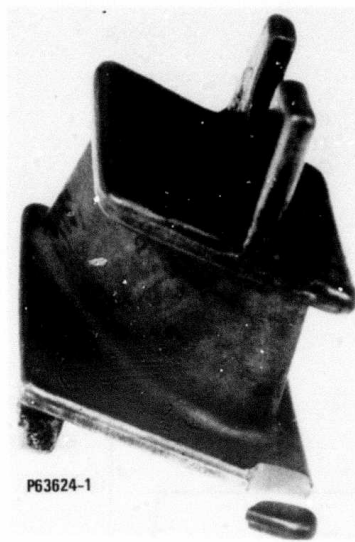
P63624-1

PART 3101976-2, S/N 177

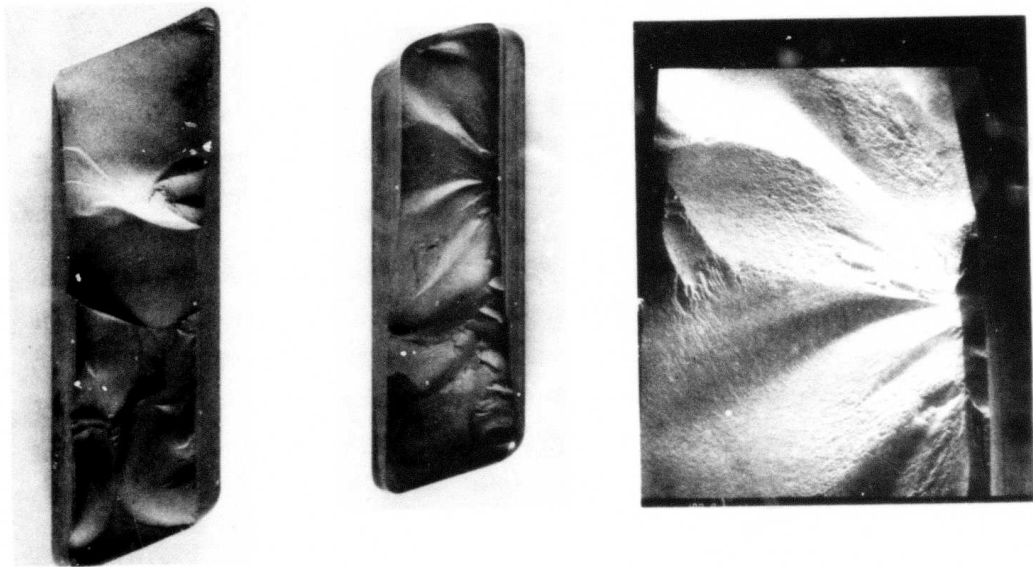
Figure 6-15. SEM Photomicrographs Showing the Fractured Surfaces of Blades that Fractured Below the Platform in Test 17 of Engine CE001.

While replacement ceramic hardware was being prepared for Engine CE 002, Engine CE 001 was assembled as Build 17. Build 17 used match ground first- and second-stage stator vane assemblies with platforms radiused at shroud contact positions. The metal aft ring was coated with cobalt instead of gold. Compatibility studies had shown that the cobalt would oxidize and provide a low friction oxide surface. The objective of Engine CE 001 Test 17 was a two-hour cycle to 41,730 rpm and 2200°F. Forty-eight minutes into the cycle, while at full speed and approaching 2200°F, engine failure occurred and all ceramic parts fractured. The metal turbine-to-gearbox coupler sheared, and the prop shaft drive pins bent. One first-stage and one second-stage rotor blade fractured below the platform. The fracture surfaces are shown in Figure 6-15. The second-stage blade failed due to a tensile overload in bending. This likely resulted from a combination of the centrifugal load plus cantilevered bend loading due to impact. Much secondary cracking was present at the first-stage blade fracture, but the fracture origin was missing so that a precise cause could not be postulated. Neither blade fracture surface showed any evidence that vibration was involved. The remaining blades fractured above the platforms due to impact, as shown in Figure 6-16.

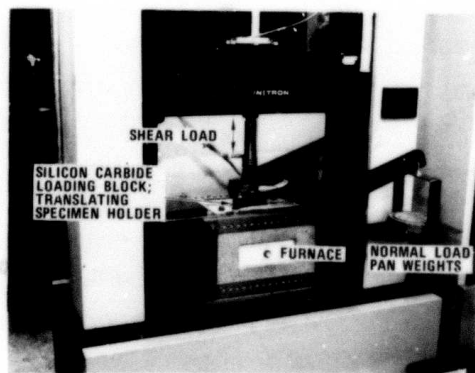
A new contact test apparatus was designed. As shown in Figure 7-2, it consisted essentially of a furnace, a leveraged dead-weight* load train for applying a normal force, and a test machine** for applying relative motion and recording the resulting tangential force.^{14,75} The following typical test sequence describes the specimen configurations and the test procedure.

Figure 7-2. Schematic and Photographs of the Contact Test Apparatus.

Step 1 - Specimen Positioning - The two ceramic test bars are inserted into notches in the load plate and load block so that the long axes are perpendicular to each other. Both specimens are crowned on one surface and flat on the opposite surface. By selectively pairing the surfaces to be in contact, point loading, line loading or area loading can be achieved. Further test variation can be achieved by placing a compliant layer material or a lubricant between the two test bars. The specimen fixturing is made of hot-pressed SiC.
