ADVANCED FLIGHT CONTROL ACTUATION SYSTEM (AFCAS - E/P)

**Fabrication and Design Verification Testing of a
Dual Mode Electro/Pneumatic Actuator for the
T-2C Aircraft**

Bendix Corporation
Flight Systems Division
Teterboro, New Jersey

APRIL 1982

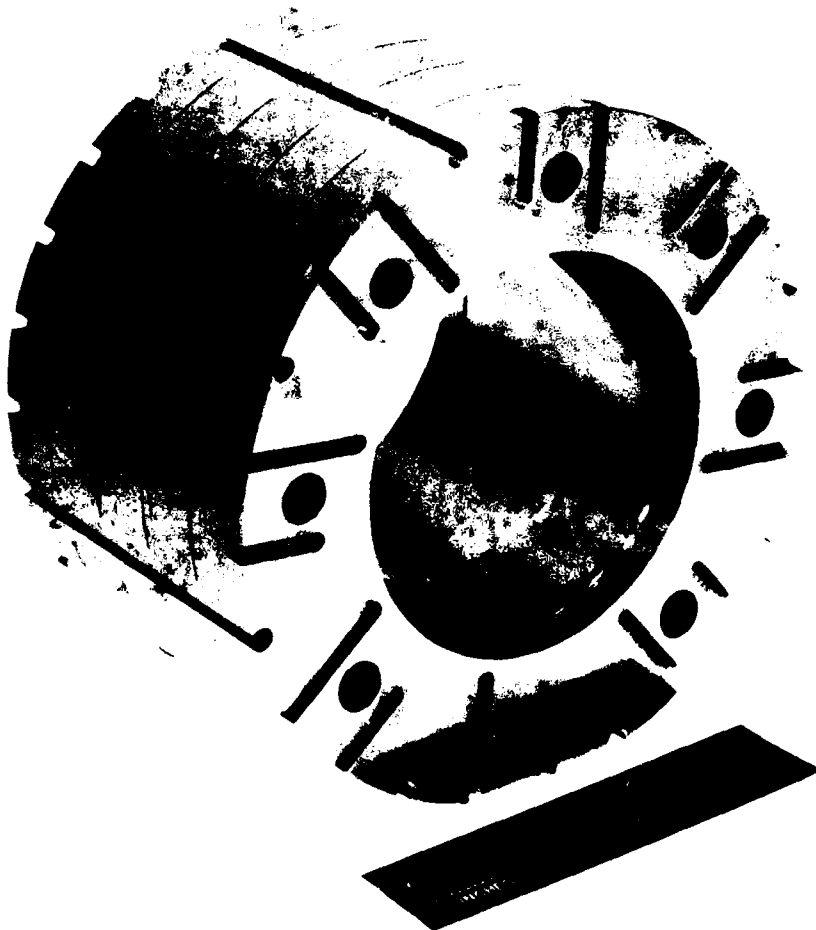
ROTOR
FIGURE 7
