TECHNICAL REPORT GL-82-7

# MEMBRANE-SOIL COMPOSITE LAYERS IN THE DESIGN, CONSTRUCTION, AND PERFORMANCE OF AN EXPEDIENT BRIDGE AND APPROACH

George L. Regan

September 1982

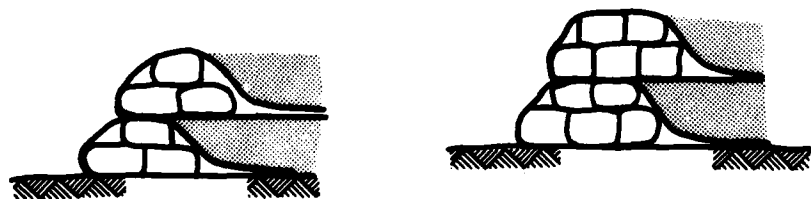
Figure 20. Recommended construction technique and sandbag configuration for layered approaches

- c. Construction and performance of similar structures designed for load class 60, high-volume traffic should be evaluated.
- d. In design and construction of layered approaches, a modified technique, consisting of a more stable sandbag arrangement along the facing, should be used. A recommended facing technique, using staggered sandbags, is shown in Figure 20.

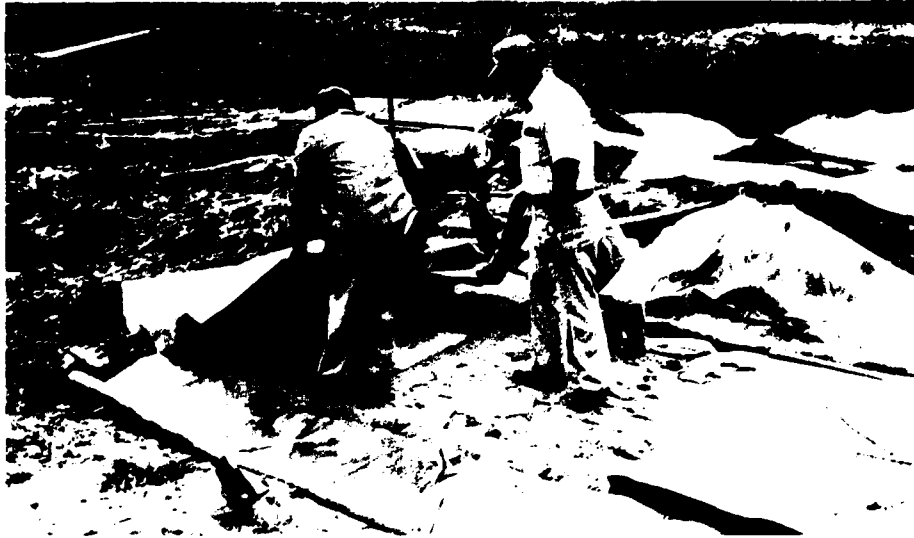
Photo 11. Closing flaps of membrane support layer (note plywood board)

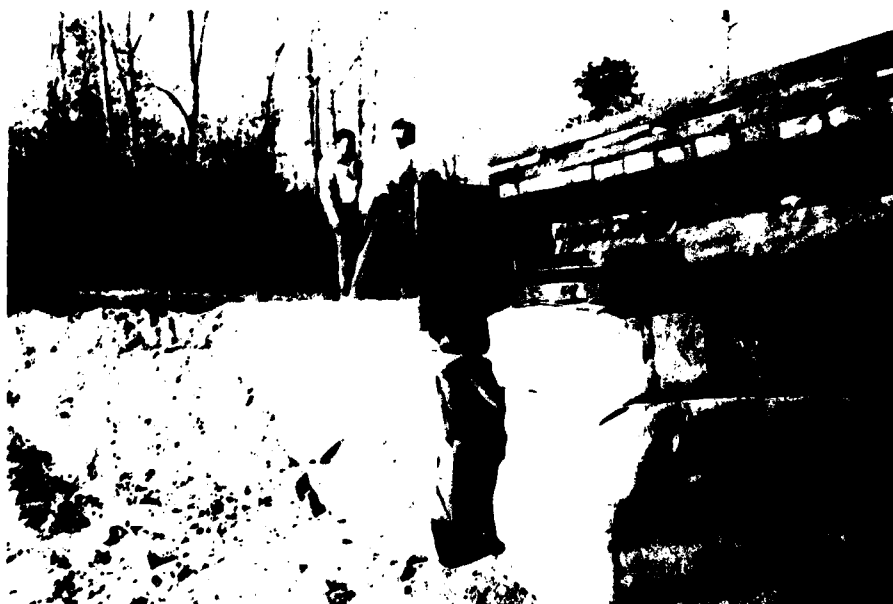
Photo 24. Layered approach construction  
north of support 4

43. The preceding general steps were followed; however, construction problems led to the use of two building techniques on the north approach. In the first technique, shown in Figure 14, facing sandbags were stacked three layers high, membrane was not overlapped at the interior, and inner sandbags were placed adjacent to facing sandbags to hold membrane in place. This technique was used on the lower three layers. As the approach was built higher by filling and compacting the lean clay soil, more outward leaning and lateral movement of the wall faces was observed. Technique 1 and the effect of using Technique 1 can be seen in Photos 23 and 24, respectively.
