## REPETITIVE SWITCHING FOR INDUCTIVE ENERGY STORAGE

JOHN P. BARBER  
THOMAS J. TRZASKA

AUGUST 1982

| REPORT DOCUMENTATION PAGE | | READ INSTRUCTIONS<br>BEFORE COMPLETING FORM |
|---|---|---|
| 20. ABSTRACT (Continue on reverse side if necessary and identify by block number)<br>This report describes the development and testing of a high current repetitive switch. The objective was to develop a switch capable of repetitively diverting current and energy from an inductive energy store into a load. A mechanical switch employing sliding electrical contacts was built and tested. The switch demonstrated performance exceeding design goals. In an inductive energy storage circuit the switch successfully commutated a current of 7640 A at a repetition rate of 33 Hz. The switch has | | |

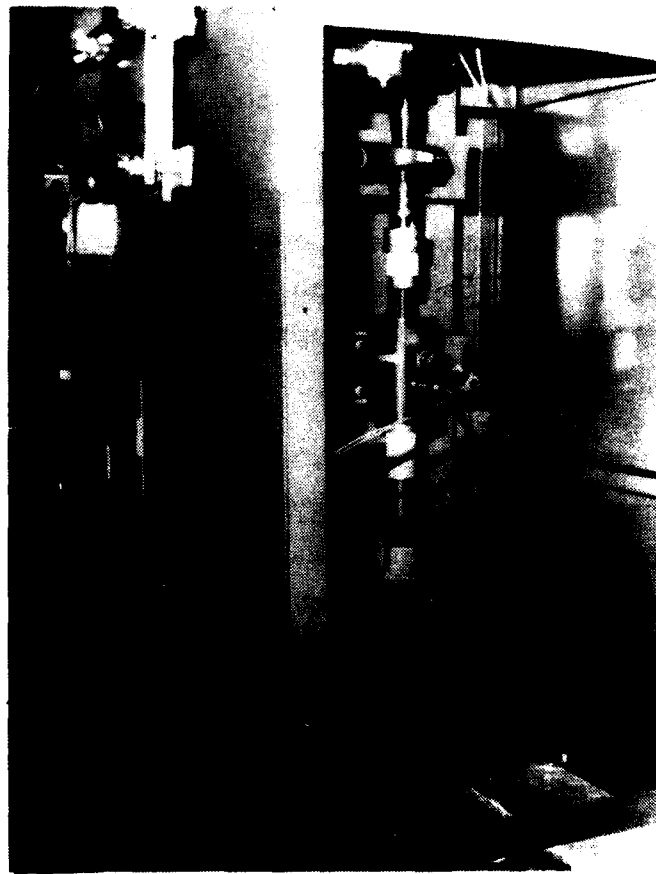
The rotor drive system was based on a 10 HP AC motor with a variable speed drive. The motor was mounted vertically in a welded steel frame and direct coupled to the rotor via a torque transducer. The drive motor, torque transducer and couplings are illustrated in Figure 4. The motor and variable speed drive are capable of operation at any speed between 0 and 4000 RPM.

Figure 4. The Motor and Drive Train Assembly Installed.
