**US Army Corps  
of Engineers**

December 1981

**THE STREAMBANK EROSION CONTROL  
EVALUATION AND DEMONSTRATION ACT OF 1974  
SECTION 32, PUBLIC LAW 93-251**

## Appendix B - Hydraulic Research

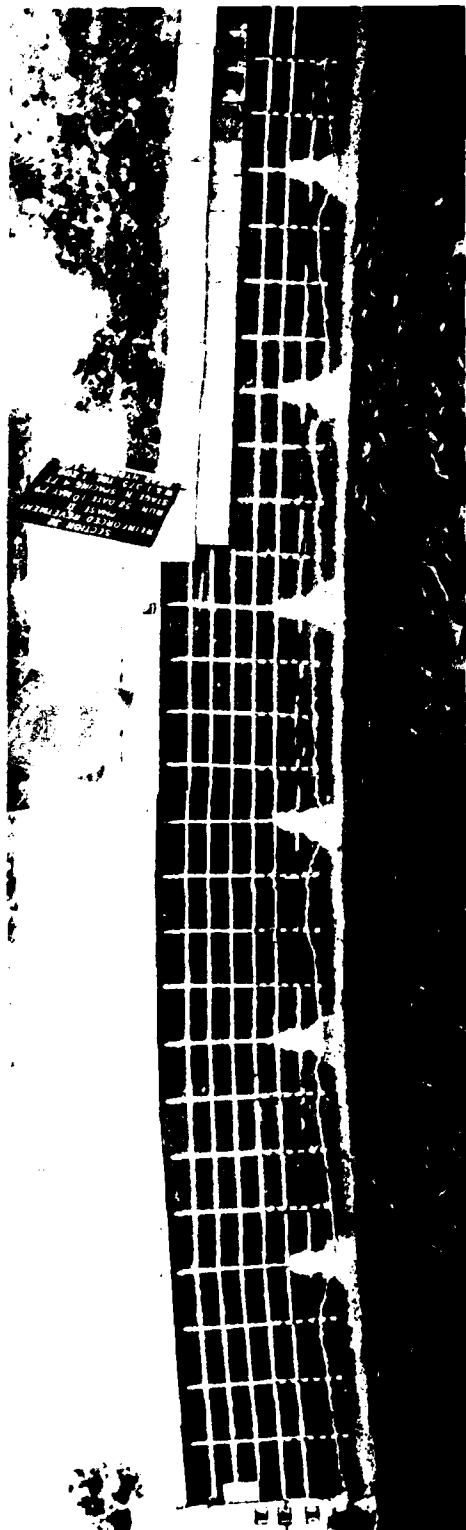
Photo 32. Overhead view of test area at the end of Run 58, Type I. Tieback spacings of 4 feet (160 feet prototype), toefill crown was at elevation 0.18 foot below NWS, and stage at NWS (unprotected depth of 0.18 foot).
