MECHANICAL PROPERTY DATA ON P/M ALUMINUM X7091-T7E69

J J RUSCHAU ET AL. OCT 82 UDR-TR-82-99 AFWAL-TR-82-4161

Interim Report for Period August 1981-July 1982

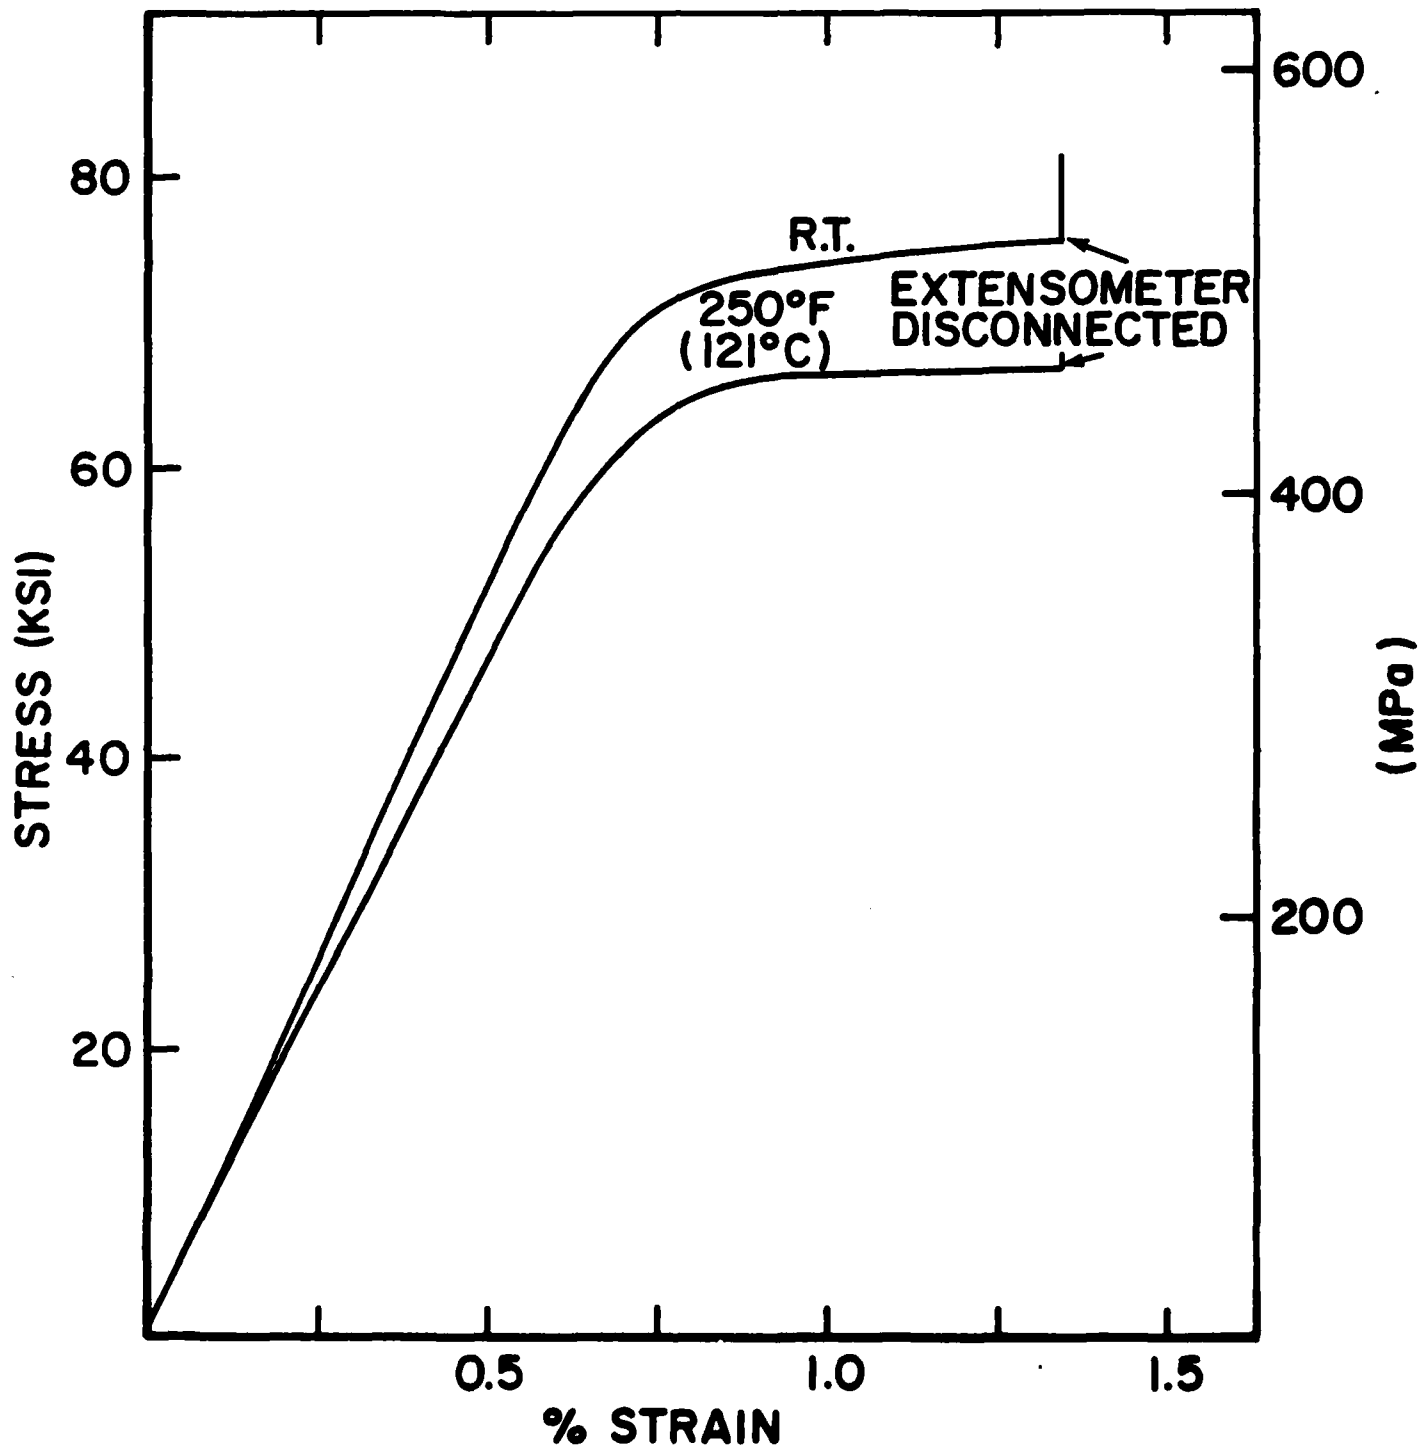
Figure 7. Typical σ - ϵ Tensile Curves for X7091-T7E69 at Room Temperature and 250°F (121°C).

Typical stress-strain curves for room temperature and 250°F (121°C) tensile tests are presented in Figure 7. Stress-strain response for both longitudinal and transverse directions appeared similar at both test temperatures; consequently, only longitudinal specimen data are presented. Typical room temperature compression stress-strain curves for both longitudinal and transverse directions are illustrated in Figure 8.

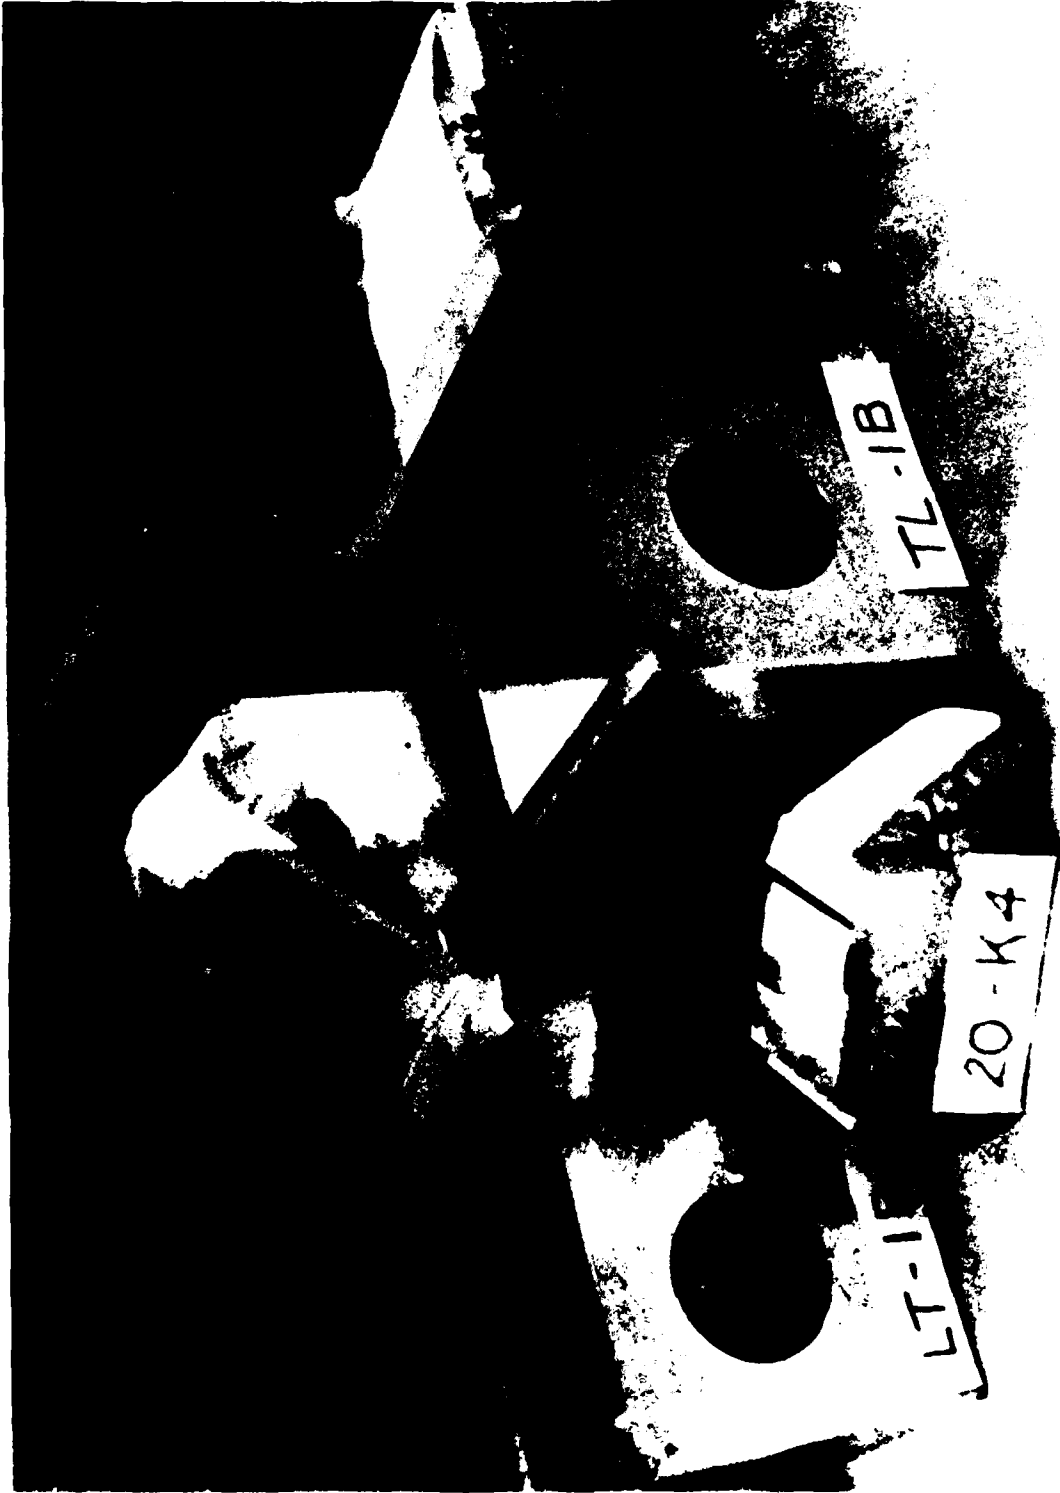
Figure 9. Fracture Appearance for X7091-T7E69 Toughness Specimens.

Fracture results are presented in Table 2 for both L-T and T-L orientations. Due to the apparent high toughness and limited material thickness, only one valid K_{IC} value was obtained for the nine specimens tested, that being a T-L oriented specimen with a critical toughness of 46.4 KSI $\sqrt{\text{in}}$ (51.0 MPa $\sqrt{\text{m}}$). Results listed in Table 2 indicate this material is an extremely tough aluminum alloy, with possibly greater toughness in the L-T orientation than in the T-L orientation. Fracture appearances for all the invalid specimens was consistently irregular, as shown in Figure 9, for specimens #LT-1B and #20-K4. In all the invalid cases, rapid fracture occurred on approximately a 45° plane relative to the precrack plane. Fracture appearance of the one valid specimen, #TL-1B, was a more traditional flat fracture with minimal shear lip formation, as shown in Figure 9.
