USAAVRADCOM-TR-82-D-35

**VERIFICATION TESTING OF A UH-1 WIRE STRIKE PROTECTION  
SYSTEM (WSPS)**

**LeRoy T. Burrows**

**November 1982**

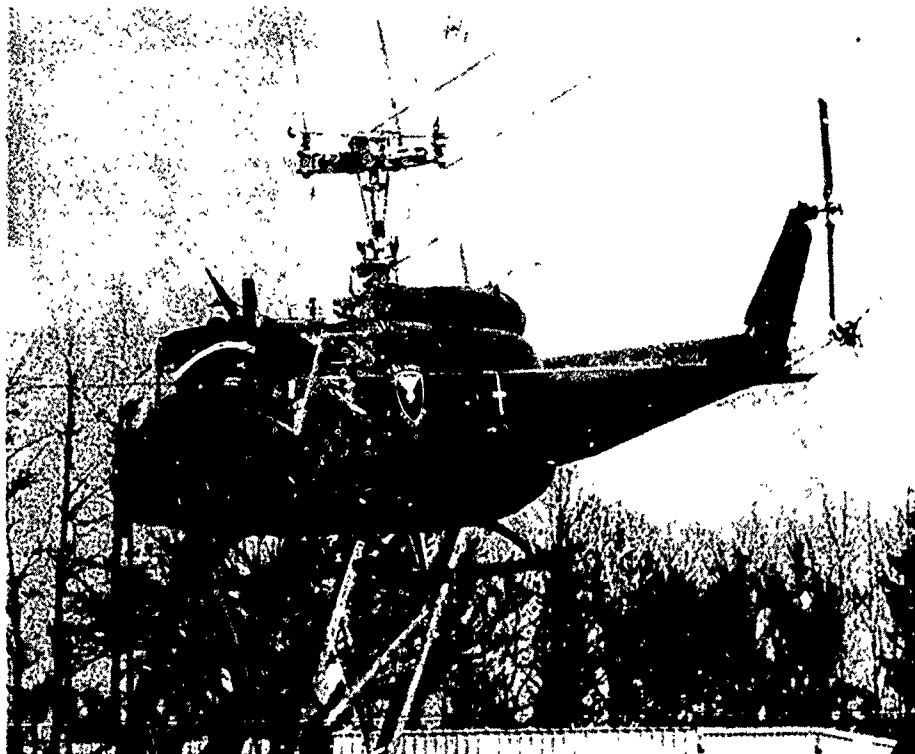
Figure 6. Test aircraft in pre-pullback position.

For this test the wire impact point was to be on the windshield at a point approximately one-third up the side post. The wire was strung at an angle 30 degrees from the normal to the flight path. The pre-pullback position of the helicopter is shown in Figure 6 and the pullback position in Figure 7. The aircraft impacted the cable at the desired location and velocity without damage to the glass windshield. The cable then deflected upward to the windshield wiper shaft, where it snagged. The structure behind the wiper shaft collapsed, allowing the cable to enter the upper cockpit area and preventing it from deflecting to the upper cutter. In the absence of a cable cut, the supporting line pole broke into three sections, and two anchors were pulled out. The resulting damage to the test helicopter is depicted in Figures 8, 9, and 10 which show side, front, and top views respectively. It was obvious that the windshield wiper shaft posed a serious limitation to the WSPS configuration tested. Both BAL and ATL, with Headquarters, AVRADCOM concurrence, agreed to investigate means of alleviating this limitation with minimum cost, weight, and performance penalties.

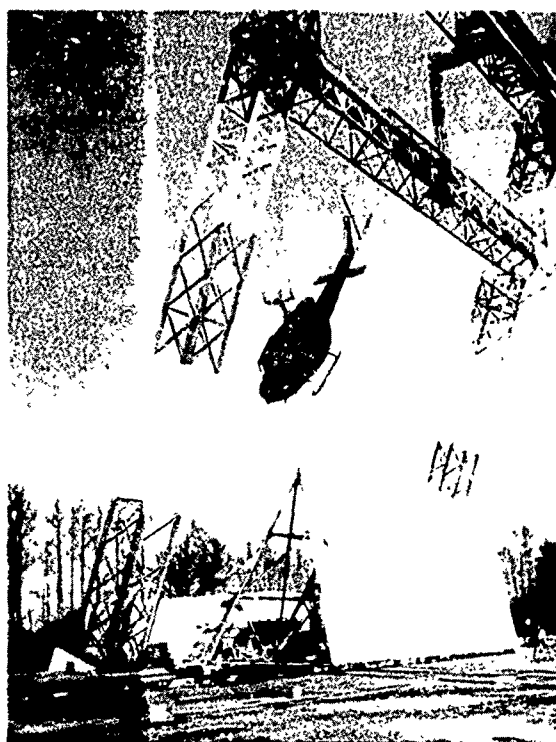
Figure 7. Test aircraft in pullback position.

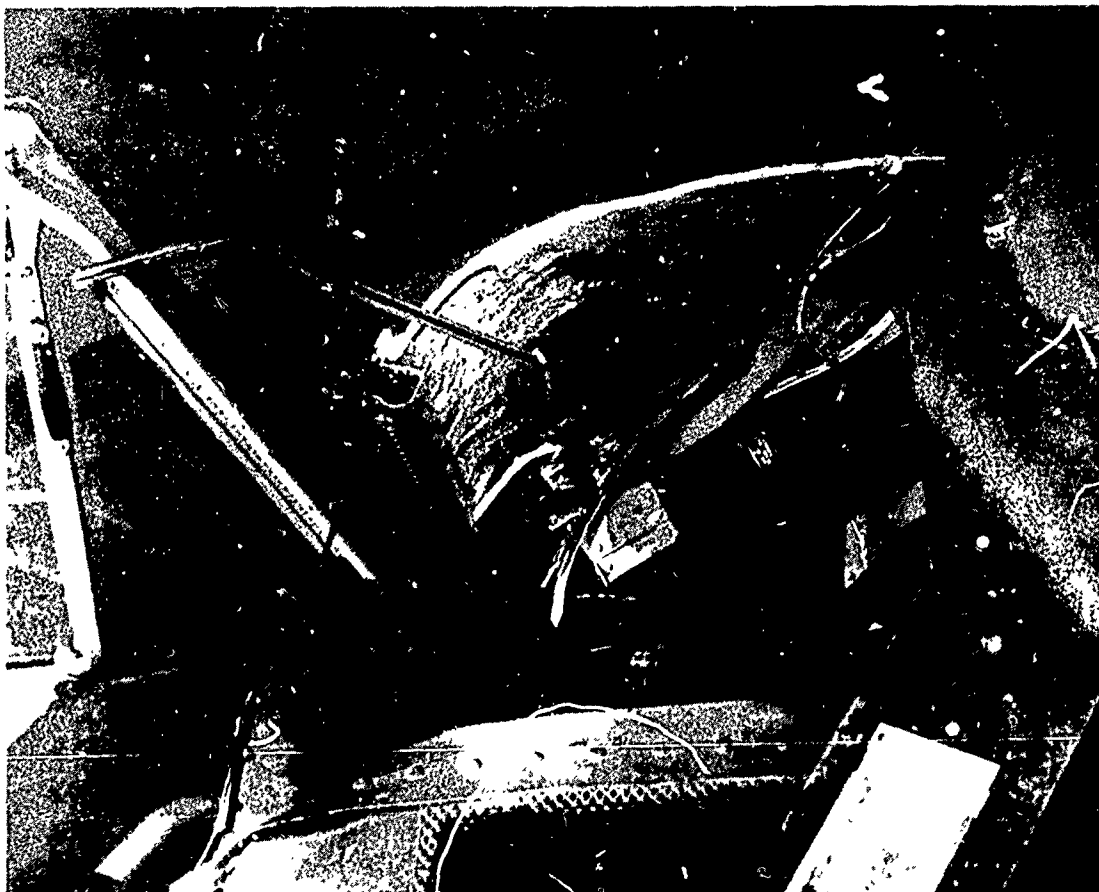
Figure 10. Test 3 aircraft damage, top view.

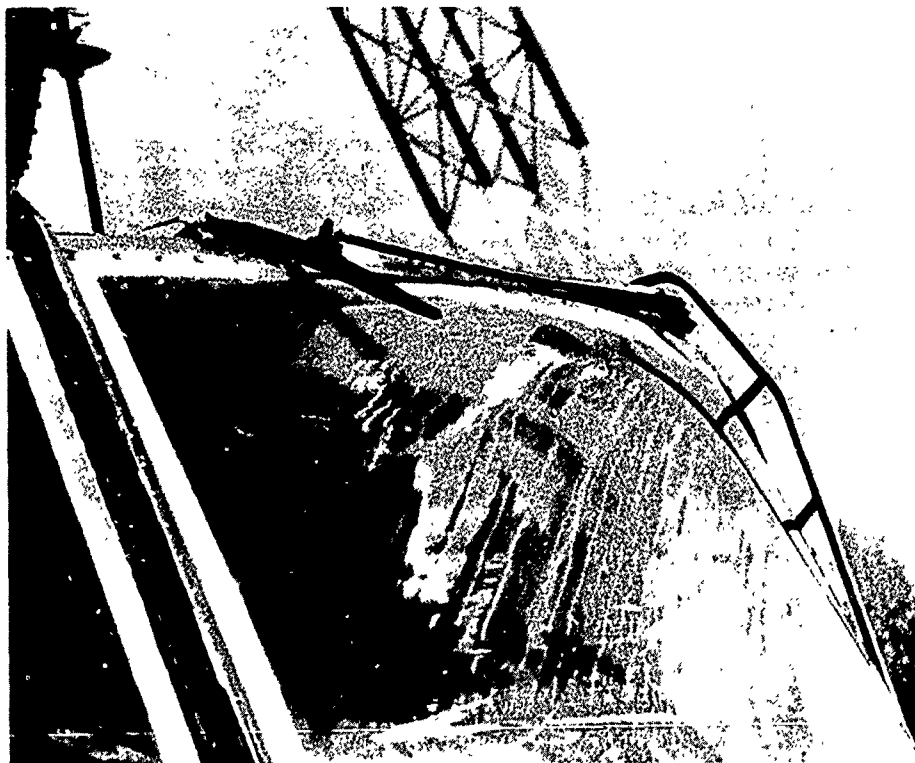
Figure 13. Aircraft condition after test 5.

A windshield wiper post deflector designed and fabricated by BAL was installed on the test aircraft (Figure 11). The aircraft was swing tested at the same conditions as Test 3 and a successful cut of the objective wire resulted (Figure 12), thus eliminating the wiper post as a snag problem. Figure 13 shows the aircraft after test. Note the paint marks on the windshield which depict wire impact location below the wiper deflector and subsequent deflection over the wiper into the upper cutter.
