ESD-TR-82-259

MTR-8682

FIBER OPTIC CABLE VULNERABILITY TEST,  
WHITE SANDS, NEW MEXICO

DECEMBER 1982

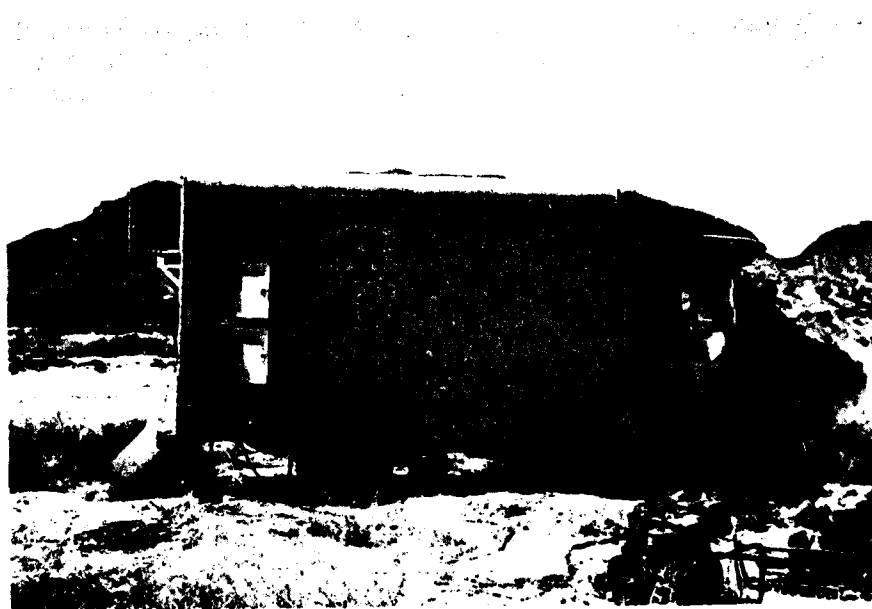
Figure 4. MITRE Fiber Optic Laboratory Van

Test preparations and measurements were conducted from a MITRE van that was specially configured for this test. The van served as a mobile fiber optics laboratory providing workspace and housing equipment used during the test. A photograph of the van at the test site is shown in figure 4.

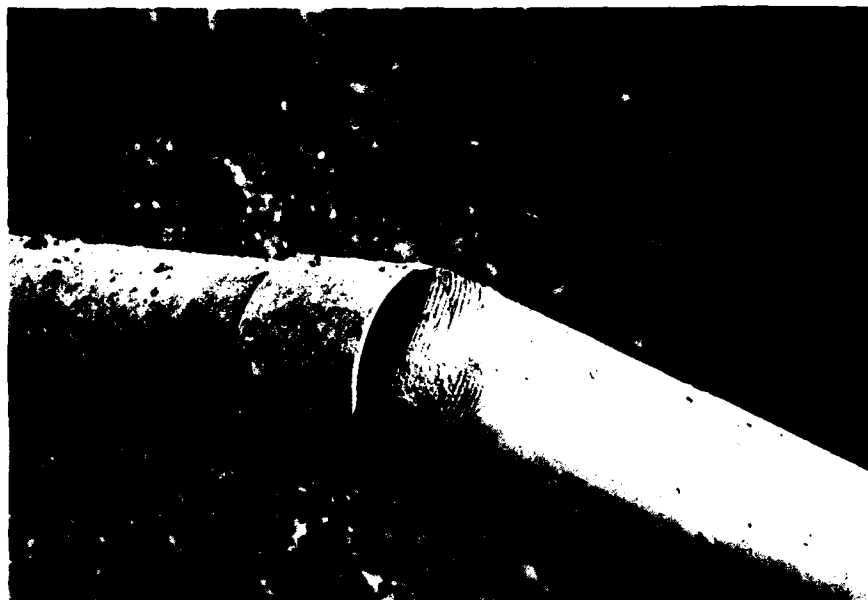
Figure 11. Vertex Formed by Conduit Separation

A differential attenuation in cable B-1-C was caused by a localized stress point created by the upheaval of the B-1-C conduit. The conduit was disconnected at all three of its joints with the middle two sections forming a triangle (shown in figure 11) sticking up out of the crater about 3 to 4 feet. The vertex of this triangle formed a sharp edge with the end of one section jammed into the opening of the next one. The cables were all somewhat pinched and under a great deal of tension. The combination of the tensile stress and the sharp edge caused the final attenuation. Upon closer examination, it was found that the outer jacket and some of the underlying KEVLAR<sup>R</sup> had been cut rather deeply by the jammed conduit. Despite this severe outer jacket damage, the optical link was still operational even with the induced attenuation.
